| Title: | TCU Module Software Patch | | | |
| Number: | SB_498 | Release Date: | 03/01/2021 | |
| Chassis Type: | All Command Zone III Chassis with a TCU | | | |

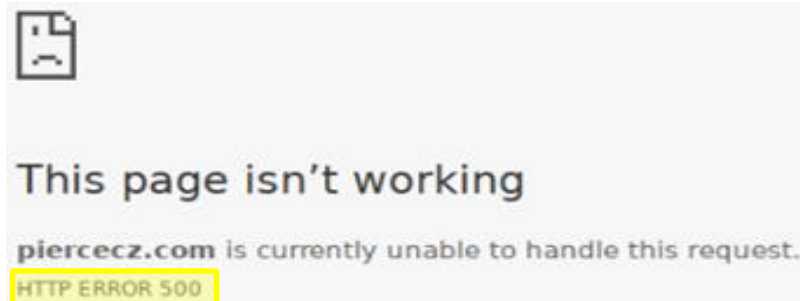
- Software Patch Installation Steps
  - Connect to the TCU using a PC web application
  - Navigate to PierceCZ.com using Incognito or Private browser window
    - If “HTTP ERROR 500” error below displays, proceed to **Step 3**

3. Ordering Replacement TCU to resolve HTTP 500 Error:

- Place Order for PN 3630705
  - Provide Job Number and Unit Number on Order
