Technical Journal

Connectivity services activation - PSIM issues

REF NO:
TJ 35902.1.1

FUNC DESC:
Mobile data services

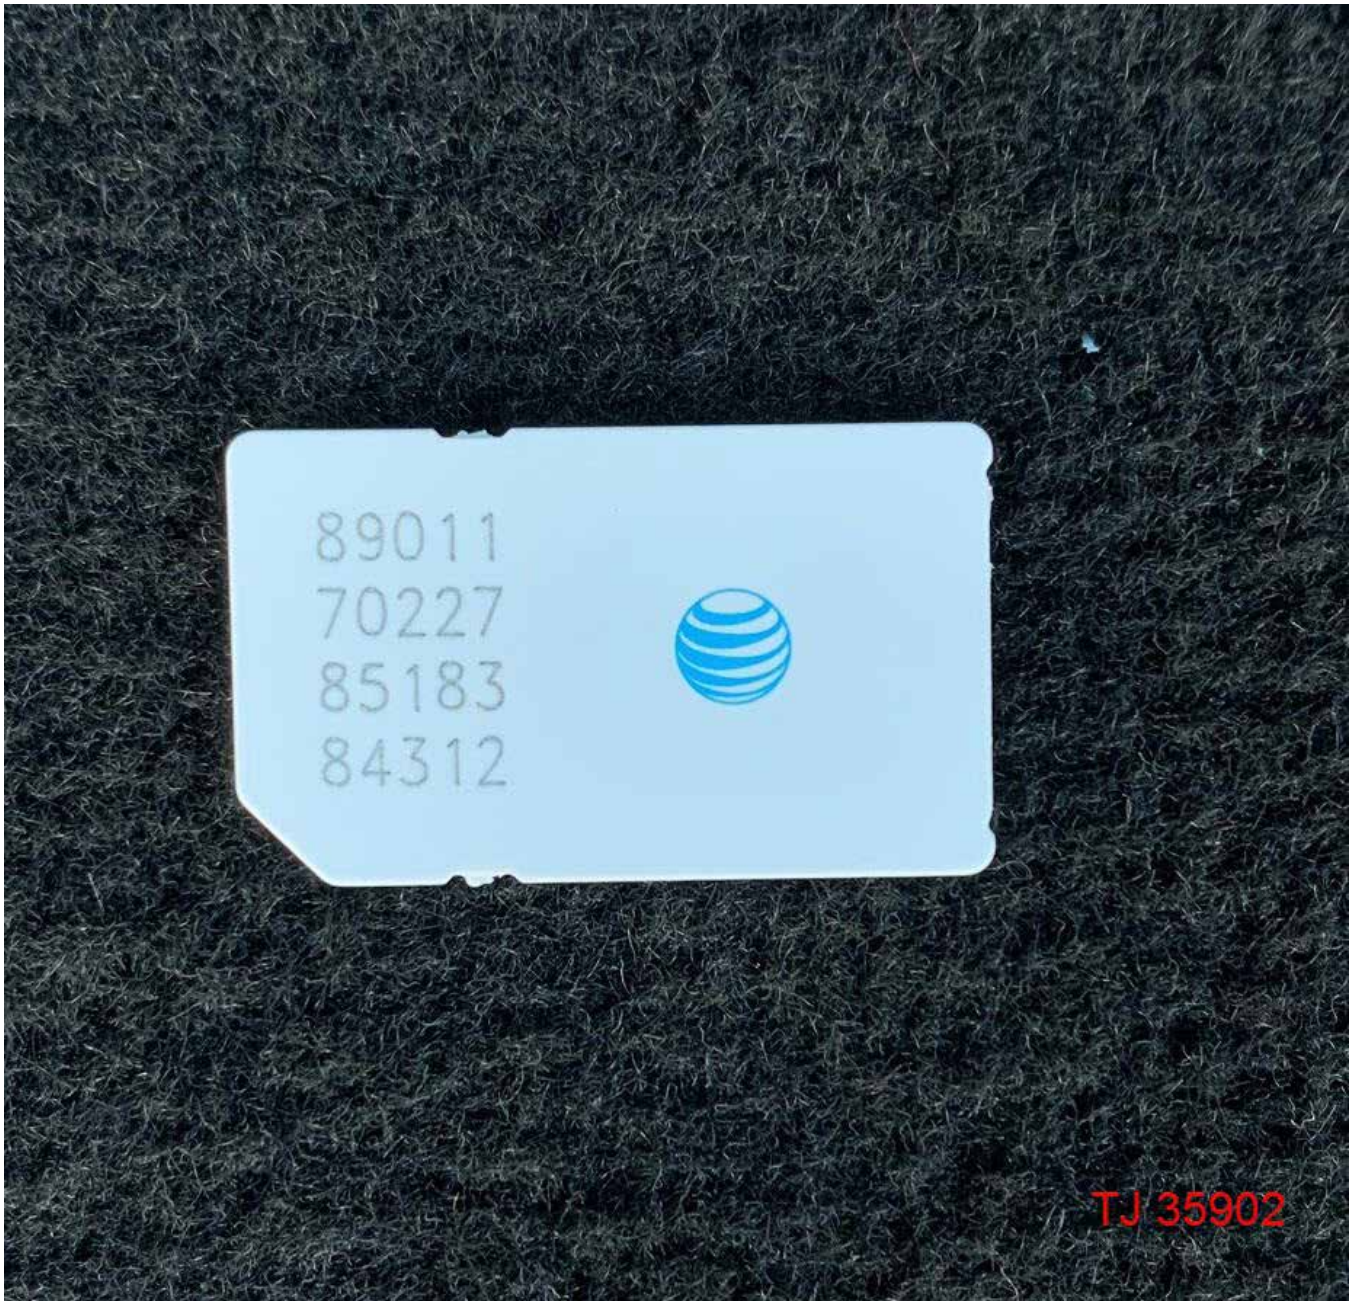
File Name	File Size
TJ_35902_PSIM.jpg	0.2798 MB

Create a TIE Vehicle report and attach a clear photo of the PSIM card with the serial number showing (see attached example *TJ_35902_PSIM.jpg*)

RTS will have the VIN and PSIM added to the AT&T system.
