Park Assist System Service Required Message in DIM

REF NO: TJ 31558.10.0	ISSUING DEPARTMENT: Technical Service	CAR MARKET: United States and Canada	
PARTNER: 3 US 7510 Volvo Car USA		ISSUE DATE: 2021-03-10	STATUS DATE: 2021-03-22
FUNC GROUP: 3871	FUNC DESC: Parking assistance	Page 1 of 5

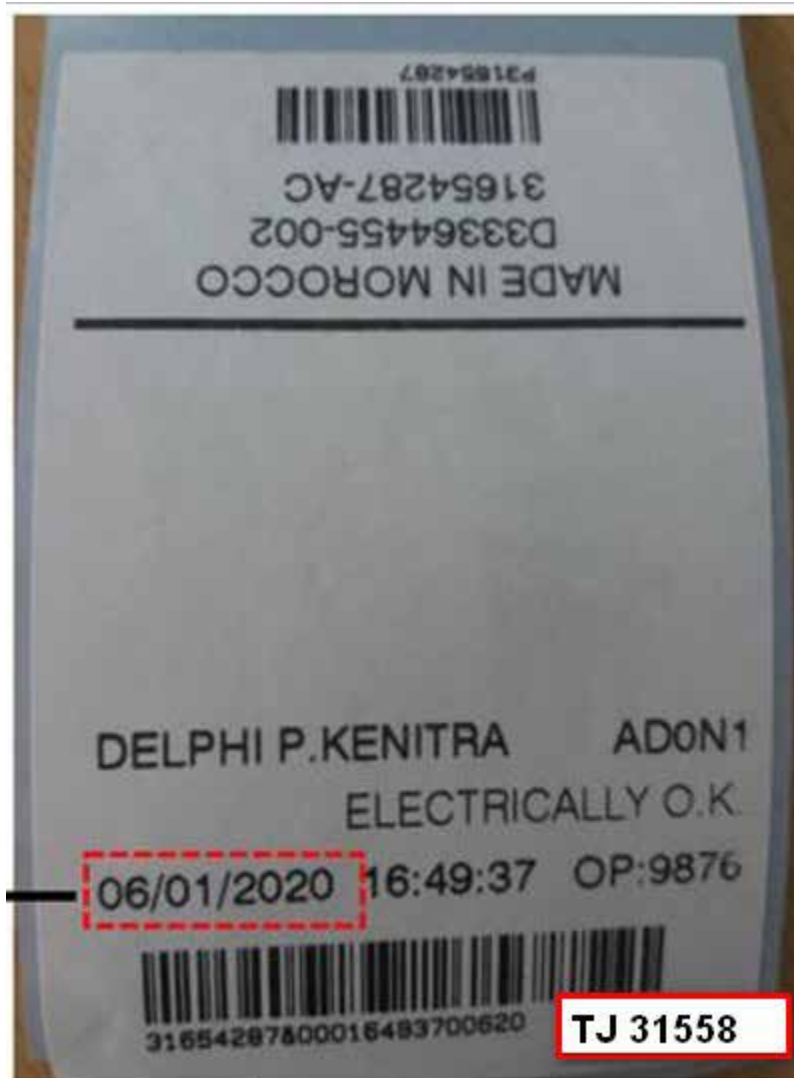
File Name	File Size
TJ 31558.jpg	0.0368 MB

- *1. Replace the cable harness according to VIDA instructions, function group 37xx cable harness front / rear bumper. Improved bumper harnesses are implemented from the date marking indicated on the label in attachment [TJ 31558.jpg](#)
