SIB 12 22 19

2021-03-17

EME GROUND CONNECTION MONITORING FAULTS

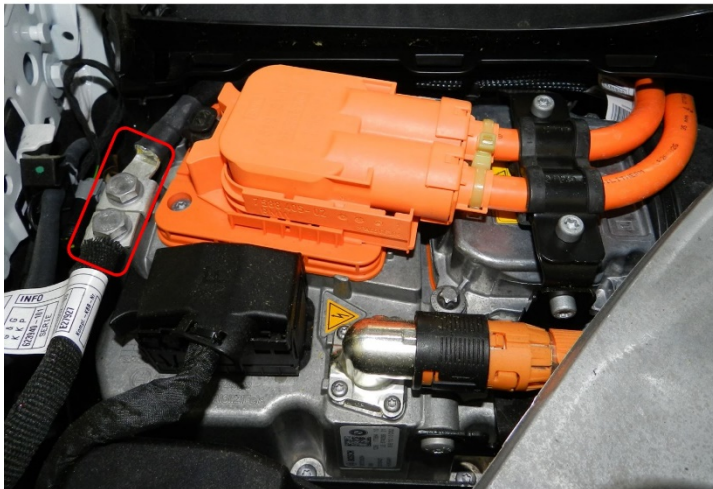
Increased ground cable contact resistance at Electrical Machine Electronics (EME) due to corrosion/oxidation.

1. Remove both grounding cables at the EME. (G30 shown)

2. Clean the contact surface of both grounding cables and the ground support point at the EME using 1200 grit emery cloth stainless steel brush or equivalent.
3. Remove residual debris using air and cleaning cloth.
4. Refit both ground cables
5. Replace both (2) grounding point bolts at the EME (part #: **12 36 5 A20 8E6**).
6. Torque grounding point bolts to 19Nm.
7. Clear faults and retest vehicle.
