SIB 52 02 21

SECOND ROW SEAT LEATHER CLOUDY/DISCOLORED

F95 X5 M Sports Activity Vehicle	F96 X6 M Sports Activity Coupe	G05 X5 Sports Activity Vehicle	G06 X6 Sports Activity Coupe
G07 X7 Sports Activity Vehicle

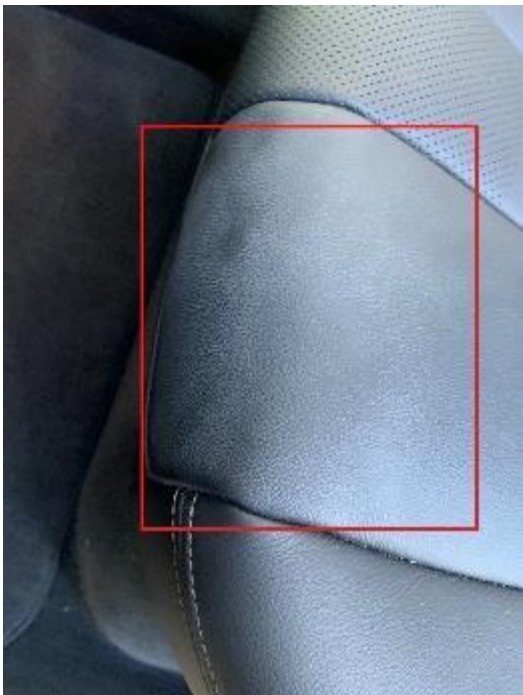
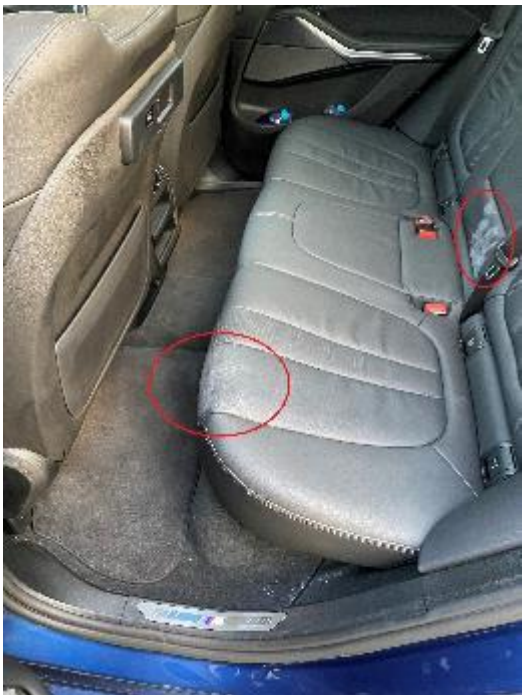
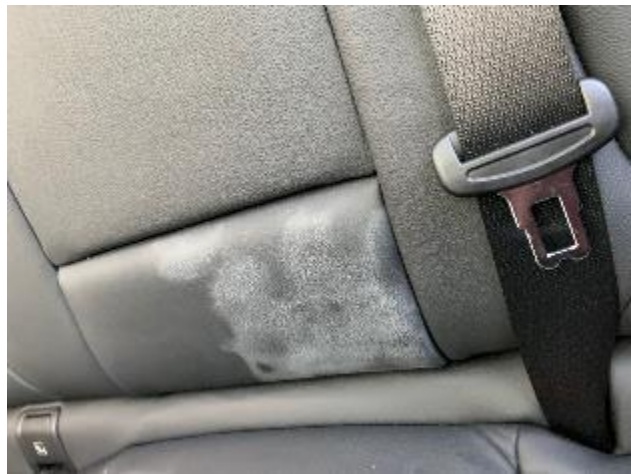
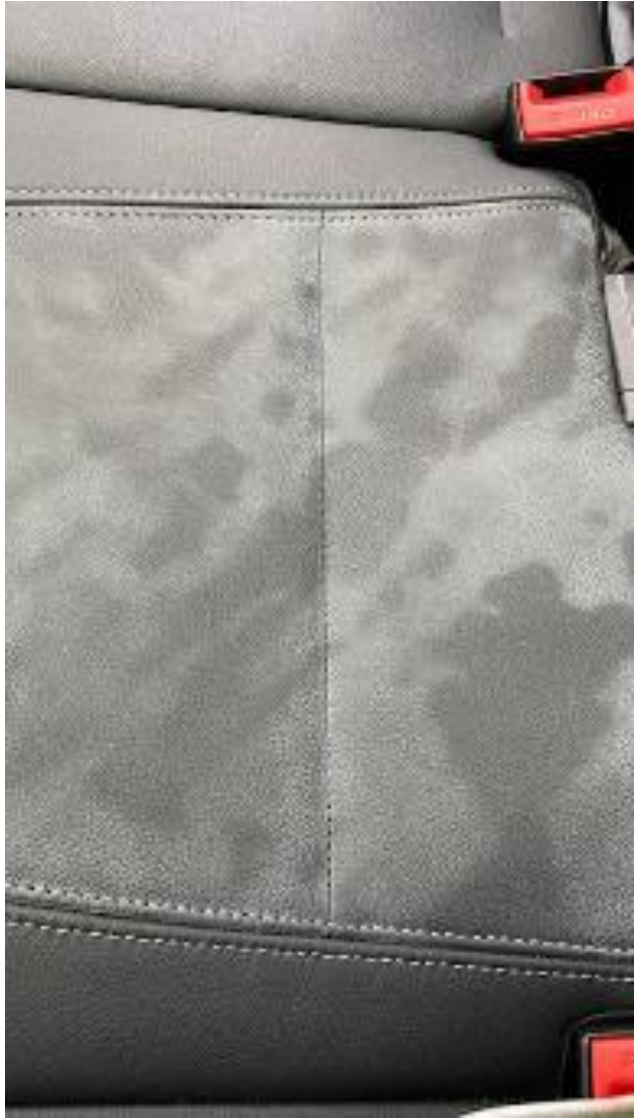
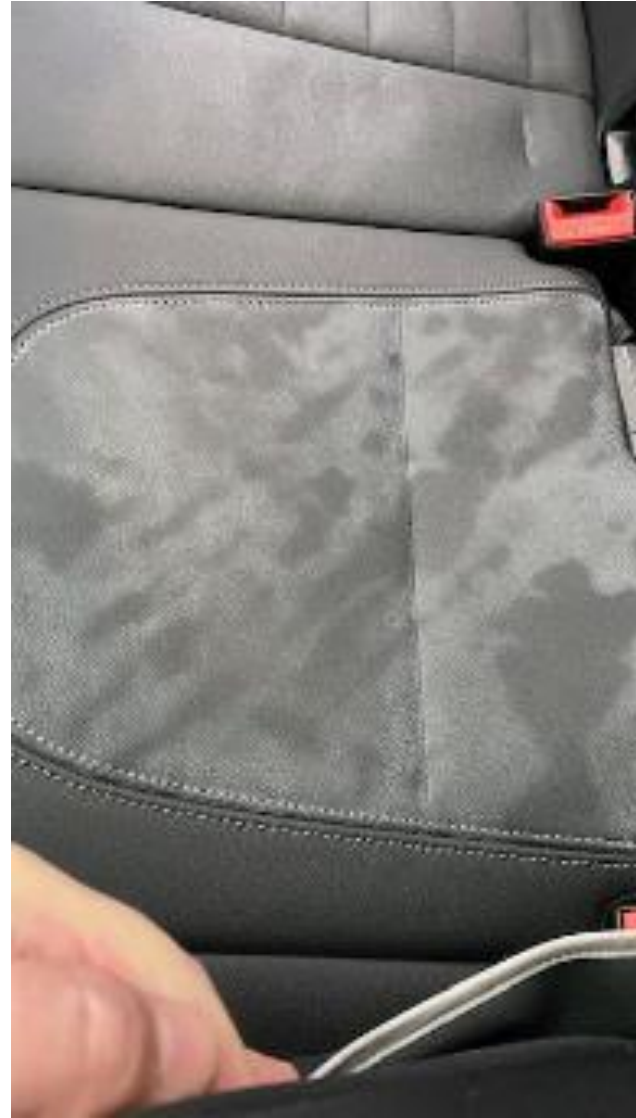
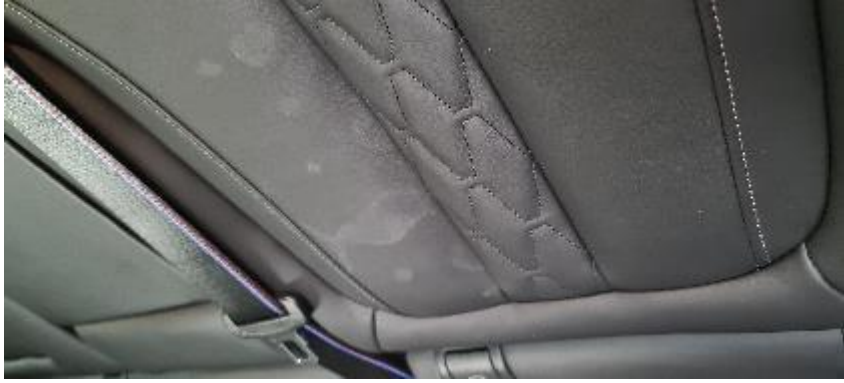
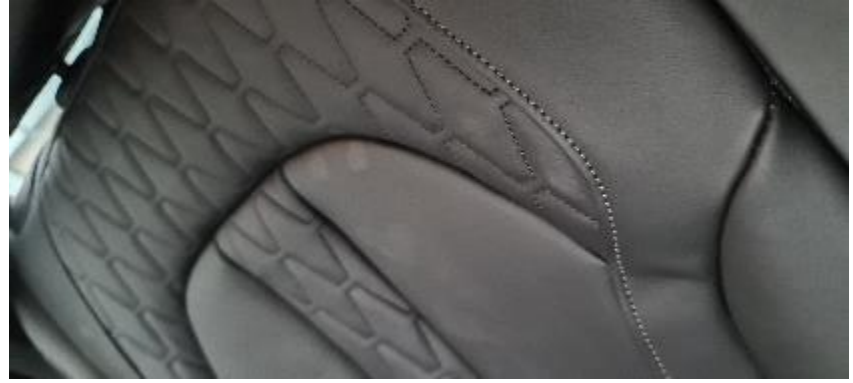
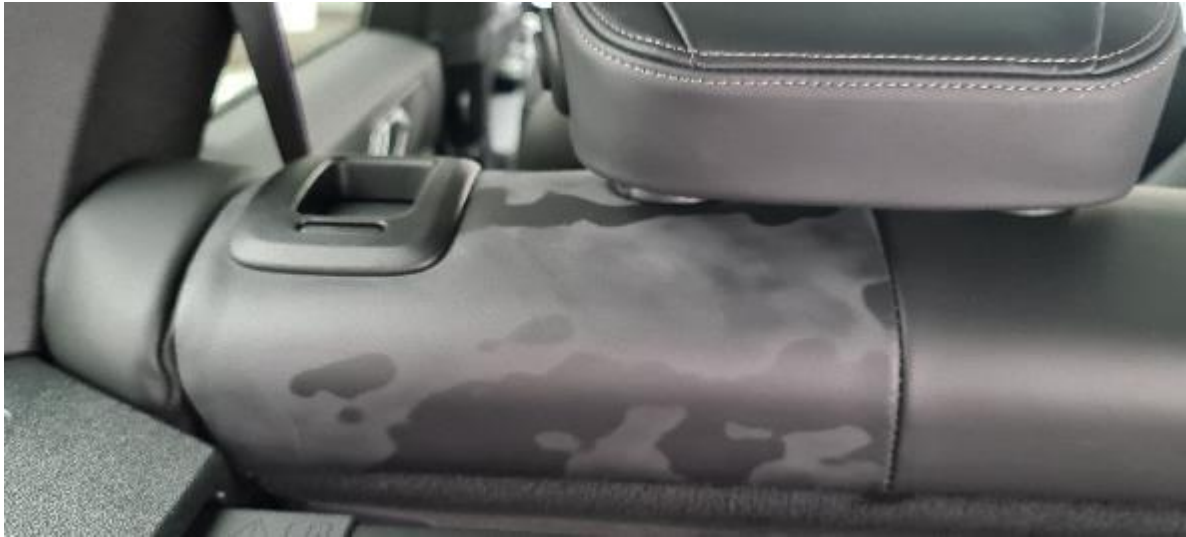
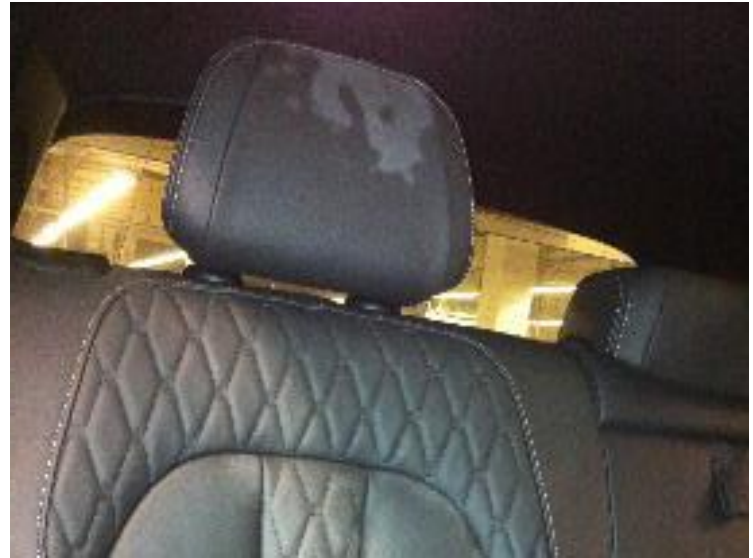
Milky-white stains (discolorations) in the leather are observed in the second-row seat bottom, backrests and/or headrests. Refer to attachment for details.

An unfavorable leather tanning process can result with isolated cases of grease residue accumulating in the second-row seat leather surfaces.

Only for the specific issue identified in the attachment, remove the tanning process-related residue in the second-row seat leather as outlined in the PROCEDURE section below.

- 1) Using a hot air blower held at 4" to 8" from the affected area, heat the leather surface with circular movements at a temperature above 160 °F/ 70 °C until the greasy residues disintegrate completely.

Ensure that the temperature of the affected area does not get warmer than 195 °F/ 90 °C as otherwise the leather can be damaged.
