SIB 62 08 18

2021-03-11

INSTRUMENT CLUSTER DISPLAY SHAKES-SHIFTS TO THE LEFT

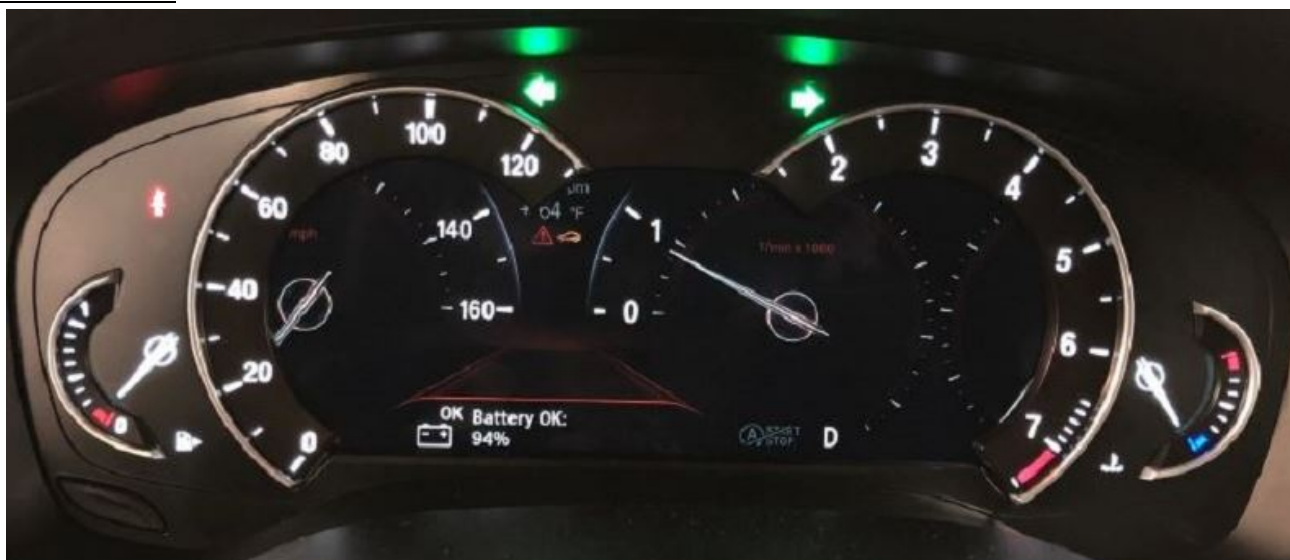
The Instrument

cluster intermittently flickers, shakes and has shifted to the left.

The fault is resolved once the vehicle goes into sleep mode.

The fault can reoccur at any point.

Problem with the contact at the Automotive Pixel Link connection plug on the instrument cluster.

Software error in the Instrument cluster (Kombi)

Replace the instrument cluster (Kombi).

Program vehicle and perform ABL Dashboard: "Display jitters/shifts to the left"
