SIB 66 29 19

2021-03-26

TOP VIEW CAMERA: IMAGE IS MISALIGNED

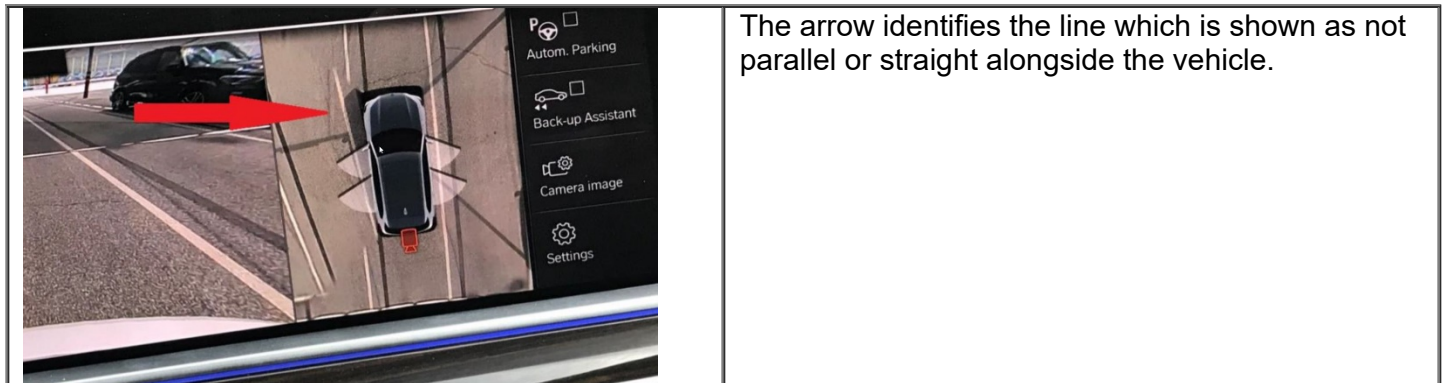
The top view image of the vehicle is misaligned when observed in the Control Information Display (CID). When the vehicle is parked in a parking spot with line markings, it is clearly noticed in the CID that the lines are not parallel to the side of the vehicle. This may be noticed on either the driver side, passenger side or both.

The arrow identifies the line which is shown as not parallel or straight alongside the vehicle.

Side view camera loose fitment in the exterior mirror bracket, causing changes to the top view image.

Reposition the camera in the exterior side view mirror with felt tape and / or software update with ISTA 4.26.3x or higher. Target Integration level (I-level) of S15A/S18A-20-11-500 or higher.
