SIM 41 01 21

SERVICE ACTION: REWORKING THE PVC SEAM ON THE TAILGATE WATER CHANNEL

E-Series	Model Description	Production Date
F55	MINI Hardtop 4 Door	September 24, 2020 – November 18, 2020

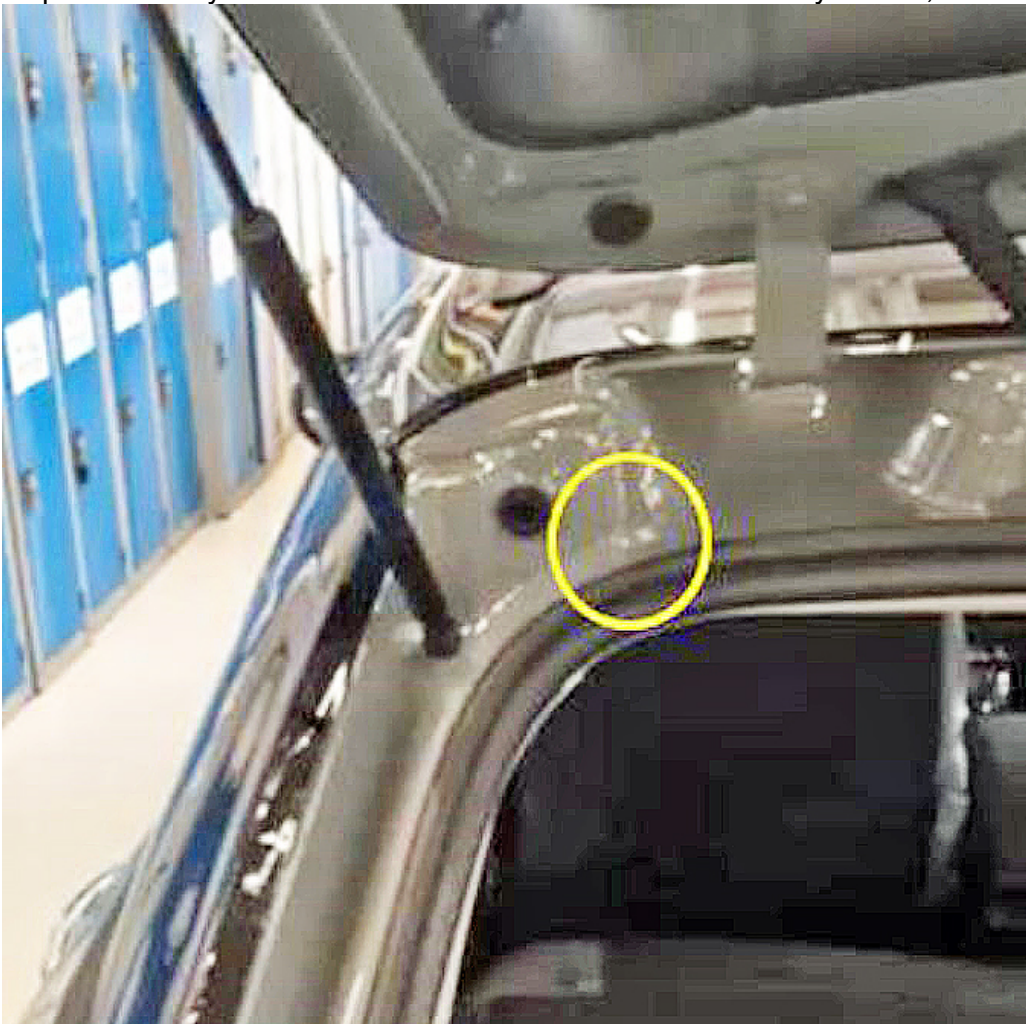
The body seam on the rear upper left of the body may not have been completely sealed, causing a water leak.

The body seam may not have been properly sealed during production.

Inspect the body seam shown below. If found to be incorrectly sealed, reseal the seam and apply paint.

3. Remove the tailgate rubber seal.
4. Clean the seam using an appropriate and available cleaner such as R2 cleaner P/N 83 19 0 417 324.
5. Seal the gap using seam sealer P/N 83 42 2 409 986.
6. Paint the new seam sealer using a touch up paint stick matched to the vehicle color.
7. Install a new tailgate rubber seal following repair instructions 51 76 046 "Replacing tailgate seal".

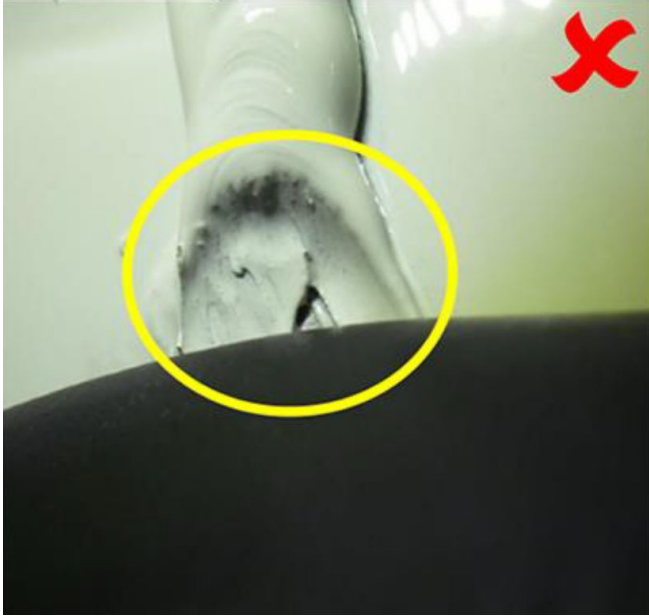
1. Carefully lift the outer lip of the tailgate rubber seal with your fingers and check the seam.

2. Is a hole or gap found in the sealer as shown to the left?

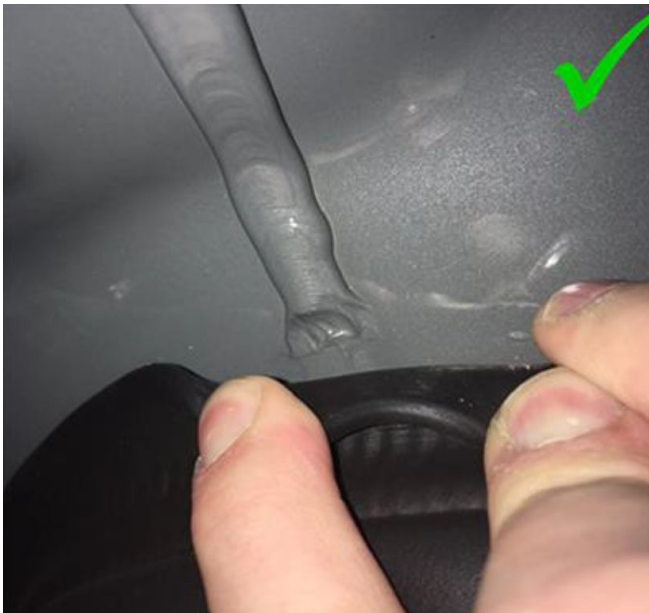
No: (refer to photo below)- No further correction is needed.

Note: Shown to the left is an example of an OK seam which doesn't require any correction.
