SIB 21 01 21

## INDIVIDUAL CLUTCH PARTS UNAVAILABLE

2021-03-19

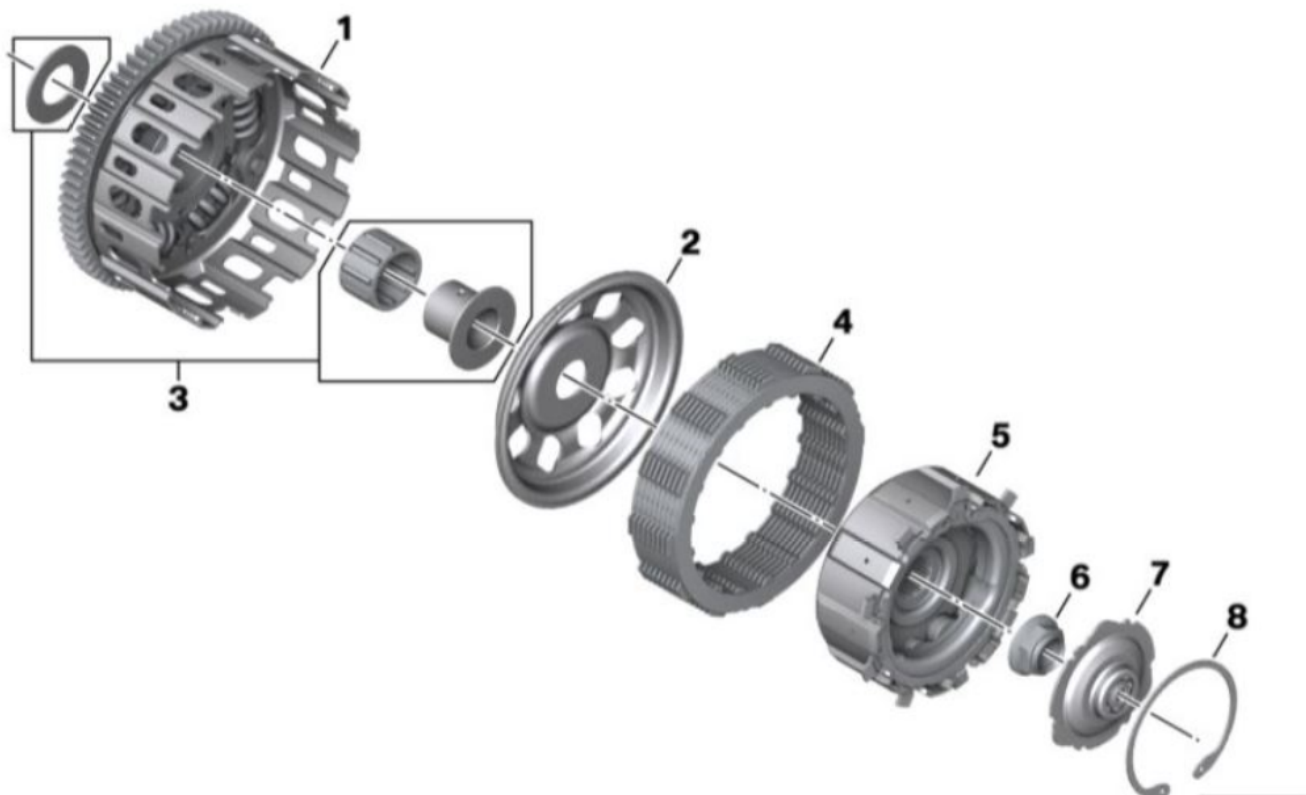
*Figure 1: Previous Build Level*

For K83, K84, produced up to August 2020, no individual replacement parts will be offered for the clutch; see image "Figure 1: Previous Build Level", below.

If necessary, motorcycles produced prior to August 2020 should have their clutch updated to the newer version.

For removal, please choose the K83/K84 repair instructions (first build level), or those provided with the vehicle identification number, "Install/remove or replace clutch". Take note of any special tools you may need.

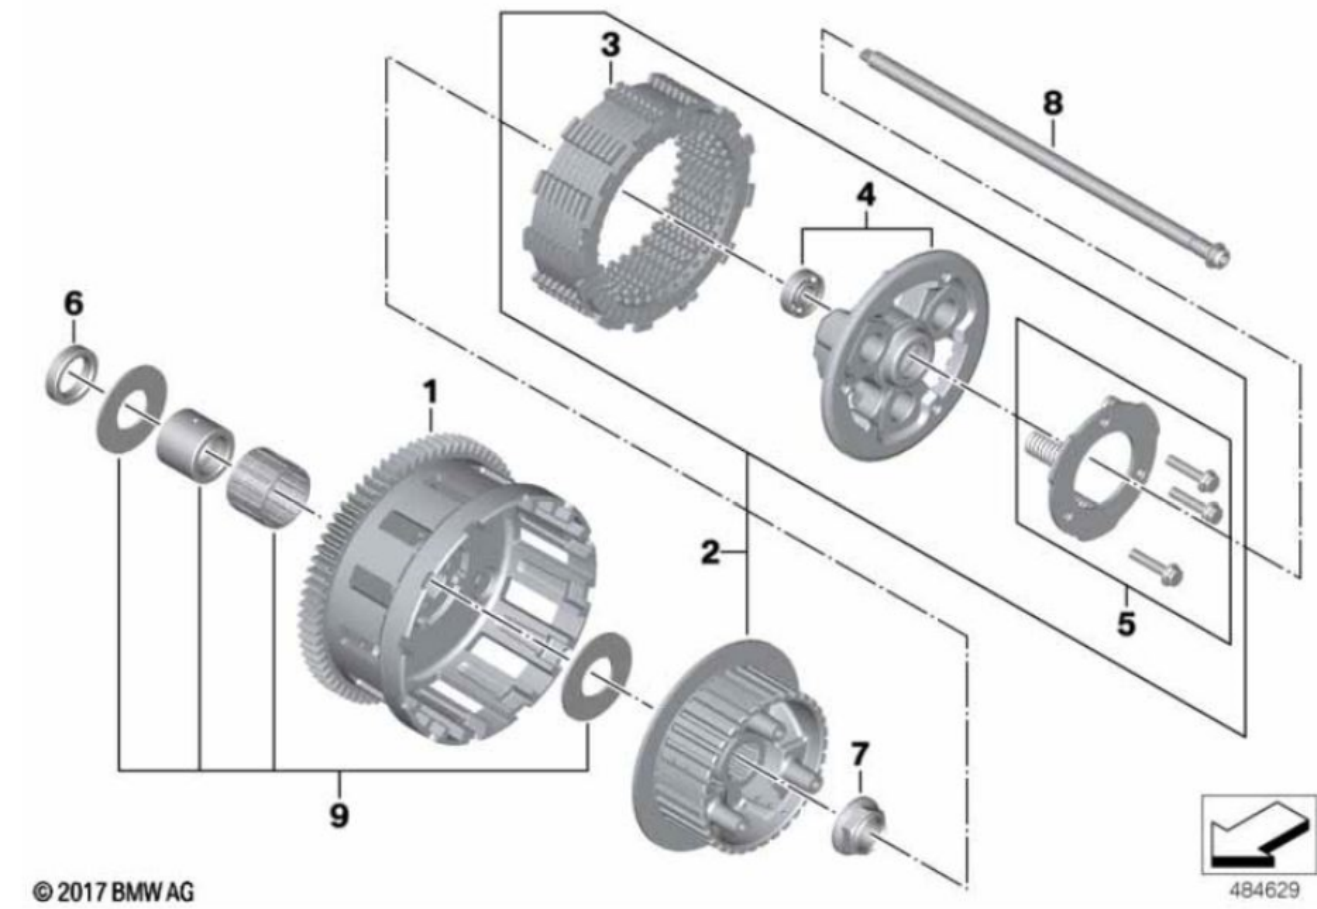
*Figure 2: Current Build Level*

For vehicles produced since August 2020, a new build level of the clutch is installed (analogous to K80, K81, K82) in the standard and replacement engines, see "Figure 2: Current Build Level", below.

The new clutch to be installed, part number 21 21 8 565 058, is identical to the clutch in models K80/K81/K82. The new clutch is installed according to the installation instructions for a K80/K81/K82 or K83/K84 (build level from August 2020) clutch under "Remove/install or replace clutch". Take note of any special tools you may need.

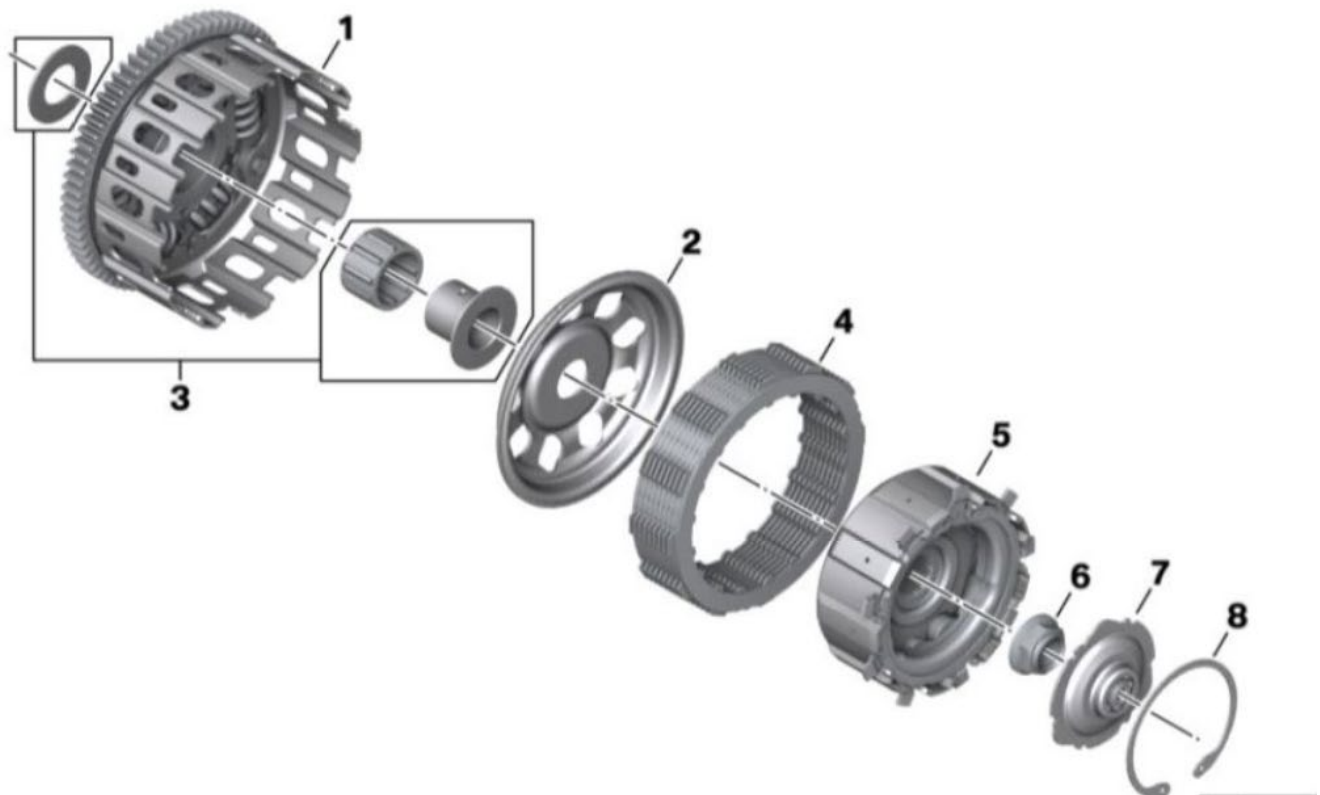
*Figure 1: Previous Build Level*

For K83, K84, produced up to August 2020, no individual replacement parts will be offered for the clutch; see image "Figure 1: Previous Build Level", below.

If necessary, motorcycles produced prior to August 2020 should have their clutch updated to the newer version.

For removal, please choose the K83/K84 repair instructions (first build level), or those provided with the vehicle identification number, "Install/remove or replace clutch". Take note of any special tools you may need.

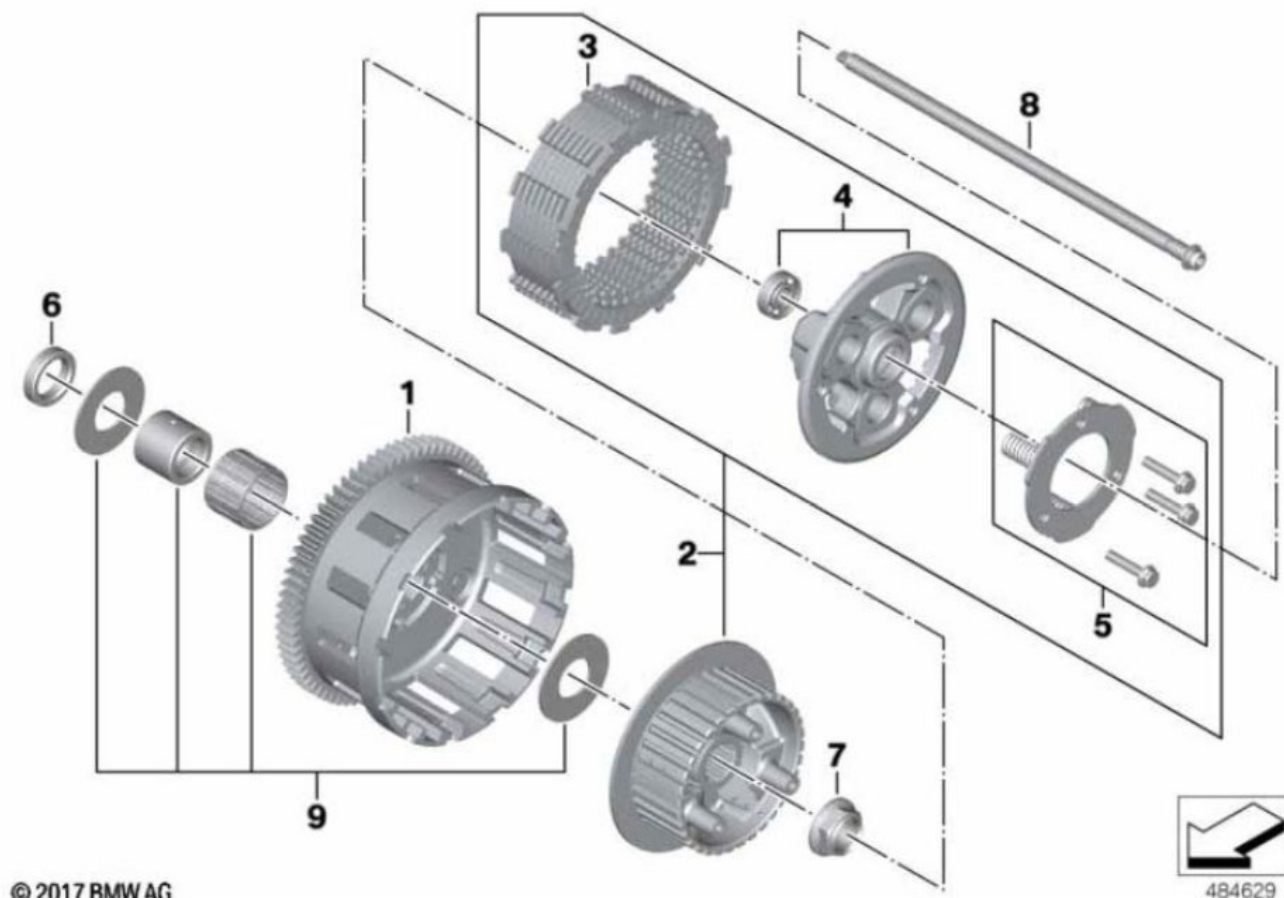
*Figure 2: Current Build Level*

For vehicles produced since August 2020, a new build level of the clutch is installed (analogous to K80, K81, K82) in the standard and replacement engines, see "Figure 2: Current Build Level", below.

The new clutch to be installed, part number 21 21 8 565 058, is identical to the clutch in models K80/K81/K82. The new clutch is installed according to the installation instructions for a K80/K81/K82 or K83/K84 (build level from August 2020) clutch under "Remove/install or replace clutch". Take note of any special tools you may need.
