SIB 61 05 21

SERVICE ACTION: WIRE ROUTING ADJUSTMENT

2021-03-23

| Model | Model Description | Production Date |
|---|---|---|
| K33 11 | R nineT Urban G/S | To February 24, 2021 |

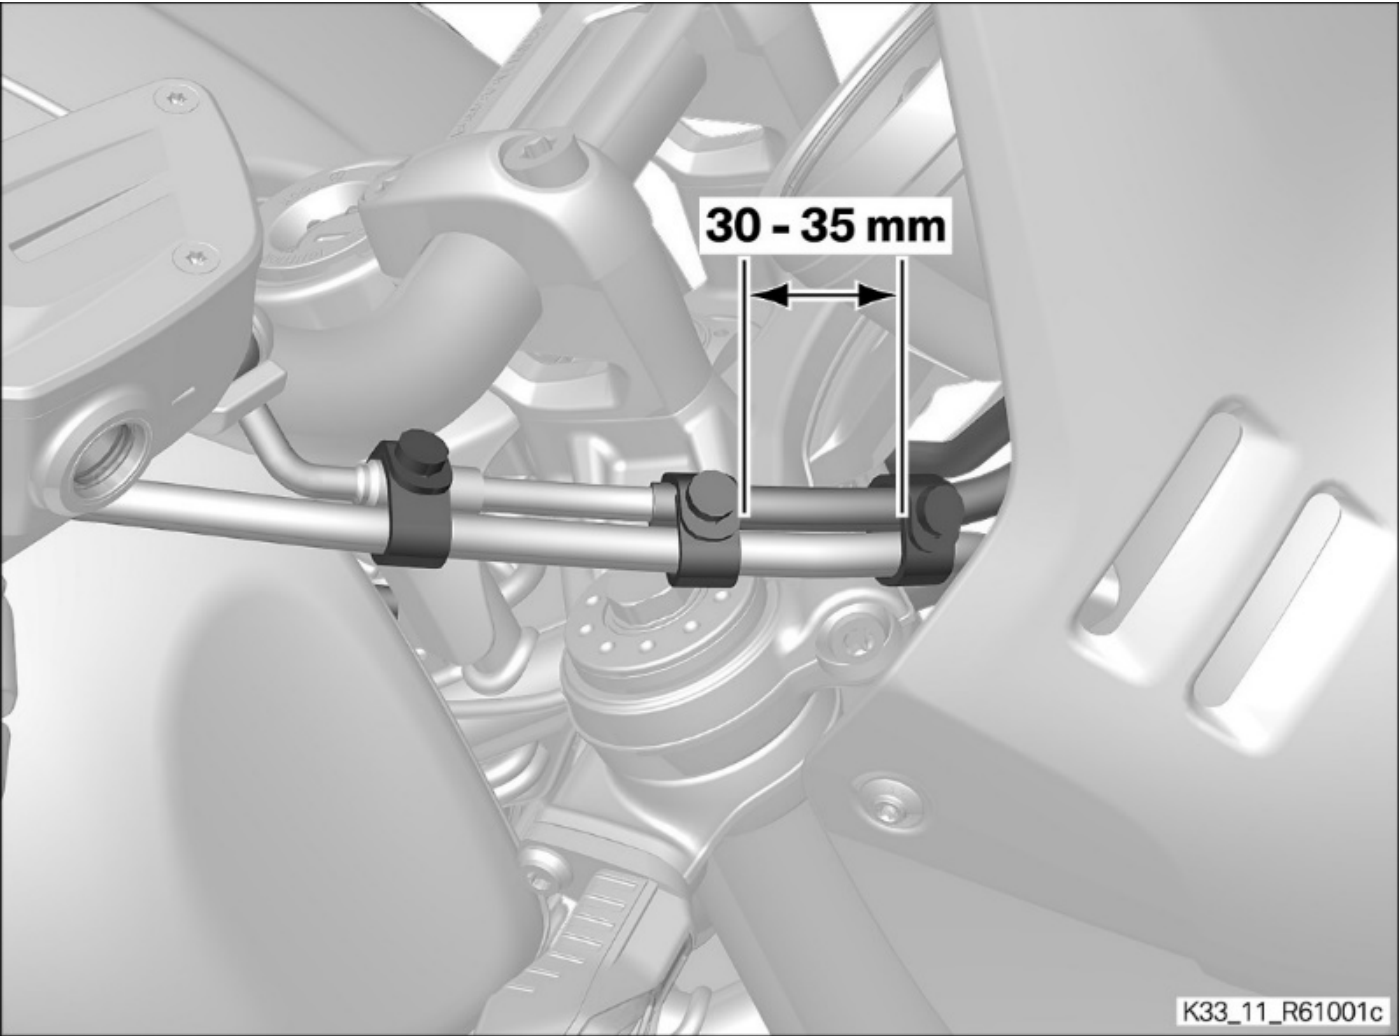
The bands holding the wiring harness in the area of the steering head are positioned incorrectly from the factory. This can cause rubbing against the steering head at maximum steering angle and could eventually cause damage to the surface of the steering head.

Position the bands as illustrated in the image below.

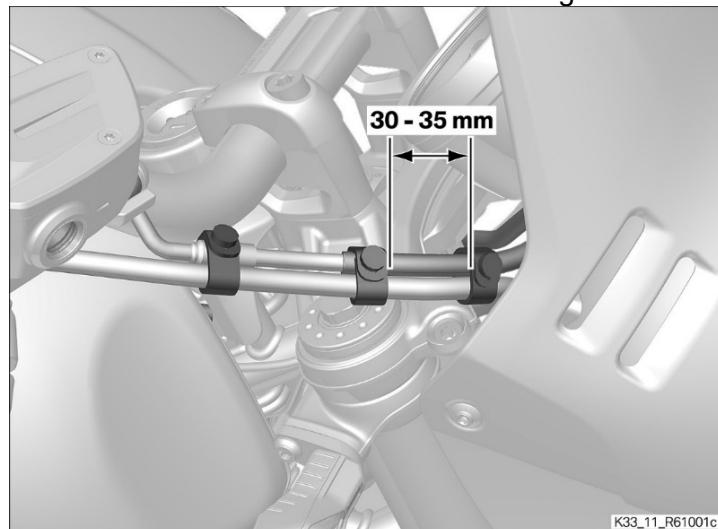
The bands holding the wiring harness in the area of the steering head are positioned incorrectly from the factory. This can cause rubbing against the steering head at maximum steering angle and could eventually cause damage to the surface of the steering head.

Position the bands as illustrated in the image below.
