McLaren Elva Emergency Cabin Cover Customer Fitment Instruction

Bulletin type: Service Campaign
Reference number: SCB 26 Q 002
Attention: EU, NA, APAC and MEAF Retailer Service Managers and Retailer Technicians
Affected vehicles: McLaren Elva
Situation: The emergency cabin cover customer fitment instruction was not placed inside the emergency cabin cover bag prior to shipment
Procedure: Action affected vehicles during next Retailer visit. Please refer to the information outlined in this document to provide the part in the customers vehicle
Date: 8th April 2021

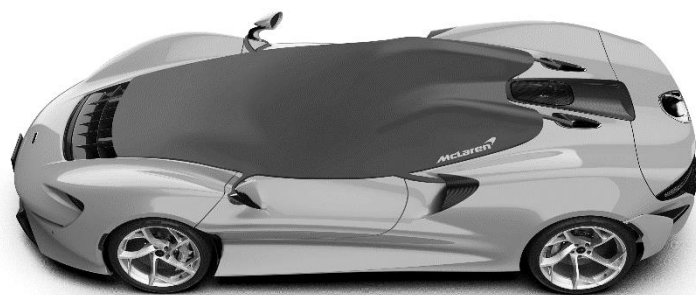
Emergency Cabin Cover Fitment Instruction (A5 laminated sheet)

Through continuous product quality monitoring, it has been identified that a number of McLaren Elva vehicles did not have the emergency cabin cover customer fitment instruction placed in the emergency cabin cover bag prior to shipment. Therefore, ordering and placement of the part inside the vehicle is required. If the vehicle has been handed over to the customer, please forward the part on.

To perform the required work, order the part and place inside the emergency cabin cover bag located in the space under the tonneau cover. If the vehicle has been handed over to the customer, please forward the part on.
