# McLaren Speedtail - Rear Clutch Breather Pipe Rework at 1<sup>st</sup> Service

**Bulletin type:** Service Campaign  
**Reference number:** SCB 23 G 001  
**Attention:** Retailer Service Managers and Retailer Technicians  
**Affected vehicles:** McLaren Speedtail  
**Situation:** Potential for insufficient gap tolerance between components  
**Procedure:** Action affected vehicles during 1<sup>st</sup> Service ONLY. Please refer to the information outlined in this document to ensure required gap tolerance is achieved  
**Date:** 22<sup>nd</sup> April 2021

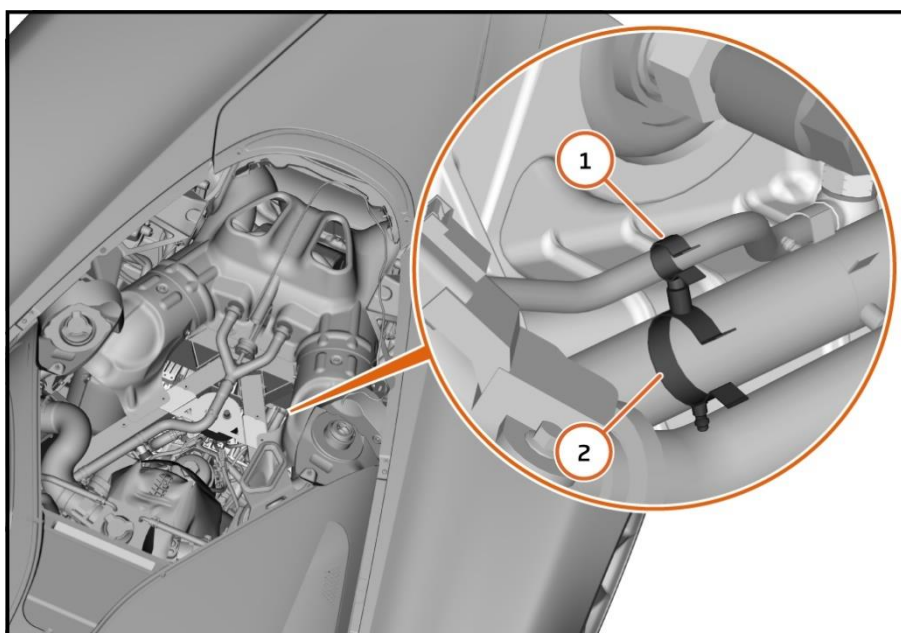
Through continuous product quality monitoring, it has been identified that a number of McLaren Speedtail vehicles, may have an insufficient gap tolerance between the rear clutch breather pipe and the (right hand) secondary air hose. This could cause damage to the components; therefore a preventive rework solution has been released.

Clip - Male (1), Swivel Clip - Male + Female (2)

These clips are to be installed at 1<sup>st</sup> service, while the airbox is removed (for access to the oil filter housing during servicing of the vehicle).

- 3.1 Remove airbox as part of 1<sup>st</sup> service (GA-RM-05F003-00-002 - Drain/Fill Engine oil).
- 3.2 Install clips together and position between the rear clutch breather pipe and the (right hand) secondary air hose according to the image in section 1, to ensure required gap tolerance between the components.
