MODEL
2021MY
Seltos (SP2)

NUMBER
PS695

RATTLE/CLUNK NOISE FROM REAR SEAT

This Pitstop provides information regarding a rattle or clunk noise from the rear seat area on some 2021MY Seltos (SP) vehicles when driving over bumps or uneven road surfaces.

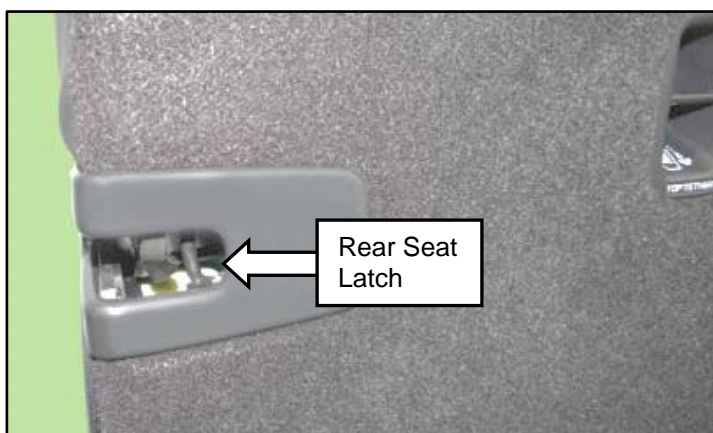
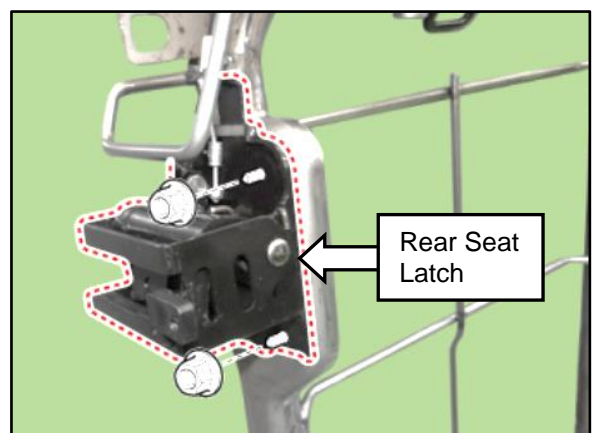
1. Duplicate the customer concern by driving over bumps or uneven road surfaces, and verify a rattle or clunk noise is heard.
2. Fold down the rear seat backs and retest by driving over the same road conditions to verify the noise is coming from the seat back latch area.
3. If the rattle/clunk noise is no longer present during the test, it may be caused by the rear seat back latch having excessive clearance to the striker. If this is the case:
 - a. Check for debris or any obstruction interfering with the latch.
 - b. Clear the area around the latch and test drive again with the seat backs up.

If the noise is still heard, or the latch cannot be adjusted properly, then one or both of the rear seat latches may require replacement.

Note: The latch can be replaced independently of the rear seat frame. Refer to EPC for part and LTS for labor operation if necessary.
