CHECK ENGINE LIGHT ON WITH DTC P0126:00

Bulletin No.: 01-011/21

Last Issued : 04/22/2021

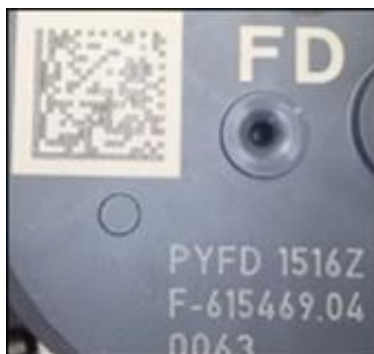
1. With a smart phone, scan the two dimensional code on the water control valve.
 2. The code consists of three blocks of codes where the sample picture is read as PYFD1516Z 171115 0000063 and the second block of the code is the production date in YYMMDD format.

- If the second block of the code is 201116 or greater (meaning November 16, 2020 or later), the coolant control valve is modified.
