RECALL: THIS MODIFICATION HAS TOP PRIORITY AND MUST BE PERFORMED IMMEDIATELY TO ENSURE CUSTOMER SAFETY

INSPECTION AND REPAIR OF THE MAIN WIRING HARNESS AND MODIFICATION OF THE TAIL END LOWER PART

**AFFECTED MODEL:
2020 1290 SUPER DUKE R**

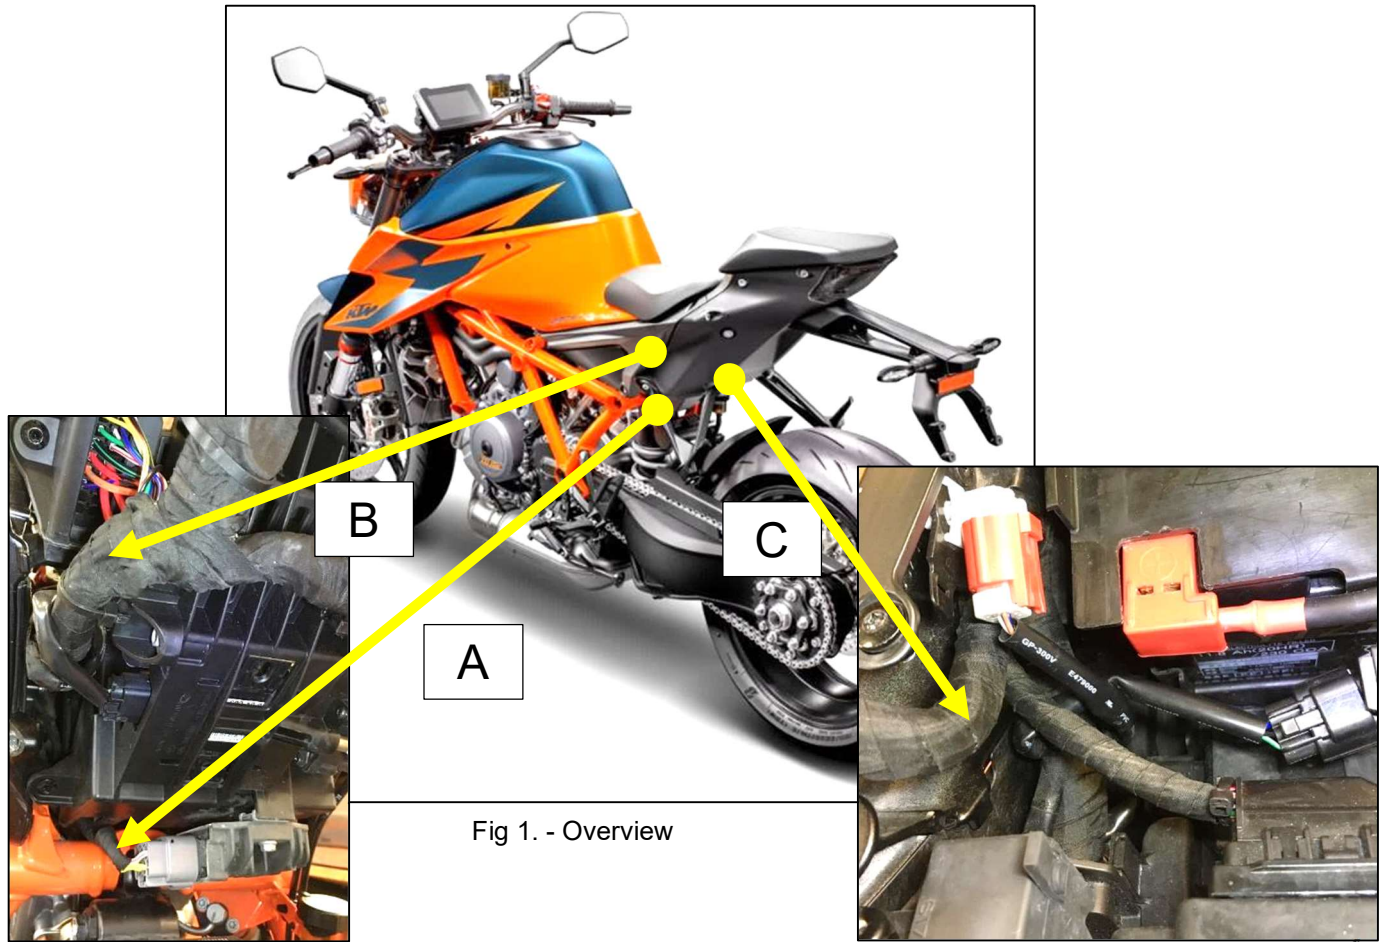
Fig 1. - Overview

Fig 2. - Zoom of Area A and B

Fig 3. - Zoom of Area C

Table 1 - Wiring locations to inspect and repair. Decide what action to take depending on the wires condition.

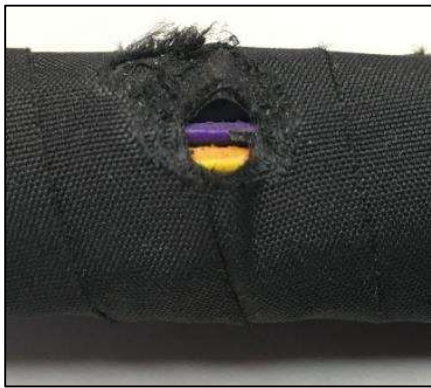
Fig. 4 - Mild or no Damage (follow code 00)

1. **Wiring repair possibility #1:** If there is no damage or mild damage (Fig. 4) to the wiring insulation tape as explained on page 9 then you must perform the steps shown on page 9. Use the Action code ending in 00 when submitting the claim.

1. Check the main wiring harness for signs of rubbing, damaged or melted wires in the locations Area A, B and C. See Figures 1 to 6 and Table 1 and Table 2 for further details.
2. If the wiring has no damage or mild damage as shown in Figure 4 repair the mildly worn insulation on the main wiring harness using black wiring harness insulation tape.
3. Also check the main wiring harness behind the side panel (Fig. 10 - page 7) for contact points and secure with cable ties if necessary.
4. As shown in Fig. 11 (Page 8), secure the wiring harness of the voltage regulator on the battery carrier, using two cable ties.

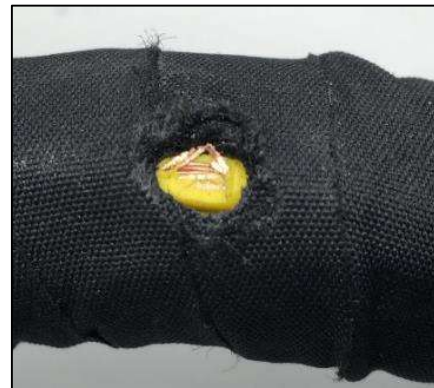
2. **Wiring repair possibility #2:** If there is damage to the wiring for the voltage regulator (Fig. 5.) which is located in **Area A** (Fig. 2) then the wire can be replaced. If the voltage regulator wire is damaged and needs replaced you will need to follow the instructions on page 10 and Annex 2 from the repair manual which is attached to the Dealer.net notification. Use the Action code ending in 01 when submitting the claim.

Fig. 5 - Copper visible (follow code 01)

1. Check the main wiring harness for signs of rubbing, damaged or melted wires. See Figures 1 to 6 and Table 1 and Table 2 for further details.
2. **If the wiring has damage to the wire and has copper visible as shown in Figure 5 repair the wire as explained in the following steps.**

3. Disconnect the 12-V battery and remove the left cover on the rear frame.
4. Remove the connector housing as per Annex 2. Laterally guide the wiring harness out of the rear frame to ensure sufficient space for the subsequent wire repairs.
Note: Annex 2 is an additional attachment that is available for download in the Dealer.net notification.

5. Perform wire repairs as per Annex 2.
6. Guide the wiring harness to the voltage regulator again and mount the connector housing as per Annex 2.
7. As in Fig. 11 - Page 8, secure the wiring harness of the voltage regulator on the battery carrier, using two cable ties.
Note: The wiring harness must not protrude over the connector housing and the course to the main frame must be checked for contact points (Fig. 12 - Page 8).

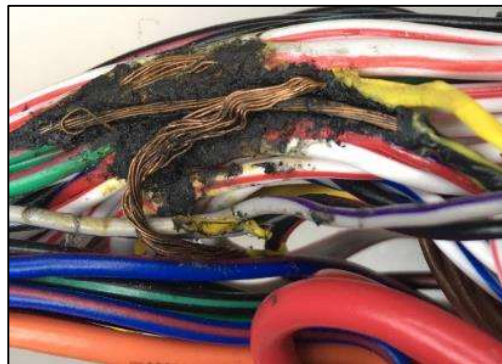
3. **Wiring repair possibility #3:** If the wiring insulation on the main wiring harness is damaged in **Area B and/or Area C** (Fig. 2, 3 & 6) then you must replace the main wiring harness and perform the steps shown on page 11. Use the Action code ending in 02 when submitting the claim.

Fig. 6 - Severe Damage (follow code 02)

1. Check the main wiring harness for signs of rubbing, damaged or melted wires. See Figures 1 to 6 and Table 1 and Table 2 for further details.
2. **If the damage to the wiring is severe as shown in Figure 6 then the main wiring harness must be replaced.**

3. Disconnect the 12-V battery.
4. Replace the main wiring harness.
5. As in Fig. 11 - Page 8, secure the wiring harness of the voltage regulator on the battery carrier, using two cable ties.
Note: The wiring harness must not protrude over the connector housing and the course to the main frame must be checked for contact points (Fig. 12 - Page 8).

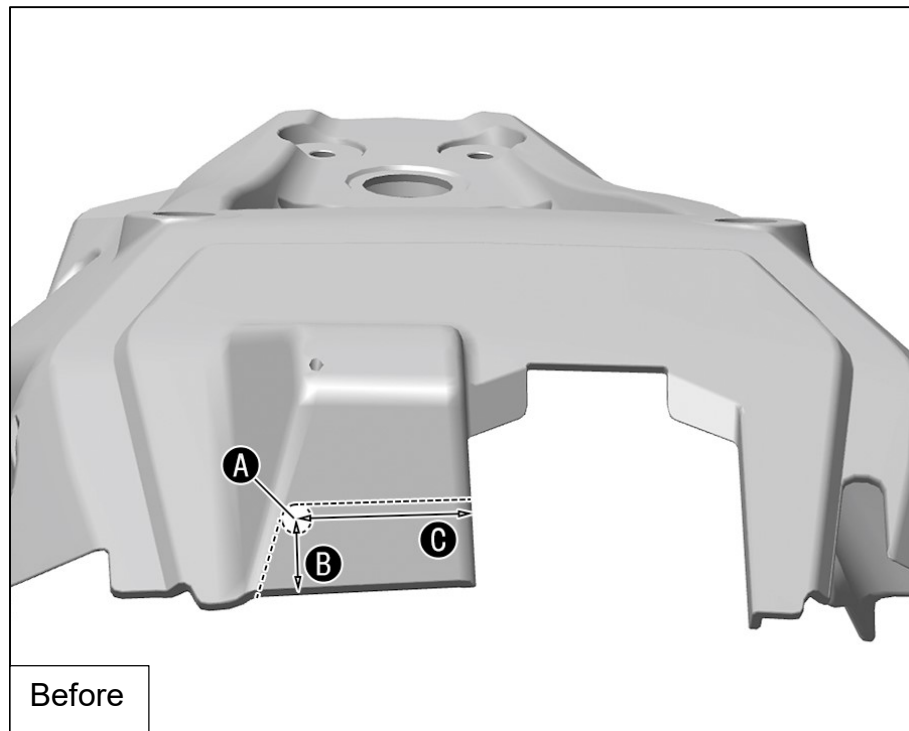
Fig. 7
As described in steps 4 through 8 on page 5 - Cut out the area shown in A, B and C
Bore position on the tail end lower part B = 15 mm C = 45 mm

4. Mark bores and cut lines as shown in Fig. 7 → B = 15 mm C = 45 mm.
5. To avoid scratches, cover the surrounding area with adhesive tape.
6. Drill a hole at the marked point using a 10 mm drill bit. → A = 10 mm (Fig. 7).

7. Use a hand saw to saw laterally into the indicated section until it is completely cut out (Fig. 7 & 8).
8. Deburr and round off the edges of the cut section and remove the adhesive tape.

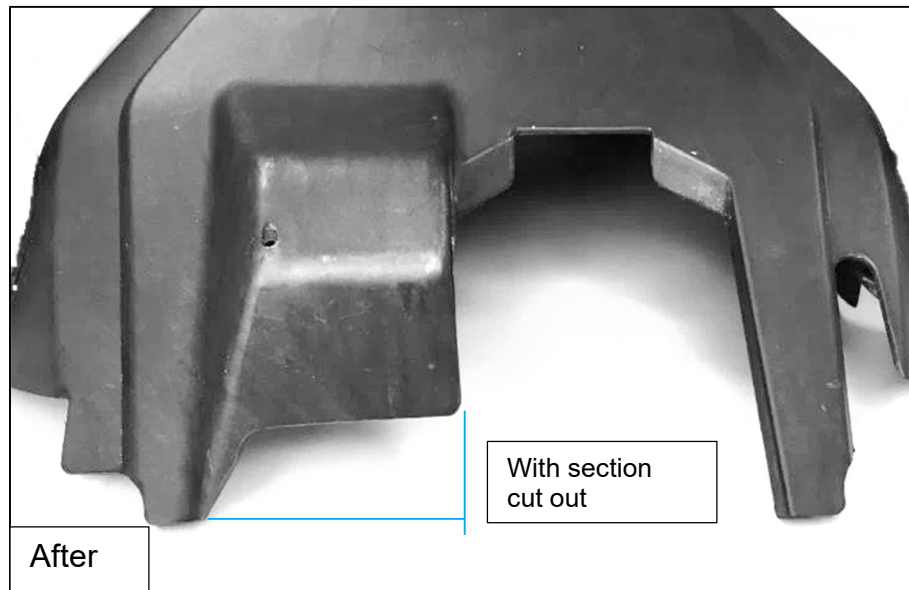
Fig. 8 - Piece of tail end lower part completely cut out

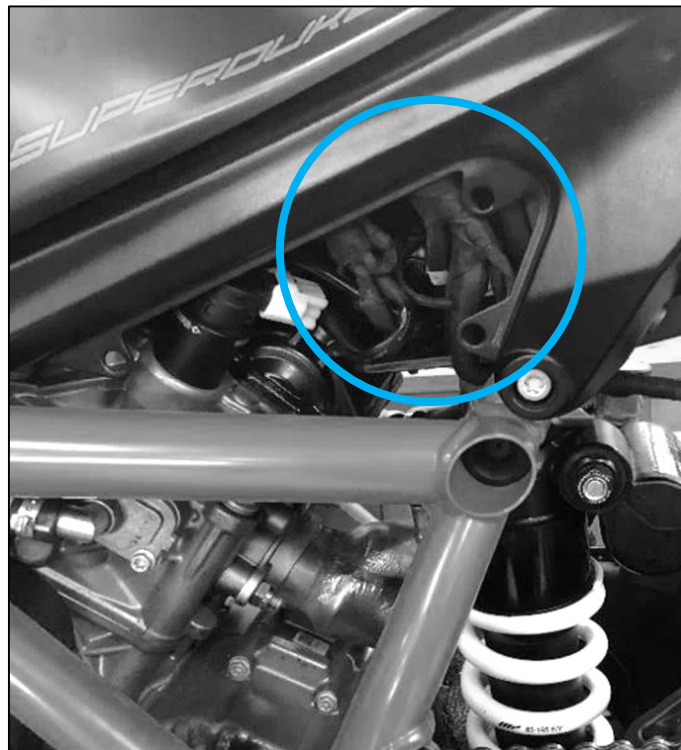
Fig. 10 - Main wiring harness area to be checked

8. Also check the main wiring harness behind the side panel (Fig. 10 - Page 7) for contact points and secure with cable ties if necessary.
9. Install the tail end lower part as per repair manual/Annex 1 and tighten screws as per Table 3.
