Subject: FRONT DOOR INTERFERES REAR DOOR GARNISH	Bulletin No.: 09-007/21
	Last Issued : 04/15/2021

APPLICABLE MODEL(S)/VINS

2019-2020 Mazda3 5-door HB (Japan built) with VINS lower than JM1BP*****158118 (produced before November 29, 2019)

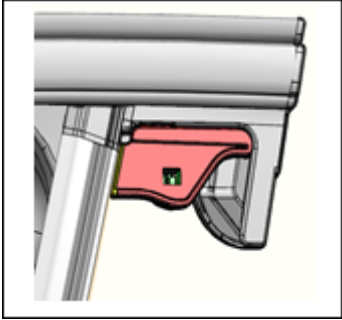
Old	New
Clip

- Phase 1
 - Adhesive has been added between the front door glass run channel and the door panel.
- Phase 2
 - The shape of the front door glass run channel has been changed so as not to make contact with the rear garnish.
 - The shape of the clip at the rear side of the front door glass run channel has been changed for stronger fixing and the hole at the door panel has been changed accordingly.
