Service Alert

Subject: INFOTAINMENT REBOOT WITH NAVIGATION SD CARD INSTALLED	Service Alert No.: SA-014/21
	Last Issued : 04/07/2021

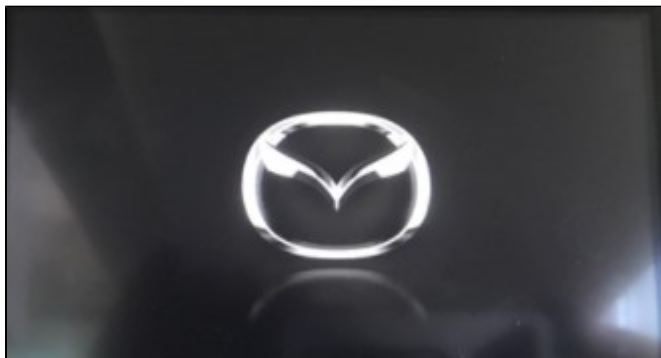
Some customers may complain about an infotainment reboot and the infotainment system recovers if the Navigation SD card is removed (see attached video).

NOTE: This concern may be present on a 2019-2020 Mazda3 or a 2020 CX-30 after the customer updates the Navigation SD card map software using Mazda Toolbox.

CX-5 and CX-9	Reflash CMU software to version 7000C0A-NA03_11026 or later. Go to MGSS -> Infotainment - MAZDA CONNECT Update
Mazda3 and CX-30 Non-Turbo	Reflash CMU software to version 7000C0A-NA01_12002 or later. Go to MGSS -> Infotainment - MAZDA CONNECT Update
Mazda3 and CX-30 Turbo	Reflash CMU software to version 7000C0A-NA04_12002 or later. Go to MGSS -> Infotainment - MAZDA CONNECT Update
