01-20-05 - MIL ON, DTC P0111

Release date: 4/20/2021

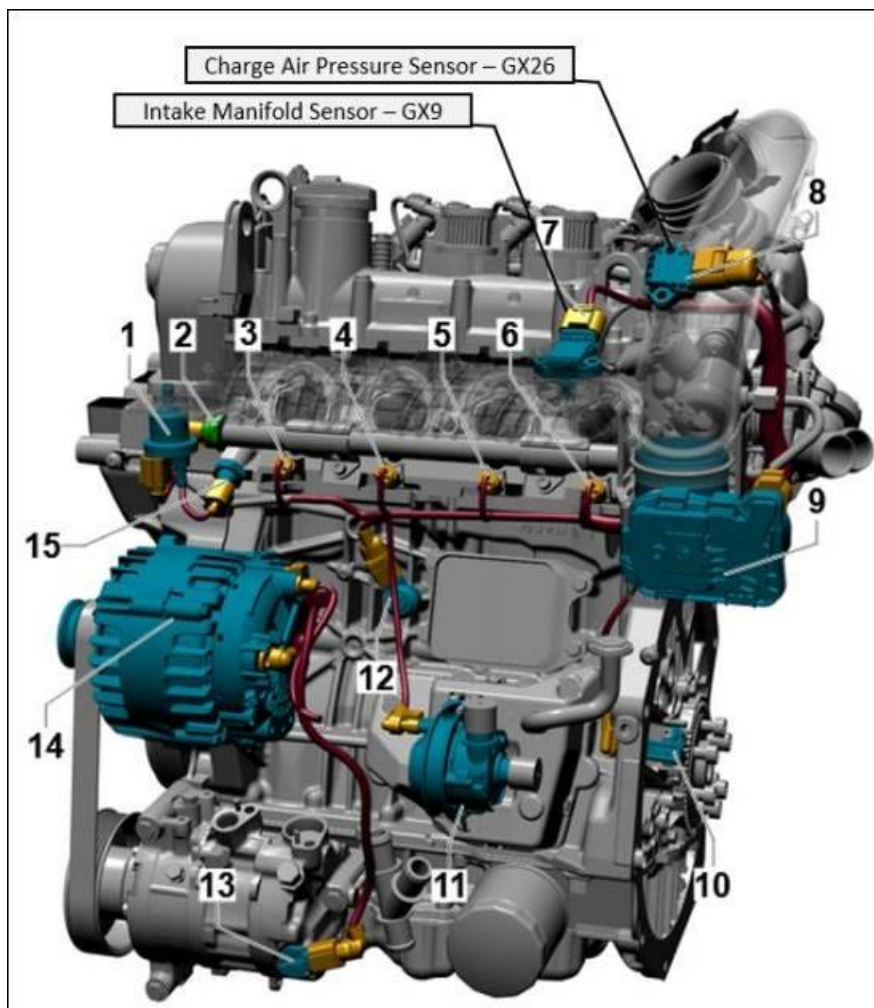
Figure 1: DGXA

Inspect both the Charge Air Pressure Sensor -**GX26**- and Intake Manifold Sensor -**GX9**- part numbers to insure they are the correct and that both sensors are in the correct location (Charge Air Pressure Sensor -**GX26**- is not in the Intake Manifold Sensor -**GX9**- location and vice versa).

If the sensors are the wrong part number or in the wrong location, this Technical Bulletin no longer applies and the correct sensor part number needs to be installed into the correct location.

If both part numbers are correct and the sensors are in the correct location, install the engine hood blanket.

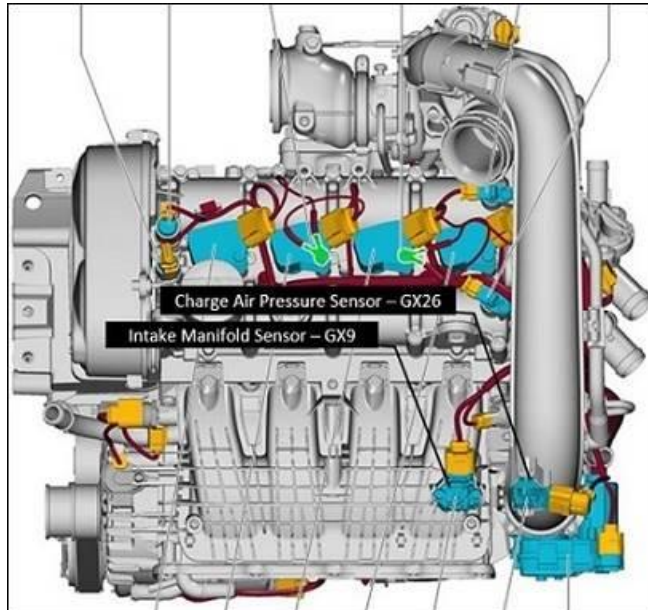
Figure 2: CZTA

The sensors do NOT need to be removed to check the part number. The air box does have to be raised slightly to see the Intake Manifold Sensor - **GX9**.
