Technical Service Bulletin

51 Water sloshing sound is heard while driving

51 21 21 2061754/2 April 20, 2021. Supersedes Technical Service Bulletin Group 51 number 20-18 dated December 18, 2020 for reasons listed below.

Model(s)	Year	VIN Range	Vehicle-Specific Equipment
A5 Sportback, S5 Sportback	2018 - 2019	All	Not Applicable
RS 5 Sportback	2019	All	Not Applicable

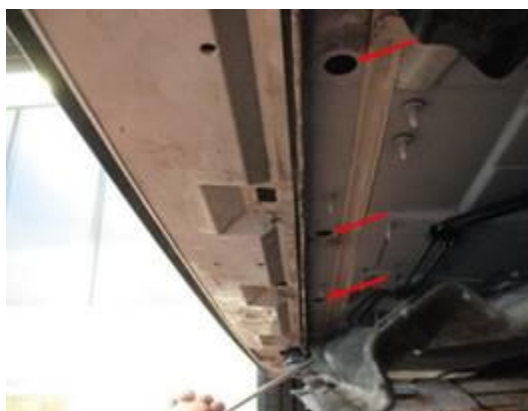
Figure 1. Access to the side member plugs.

1. Detach the underbody trim until the plugs for the side member are accessible. If water has already accumulated in the sill areas water will flow from these plug openings (Figure 1).

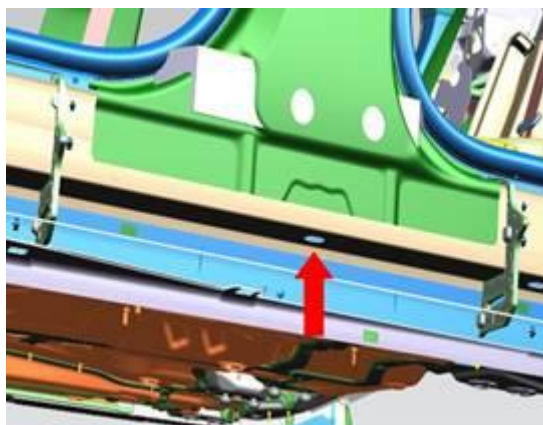
2. Figure 2 shows the opening where water generally enters this space.

Figure 2. Water entrance point.

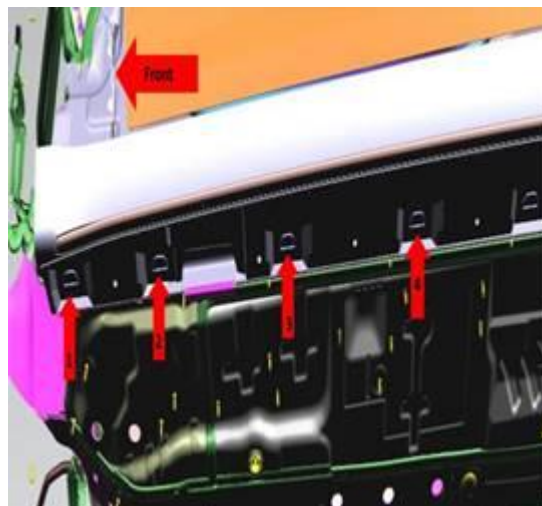
Figure 3. Sill trim fastener openings.

3. Fastener position number 4 shown in Figure 3 is the opening through which a modification to the sound absorber will be made.

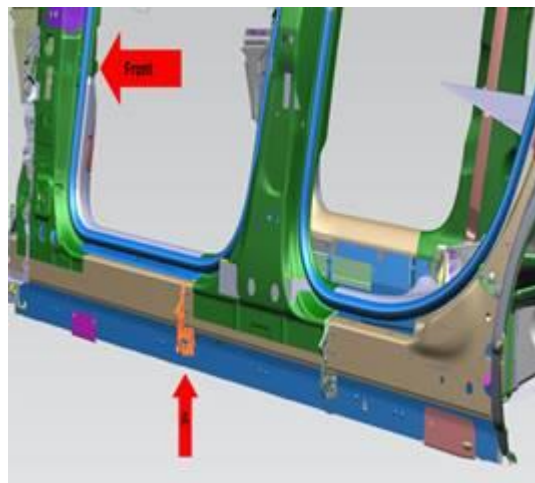
It is possible over time for water to accumulate in the side members and sills but the water is not able to drain as needed. The accumulated water is unable to reach the normal drainage because the sill cavity sound absorber blocks its flow. This accumulated water creates a 'sloshing' noise when the vehicle moves.

4. Figure 4 shows the location of the sound absorber marked 'A'.

Figure 4. Location of the sound absorber.

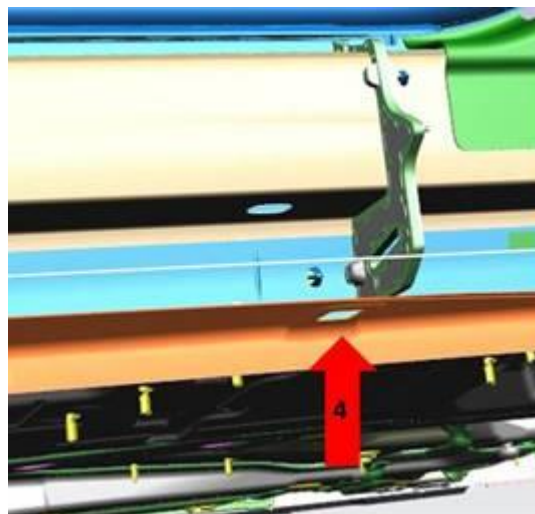
5. Figure 5 shows a closer view of the sound absorber to be modified in the cut-away image.

Figure 5. Hole through which the sound absorber will be accessed.

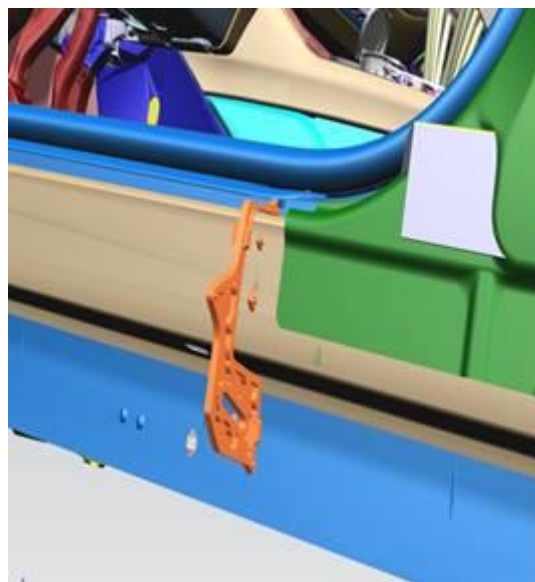
6. Figure 6 shows a cut-away view of the sound absorber from the rear.

Figure 6. Side member cavity sound absorber.

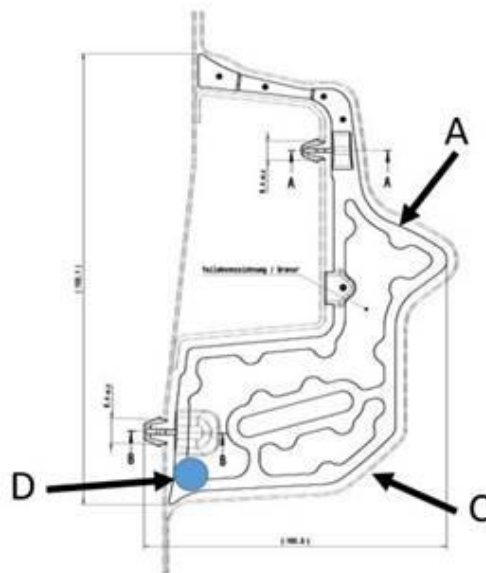
Figure 7. 8mm – 10mm hole to be made through the sound absorber.

7. Figure 7 shows a drawing of the sound absorber. The blue dot marked 'D' corresponds with a point through which a hole 8mm – 10mm in diameter will be made. This hole will allow for a normal flow of any accumulated water to reach the normal drainage and exit the sill cavity. The method for creation of this hole follows.

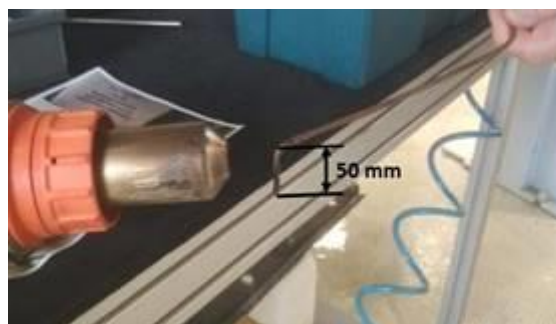
Figure 8. Heating the fabricated tool.

8. From a steel rod 8mm – 10mm in diameter fabricate a tool as shown in figure 8. Bend the end of it in an 'L' shape 50mm long. Heat the bent end of the rod to approximately 500 °C (~932° F).

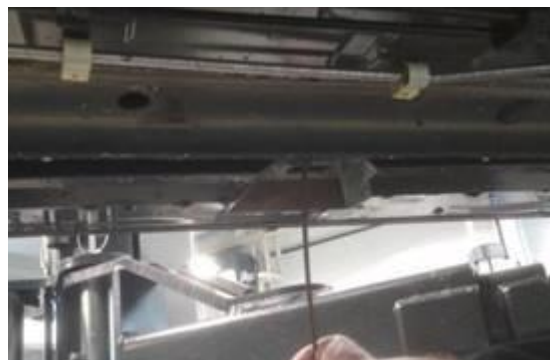
Figure 9. Making the hole in the sound absorber.

9. Guide the heated rod into opening number 4 from Figure 3 and melt a hole in the sound absorber in position 'D' from figure 7 (Figure 9).

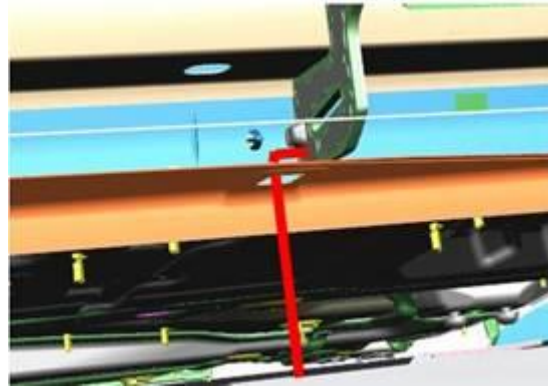
Figure 10. Correct positioning of the heated rod.

10. Figure 10 shows a drawing of the operation performed and the correct positioning.

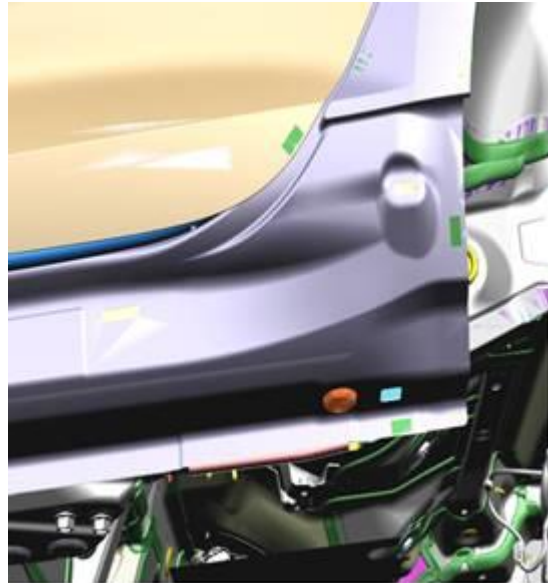
Figure 11. Drain plug on rear of the side member.

Ensure that the drain function of the draining plugs on the front and rear of the side members are fully functional and not damaged (Figure 11).

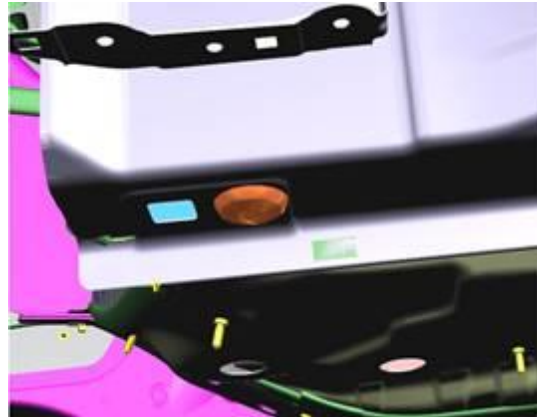
Figure 12. Drain plug on the front of the side member.

12. Figure 12 shows the drain plug on the front of the side member.
