# Technical Service Bulletin

## 68 Noises from the dash panel around the MMI display

68 21 33 2056298/4 April 20, 2021. Supersedes Technical Service Bulletin Group 68 number 21-32 dated February 2, 2021 for reasons listed below.

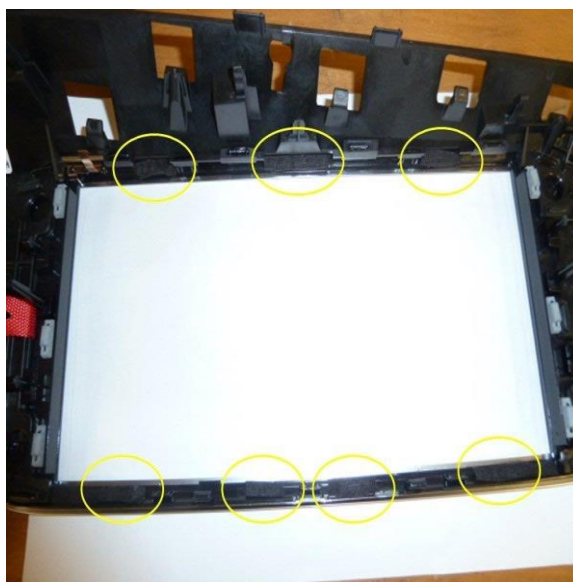
The dash panel trim can cause noise at the contact points.

**Figure 1.** Apply felt strips to the circled areas.

- Felt strips 533867910A.
1. Remove the trim strip of the dash panel and stick the felt adhesive tape on the areas marked with yellow circles (Figure 1).

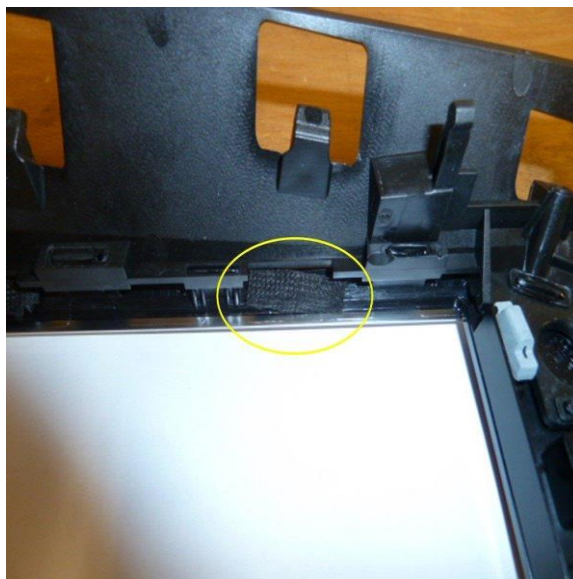
**Figure 2.** Close-up of Figure 1.

2. The felt strips shown in Figure 1 and 2 must be stuck on and folded back behind the clip (Figures 3 - 4).

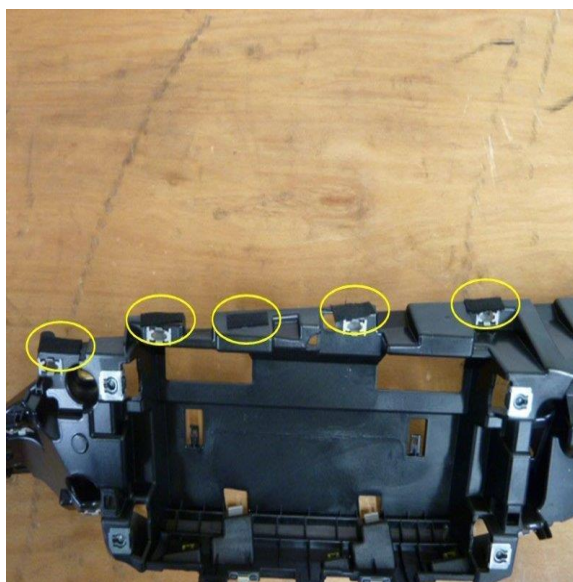
**Figure 3.** Apply felt strips to the circled areas.

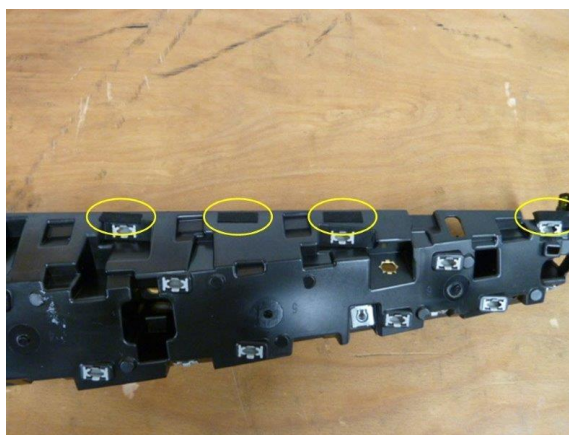
**Figure 4.** Apply felt strips to the circled areas.
