CSR 513

Component/Supplier Recall

Bulletin EPS2020-E-0002 — MVP Memory Loss

Bulletin #
EPS2020-E-0002

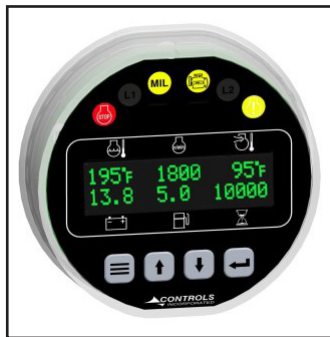
Figure 1 — Display

EPS has launched a technical bulletin for MVP controllers with potential memory loss. These controllers have a display on the DC1317 and DRM12 chippers (refer to Figure 1). Affected units have the potential for the display to go blank due to a voltage drop during the boot-up cycle. This can be fixed by reloading the firmware and configuration files. Please refer to the attached communication from EPS.

The manufacturer discovered that the program loss was caused by a significant voltage drop to the controller's microprocessor at a very specific time during the controller's boot-up cycle. In discussing the operating conditions with customers, EPS learned this voltage drop was being created most frequently by:

- Poor connections between the MVP controller and the wire harness due to dielectric grease being applied to controller's connectors;
- "Rush starting" the engine (i.e. turning from OFF directly to START) before the controller has completed booting up.

No action is required unless you are experiencing issues. If so, contact the EPS Technical Support Group using the contact information in their attached communication.

Any controller which had such issues was easily restored to full, normal operation simply by reloading both the firmware and configuration files. EPS has worked with the manufacturer and developed two solutions to the issue:

EPS has changed the variable used to display battery voltage from several possible available values to a specific internal value. This prevents the controller from searching while booting up to "select this value" from those available (which caused the program loss during voltage dips).
