SS 701-WST2021 4700-5700 DT12 Harness Chaffing - PT Can Faults

WST 4700 - 5700 with DT12 Transmissions.

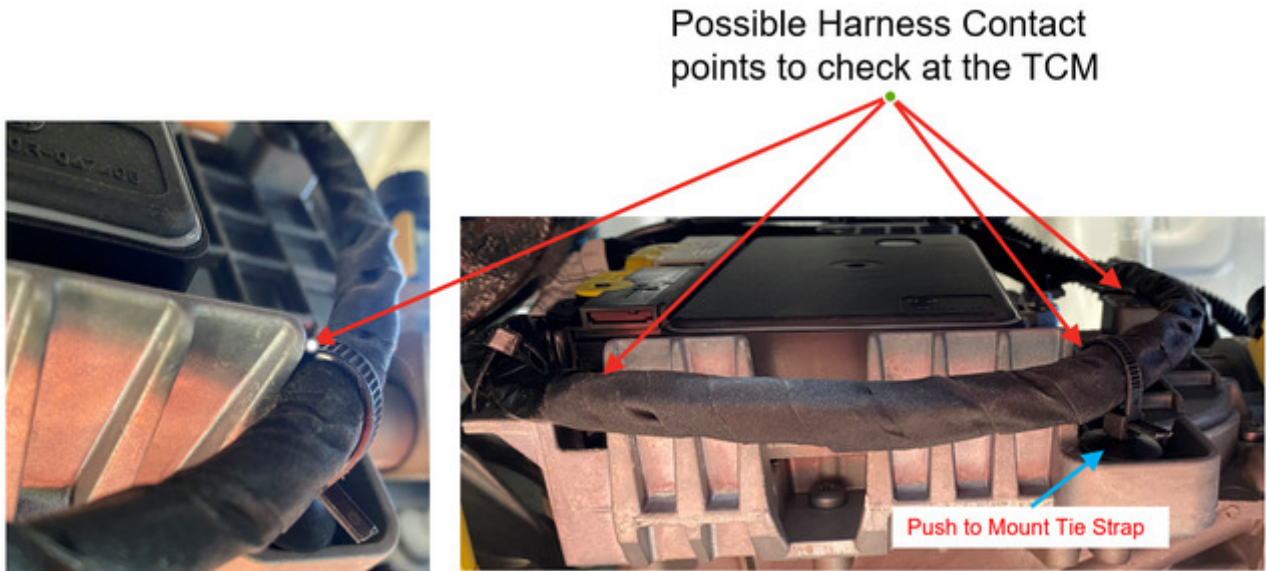
Transmission Control Harness rubbing/chaffing with TCM. Tie Strap push to mount specified for Harness routing-clipping may not stay in place causing Transmission Control Harness rubs/chafes with TCM at several points resulting in intermittent failures and triggering multiple PT Can Fault Codes if Harness is damaged. See Figure 1.

Figure 1: Transmission Control Harness routing points that require inspection/correction.

Transmission Control Harness routing and clipping needs to be revised at the TCM area, follow the instructions below and refer to see Figure 2, 3 and 4 to complete Harness routing-clipping.

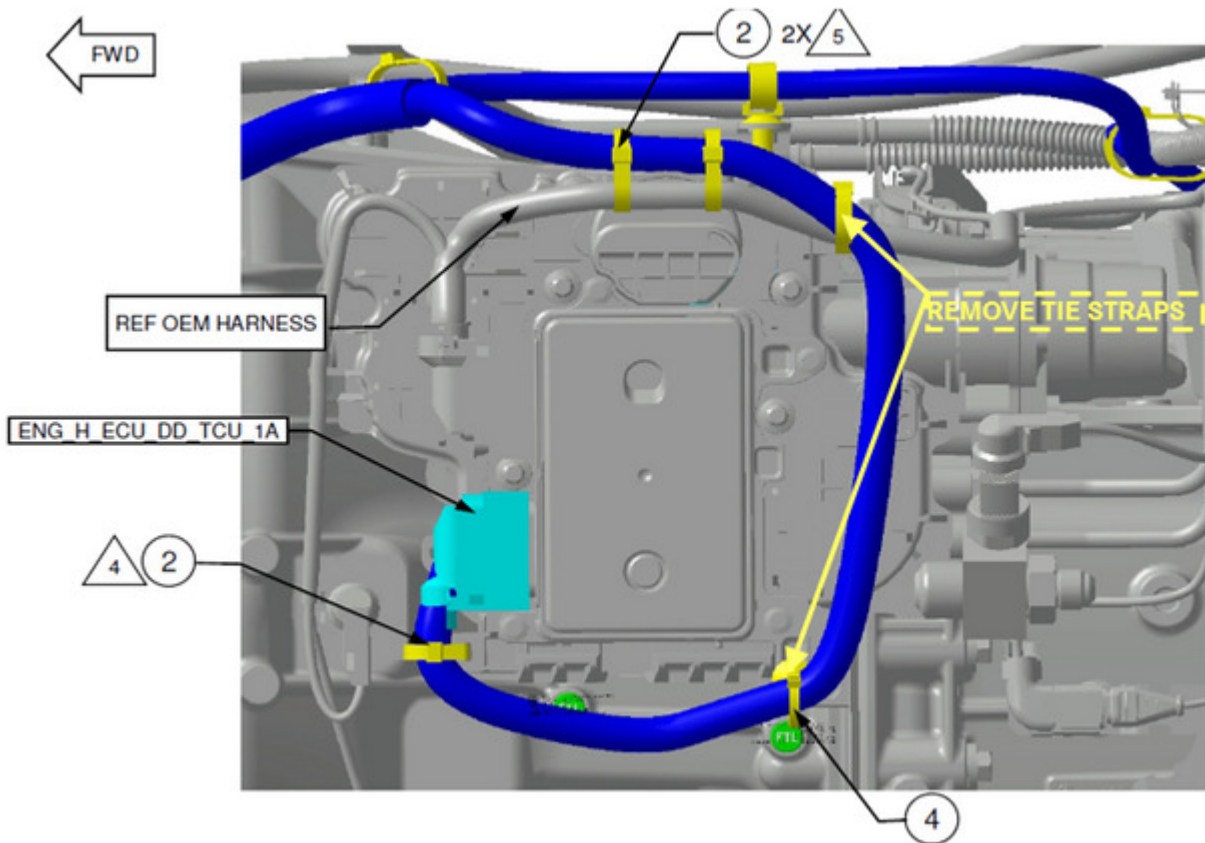
Figure 2: Initial production Transmission Control Harness routing-clipping.

- Cut and remove tie straps used to attach Transmission Control Harness, items 2 and 4 shown in Figure 2. Inspect Harness for damages caused by rubbing / chaffing and repair as needed, refer to SB 54-290 for Harness repair instructions.

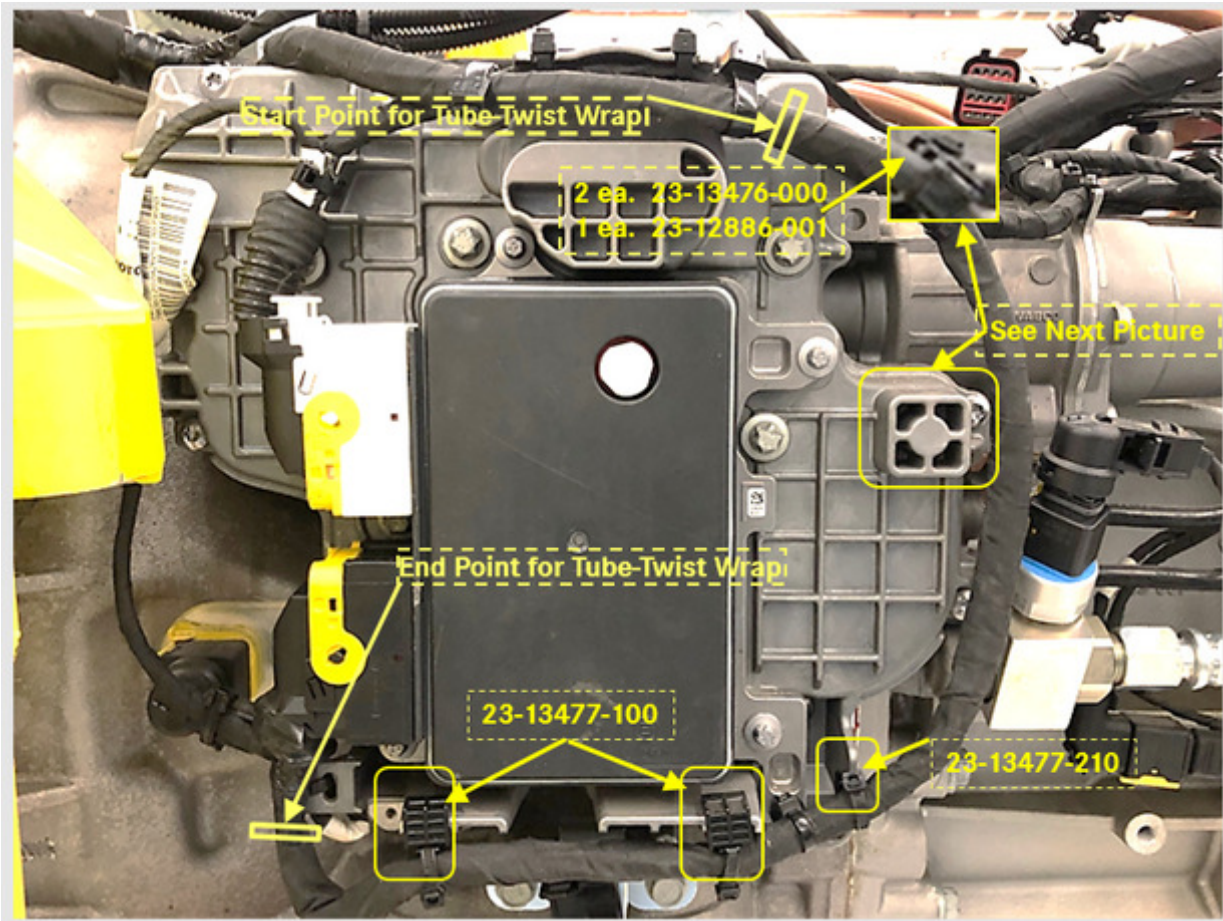
Figure 3: Updated Transmission Control Harness routing-clipping with addition of heavy duty wrap.

- 1 each 23-13477-210 tie strap with top centered push on clip
- 2 each 23-13477-100 tie strap with offset push on clip
- 1 each 23-12886-001 double strap swivel
- 2 each 23-13476-000 ½" wide tie strap
- 3 FT BEN 2421002503SCM TUBE-TWIST,BLK,DIA 25
- A/R Electrical Tape

- Add "Tube Twist" (Heavy Duty Wrap) from start to end point locations shown and secure with electrical tape to Transmission Control Harness, then route and clip to Transmission Control Harness using Tie Straps part numbers shown below at each location in Figure 3.

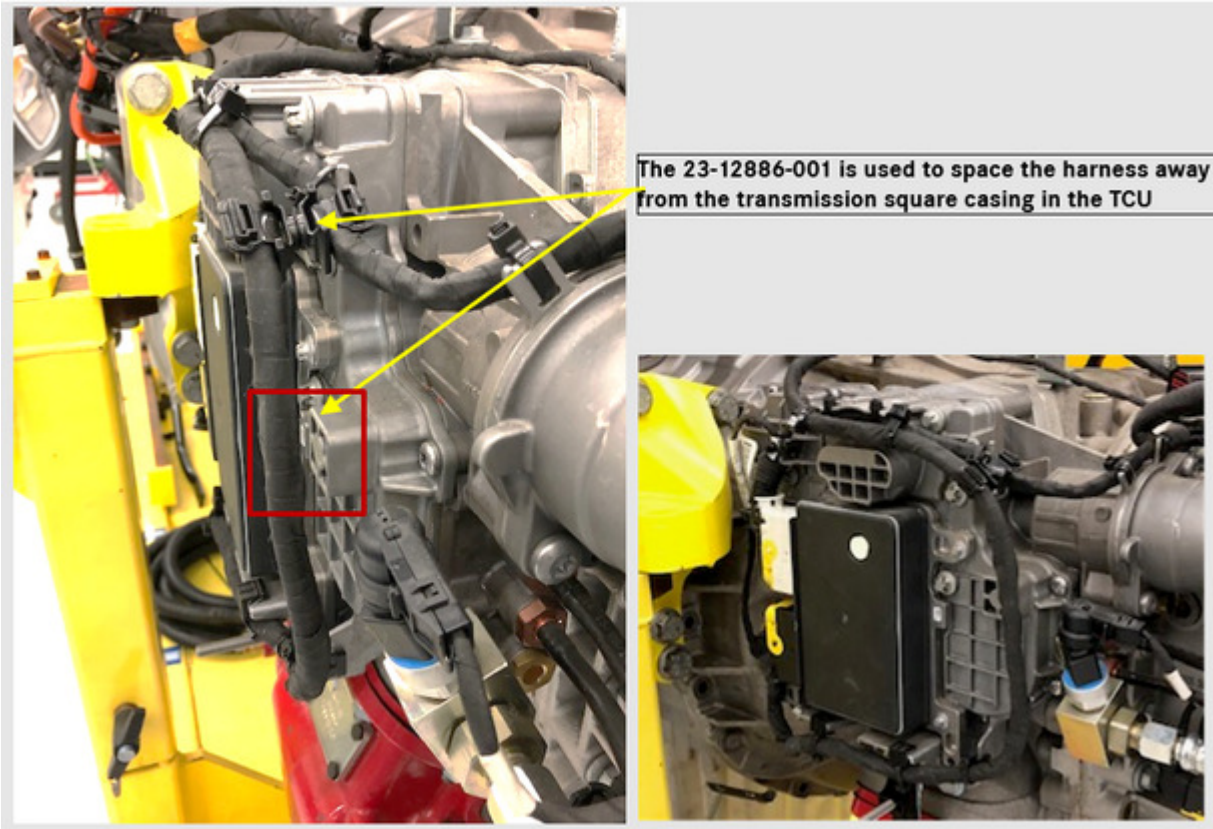
Figure 4: Check for clearance between TCM and Transmission Control Harness.
