# SS 3076-FTL2021 P4 Main Mirror Arm Covers Loose - Falling Off

All New Cascadias

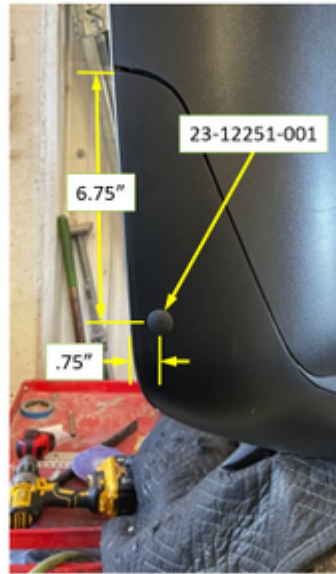
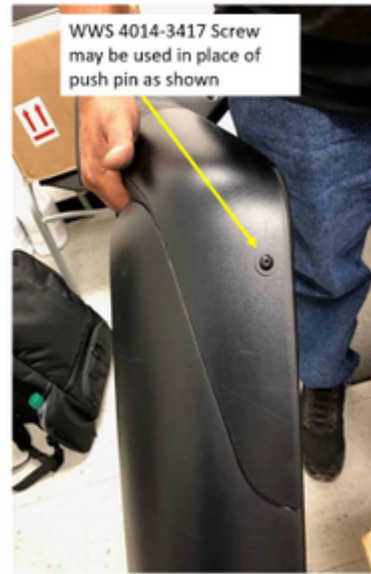
Figure 1: Installation of push pin - screw.

Lower arm covers LH/RH loose or falling off.

Lower arm covers designs have clips that hold the cover on but over time the clips can fail and allow the covers to become loose or fall off.

Add a push pin or screw to secure the Arm Covers in Place as shown in the following figure:

- RH mirror shown
- Dimensions are approximate
- Drill 1/8" diameter hole through cover and into bezel to apply push connector 23-12251-001.
- As alternate drill 1/8" diameter hole and use #8 screw WWS 4014-3417 screw instead of 23-12251-001.
- See next slide for process details
