Service Bulletin

Bulletin No.: 16-NA-109

Subject: Grease or Sealant Visible on Electronic Power Steering Gear - Should Not Be Interpreted as Leak

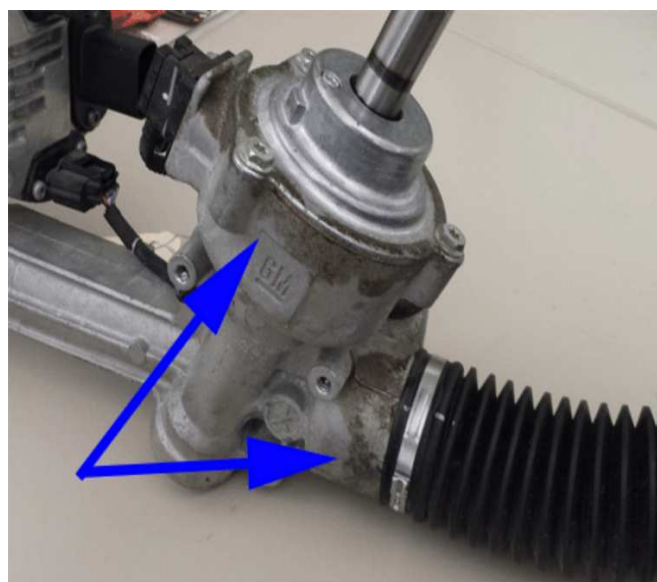
4483616

The graphics below are photo examples, which include arrows showing some of the common areas where grease may be evident after the vehicle has been driven for a length of time.

If upon inspection, the steering gear assembly clamps, boots, and fasteners are all in place, the visual evidence of grease/sealant on the exterior of the steering gear is considered normal and no correction is necessary. If excess grease is noted, it should be wiped off the exterior of the gear, however, sealant should be left in place as a barrier to water and contamination, and no cleaning is required.
