Service Bulletin

Bulletin No.: 17-NA-384

Subject: Squeak, Rattle or Creak Coming from Second Row/Rear Seat Area

Brand:	Model:	Model Year:		VIN:		Engine:	Transmission:
		from	to	from	to		
Cadillac	XT5	2017	2021			All	All
	XT6	2020	2021				
GMC	Acadia (VIN N)	2017	2021				
Holden	Acadia	2019	2021

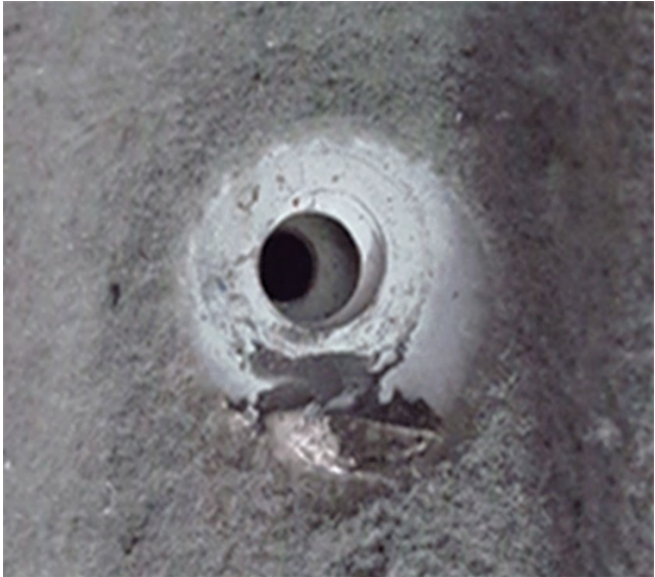
Involved Region or Country	North America, Europe, Russia, Middle East, Israel, Japan, South Korea and Egypt.
Condition	Some customers may comment on hearing a squeak, rattle or creak coming from the second row/rear seat area. The right 40% seat is more prone to this condition, however the left 60% seat could be affected.
Cause	<p>The cause of the condition may be either of the following:</p>

<p style="text-align: right;">4911773</p> <p>Note: The "winking" is caused by excessive overlap of body panels and, as shown in the graphic above, the sheet metal holes are offset. This is most commonly found at the right rear fastener location of the right rear seat, or the left rear fastener of the left rear seat.</p> <ul style="list-style-type: none"> • Possible "winking" condition of right rear 40% seat floor pan outboard track rear bolt hole, or the left rear 60% seat floor pan outboard track rear bolt hole. • A seat track synchronization/torque condition may require a torque sequencing of the seat attachment bolts, on either seat.

Correction	<p>Note: Perform the "winking" inspection, and repair procedure as necessary first, prior to performing the torque procedure.</p> <p>For vehicles exhibiting the condition, follow the Service Procedure below to inspect for and correct the winking condition, and also complete the torque sequencing procedure.</p>

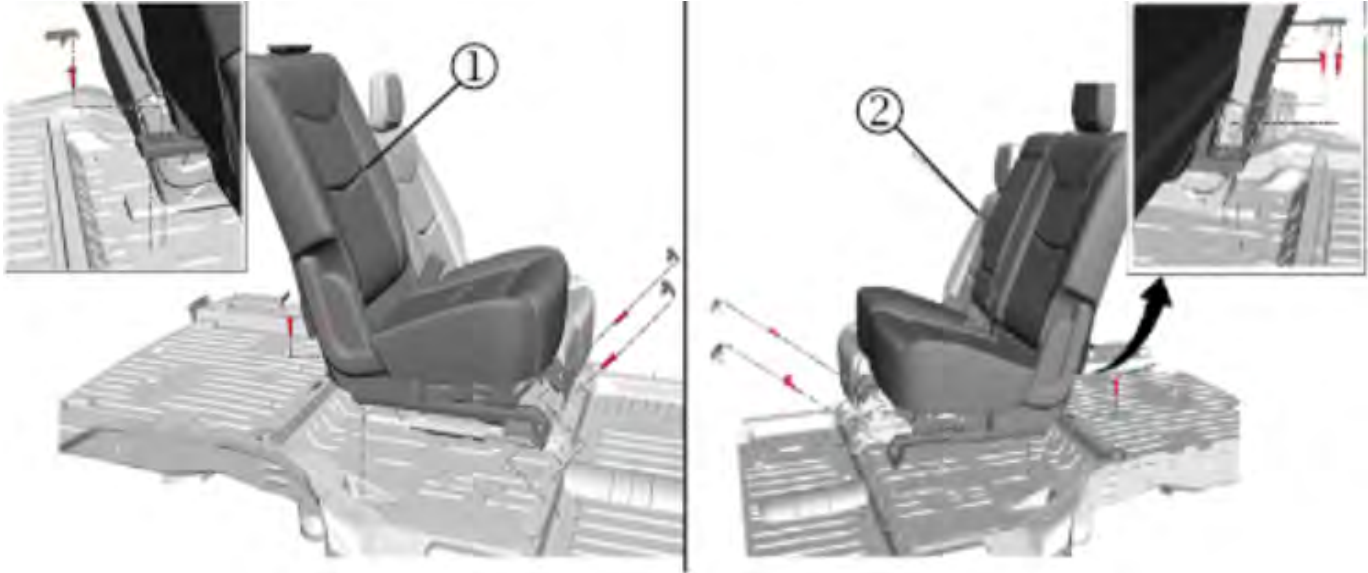
5403437

1. Verify which rear seat exhibits the condition: the right rear 40% seat, (1) and/or the left rear 60% seat. (2)

2. Remove the affected right (1) and/or left (2) rear seat. Refer to *Rear Seat Removal and Installation (40%)* and/or *Rear Seat Removal and Installation (60%)* in SI,
 - 2.1. Adjust the seat to full rearward position.
 - 2.2. Loosen the outboard front attachment bolt, then the inboard bolt.
 - 2.3. Adjust the seat to full forward position.

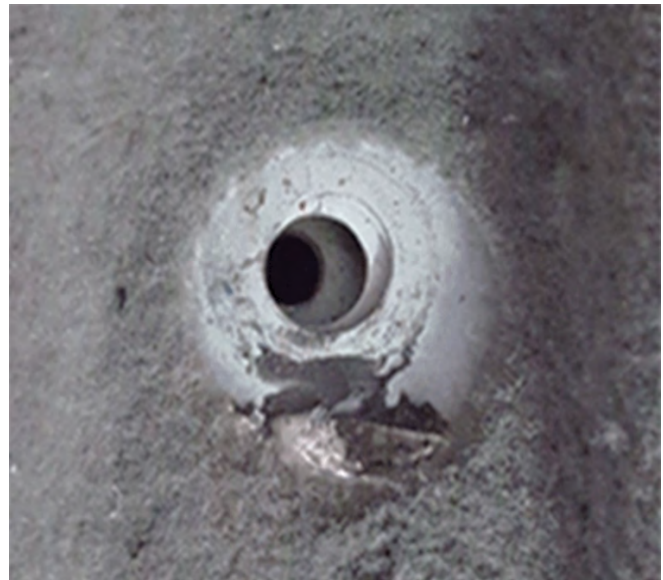
4911773

- 2.4. Ensure that both seat tracks are locked.
- 2.5. Loosen the outboard rear attachment bolt, then the inboard bolt.
3. inspect the right outboard rear seat fastener location of the right rear seat and/or the left outboard rear seat fastener location of the left rear seat for possible “winking” condition:

- If “winking” condition DOES exist, continue ahead to step #4 and remove sheet metal material.

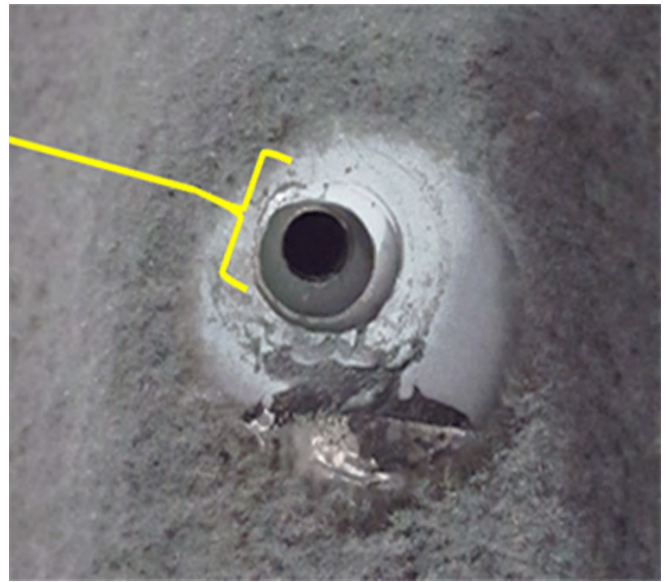
4911785

Note: In the graphic example above, the sheet metal is still offset, but the nut is centered enough to avoid contact of the seat bolt to the sheet metal.

- If “winking” condition DOES NOT exist, jump ahead to step #6 and follow the torque sequence procedure.
