Service Bulletin

Bulletin No.: 17-NA-394

Subject: Squeak, Clunking Type Noise Heard From Rear of Vehicle

Brand:	Model:	Model Year:		VIN:		Engine:	Transmission:
		from	to	from	to		
Chevrolet	Colorado	2015	2021			All	All
GMC	Canyon	2015	2021

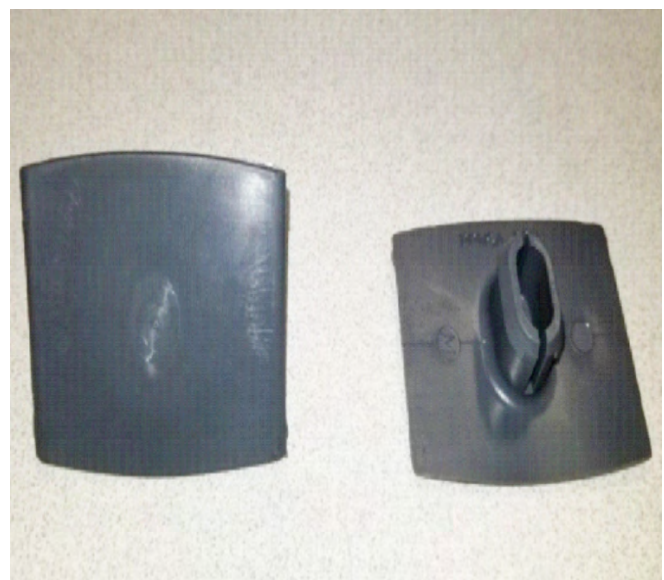
5341853

1. Raise the vehicle on a frame lift-type hoist. Refer to *Lifting and Jacking the Vehicle*, in SI.
2. Inspect the springs for damage.
 - If damage has been found, refer to *Rear Leaf Spring Replacement*, in SI.
 - If damage has NOT been found, proceed to the next step.
