# TECHNICAL SERVICE BULLETIN

## 10R140 Transmission - Ticking Or Scraping Noise Coming From Bellhousing

**21-2100**  
01 April 2021

Ford 2020-2021 F-Super Duty	Transmission/Transaxle: (10R140)
--------------------------------	----------------------------------

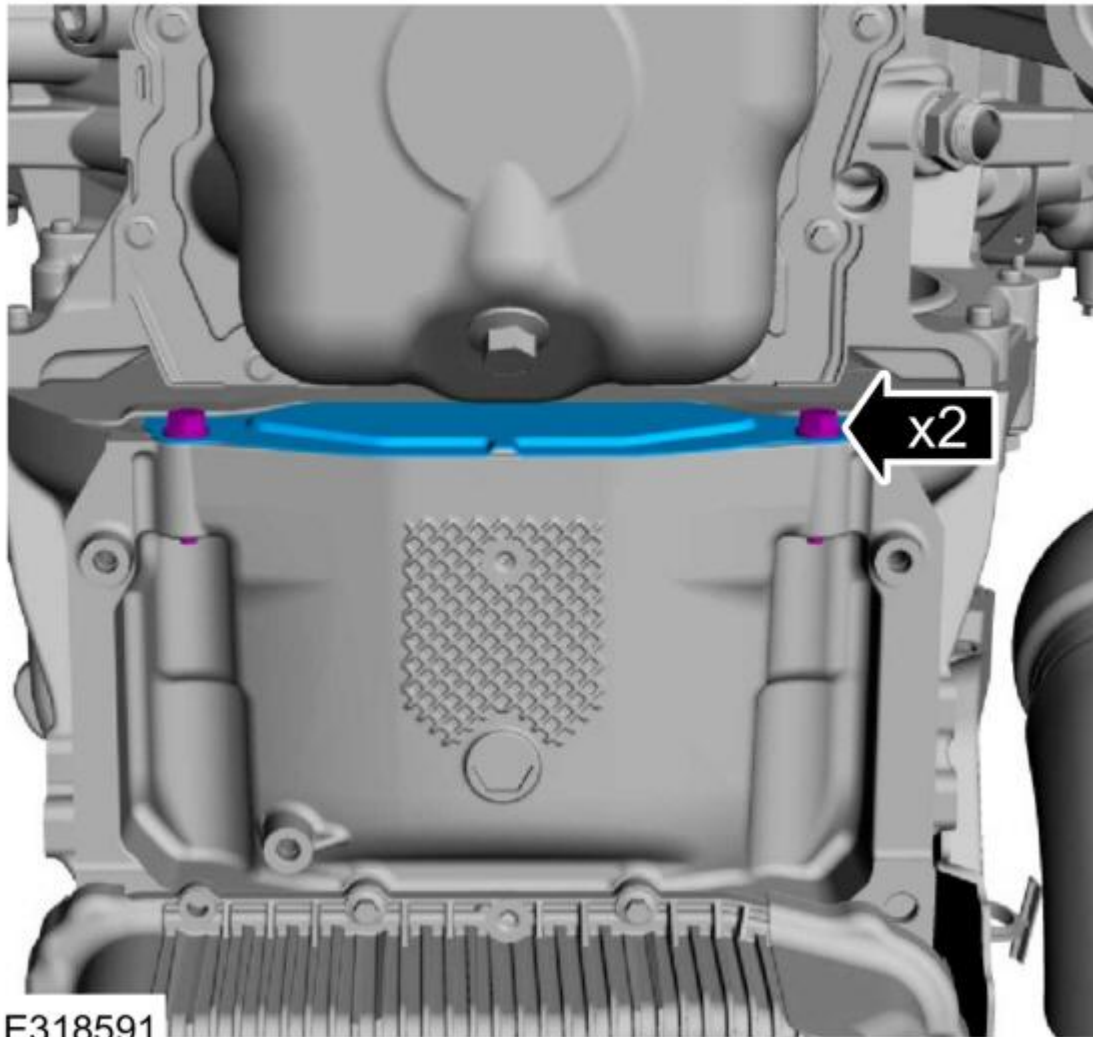
Figure 1

**Issue:** Some 2020-2021 F-Super Duty vehicles equipped with a 10R140 transmission may exhibit a ticking or scraping noise coming from the bellhousing. The noise may or may not go away while in PARK and/or NEUTRAL. This may be due to the torque converter studs contacting the flexplate inspection cover and/or internal torque converter damper spring contact. To correct the condition, inspect and adjust the flexplate inspection cover (gas engine only) and/or replace the torque converter (gas or diesel engine).

- (1). Yes - remove and inspect the flexplate inspection cover for contact with the torque converter studs. If contact is found, adjust the cover so contact does not occur. Refer to Figure 1.
- (2). No - proceed to Step 3.
