TECHNICAL SERVICE BULLETIN

Pop/Sizzle/Crack Noise From Exhaust

21-2109
09 April 2021

Ford 2020 Transit

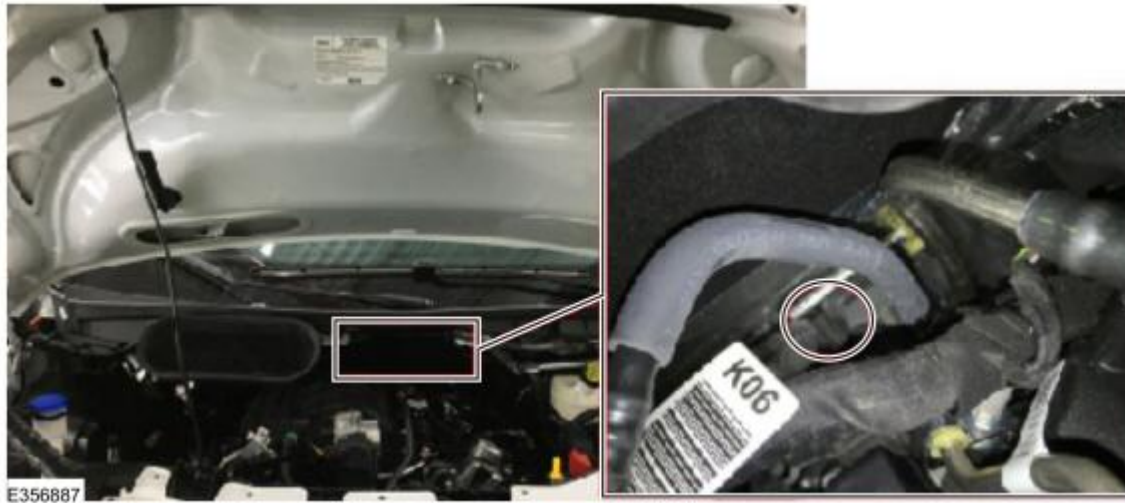
Figure 1

Issue: Some 2020 Transit vehicles may experience a pop/sizzle/crack noise from the exhaust. This may be due to water dripping on the exhaust from the evaporator drain tube. To correct the condition, follow the Service Procedure to extend the length of the evaporator drain tube.

1. Apply a thin coat of Motorcraft® Seam Sealer (Black) to the inside of one end of a locally acquired vinyl tube measuring 5 cm (2 in.) long and an inner diameter of 13 mm (1/2 in.).
2. Install the vinyl tube from the top side of the vehicle to the evaporator drain tube. Use a set of pliers to extend reach if necessary. (Figure 1)
