David J. Johnson
 Director
 Service Engineering Operations
 Ford Customer Service Division

SUBJECT: **NEW VEHICLE DEMONSTRATION / DELIVERY HOLD**
Customer Satisfaction Program 21B03 - Supplement #2
 Certain 2020 Model Year Super Duty F250-F600 Vehicles Equipped with a 10R140
 Transmission - Number One Planetary and Ring Gear Assembly

Certain 2020 Model Year Super Duty F250-F600 Vehicles Equipped with a 10R140 Transmission
Number One Planetary and Ring Gear Assembly

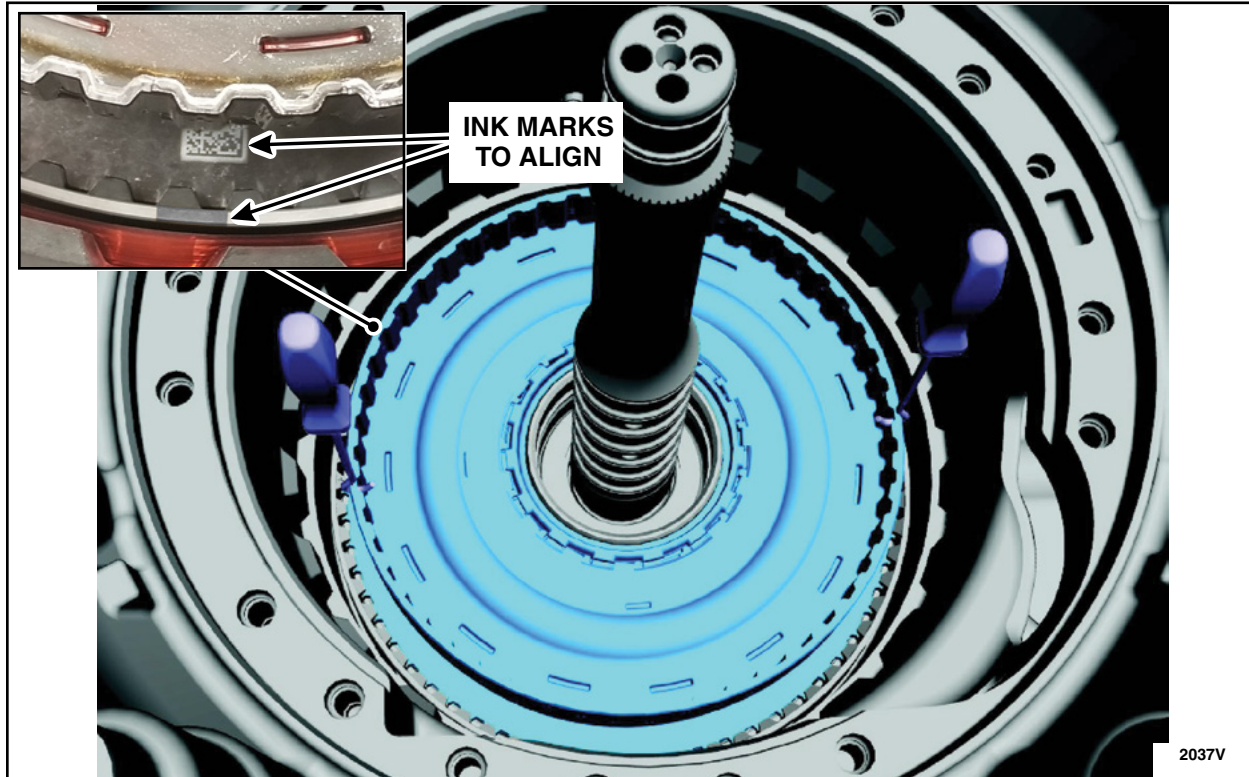
FIGURE 15

NOTE: The ink marks must be aligned or a transmission vibration can occur.

17. Using two pick hooks, install the new number one planetary carrier with the ink markings aligned.
See Figure 15.
