# Service Bulletin

Bulletin No.: 18-NA-020

**Subject: Malfunction Indicator Lamp Illuminated with DTC P0300 and/or P0299/P2227 Set**

Brand:	Model:	Model Year:		VIN:		Engine:	Transmission:
		from	to	from	to		
Chevrolet	Equinox	2018	2021	-	-	Equipped with 2.0L or 1.5L Engine (RPOs LTG, LYX)	All
GMC	Terrain

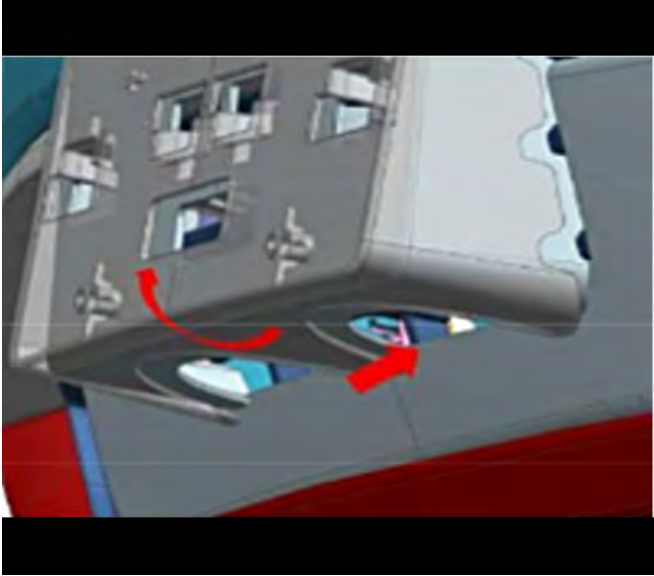
5775941

<p>*** For Terrains with front license plate bracket (VK3), install tape over the openings on bottom of the license plate bracket, to prevent airflow from bypassing the grill cover and flowing directly at the charge air cooler, as shown in the picture above.</p>

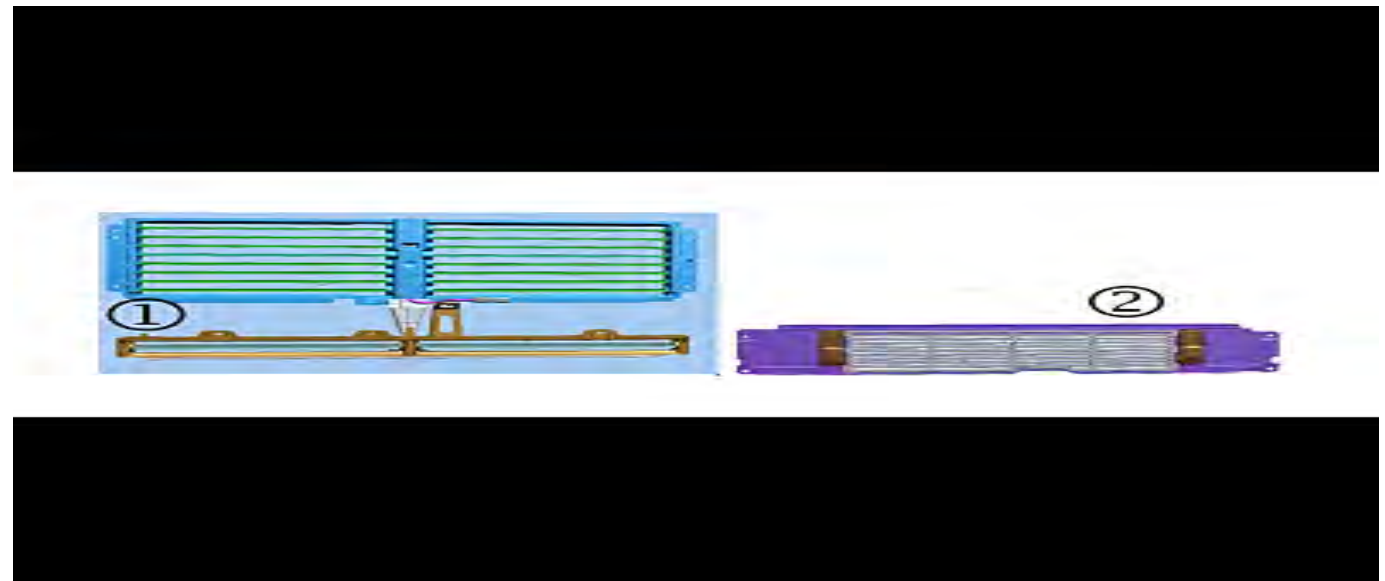
5736482

- Front Bumper Upper Shutter with the Front Bumper Secondary (lower) Shutter attached (1), as shown in the picture above.
- Front Bumper Lower Shutter that mounts in the front of Charge Air Cooler (2), as shown in the picture above.

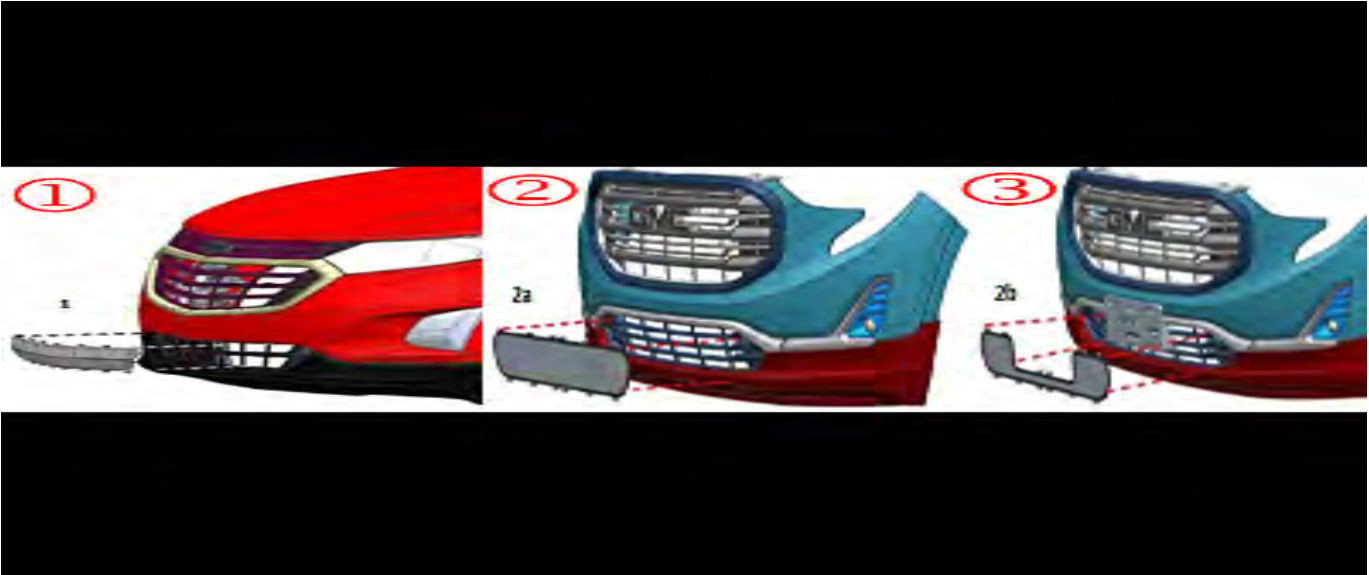
5776421

Shown in the picture above are examples of the grill opening covers for the Equinox (1), Terrain without (RPO VK3) (2) and Terrain with (RPO VK3) (3).
