Service Bulletin

Bulletin No.: 18-NA-069

Subject: Poor Engine Performance in Extremely Cold Weather Conditions for LFB Engines, Charge Air Cooler Icing - Malfunction Indicator Lamp (MIL) Illuminated, DTC P0299, P0236, P2227, P00C7 Set

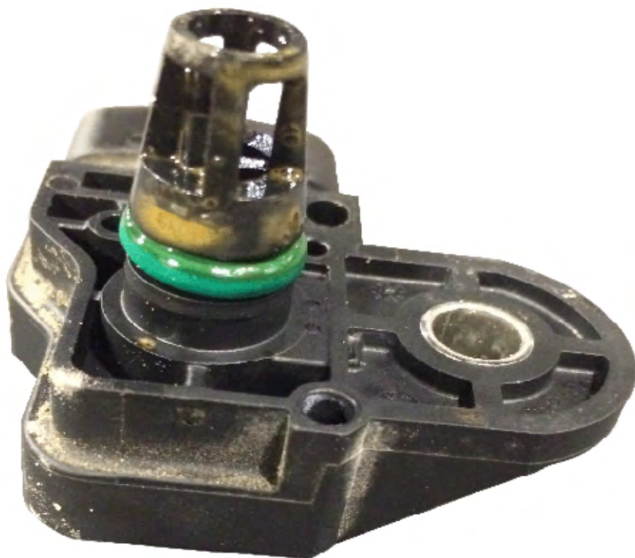
4910683

4. Inspect the sensor of any contaminants.

Important: Due to the sensitivity of the sensor, **Do Not** use any chemical cleaners including water and **Do Not** use compressed air to remove contaminants.
