# Service Bulletin

Bulletin No.: 19-NA-240

**Subject: Steering Wheel Oscillation, Vibration, Shake at 80-129 km/h (50-80 mph)**

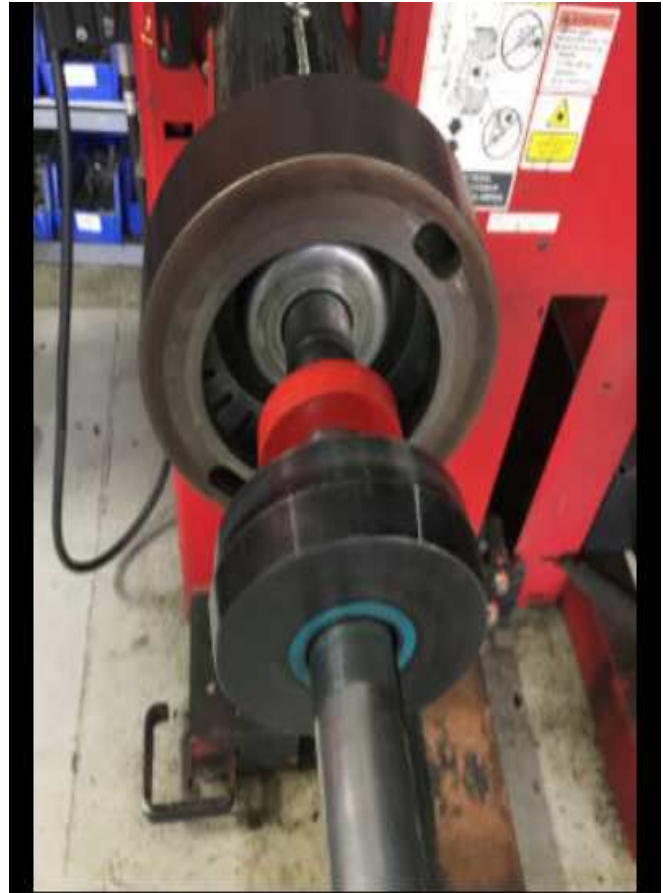
5422805

**T1 Y-axis higher than 25 mg**

- T1 Y-axis consistently over 25 mg, service all wheel and tire assemblies per the latest version of Corporate Bulletin Number 10-03-10-001.
- When mounting the wheels to the balancer, it is critical to make sure the assembly is held tightly centered during the measurement. Below are adapters that have been verified to maintain this relationship (Single rear wheel only).
- Balance and road force correct the assemblies. It is recommended to get the road force values to the specs below:

Less than 30 lbs on the front tires
-------------------------------------

Less than 45 lbs on the rear tires
------------------------------------
