Service Bulletin

Bulletin No.: 19-NA-255

Subject: Wax Coating on Frame Peeling, Metal Shows Corrosion/Rusting (U.S. and Canada Only)

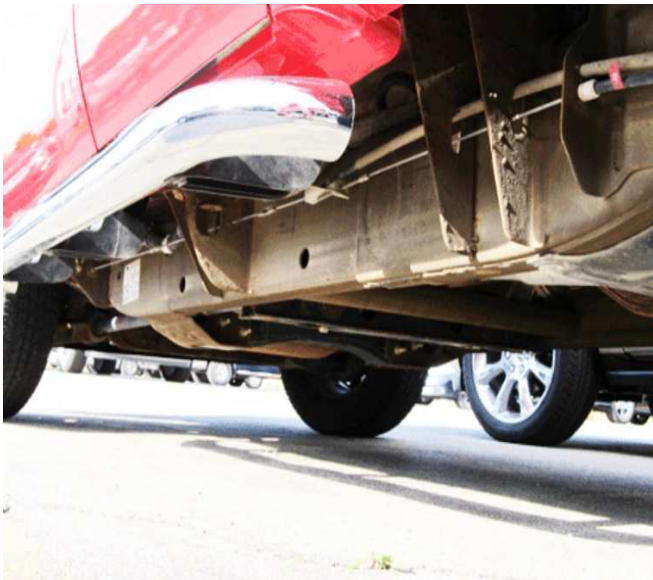
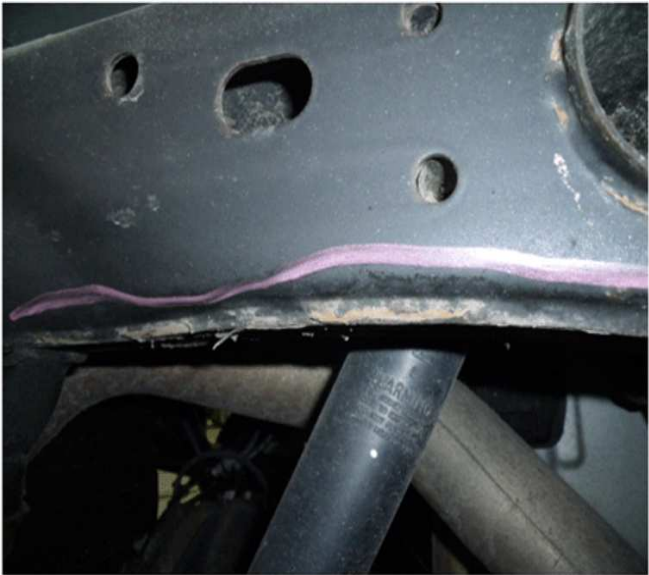
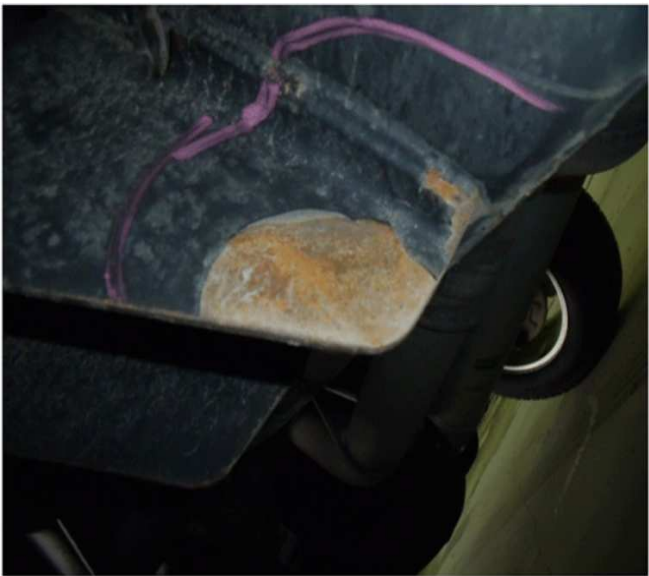
Truck Example Photos

Involved Region or Country	North America, Europe, Middle East, Israel, Palestine, Chile, Columbia, Ecuador, Paraguay, Peru, Uruguay, Japan, S Korea, China, Taiwan, Thailand, Africa and Egypt, Russia, Uzbekistan, S. Africa, Australia and New Zealand.
Additional Options (RPOs)	
Condition	Some customers may comment that areas of the frame wax coating are peeling off and rust/corrosion is visible on the metal in these areas. Several examples of this condition are shown in each group of graphics below.

Cause	The cause of this condition may be that the frame supplier may not have properly prepped the metal before the wax coating was applied.
Correction	<p>Note: A combination of specialized metal coating products manufactured by Lloyds and Daubert have been found to be the most suitable products to provide corrosion control and protection to address this type of repair. Our recommendation is to prep the metal surface using *Lloyd's Pure Prep™ Metal Surface Preparation P/N 25418, then topcoat with both *Lloyds Kryptonite Metal Treatment P/N 36502 Life Long Rust Protection and *Daubert Non-Rust® P/N X-121B One Coat Rust Preventative Coating. It is strongly recommended they be applied according to the manufacturer's procedures.</p> <p>*We believe this source and their products to be reliable. There may be additional manufacturers of such products/materials. General Motors does not endorse, indicate any preference for, or assume any responsibility for the products or material from this firm or for any such items that may be available from other sources.</p> <p>Prep the frame and apply the Lloyds and Daubert coatings following the steps in the Service Procedure below:</p>
