Service Bulletin

Bulletin No.: 20-NA-121

Subject: Water Leak at Roof Area, Various Electrical Issues, No Start, Stall, Brake Lamp Not Off, Radio Inoperative, Remote Key Inoperative, Malfunction Indicator Lamp (MIL) Illuminated

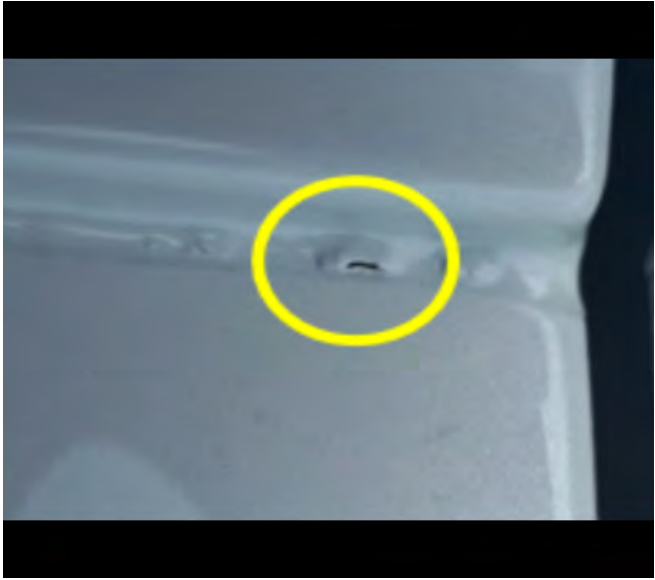
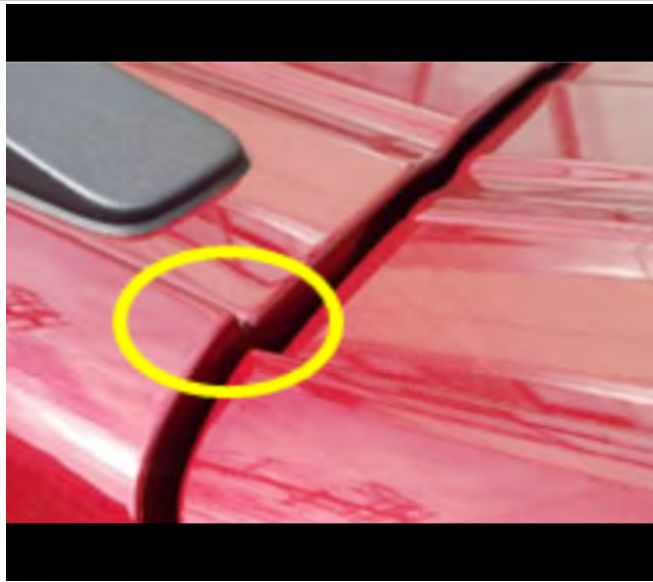
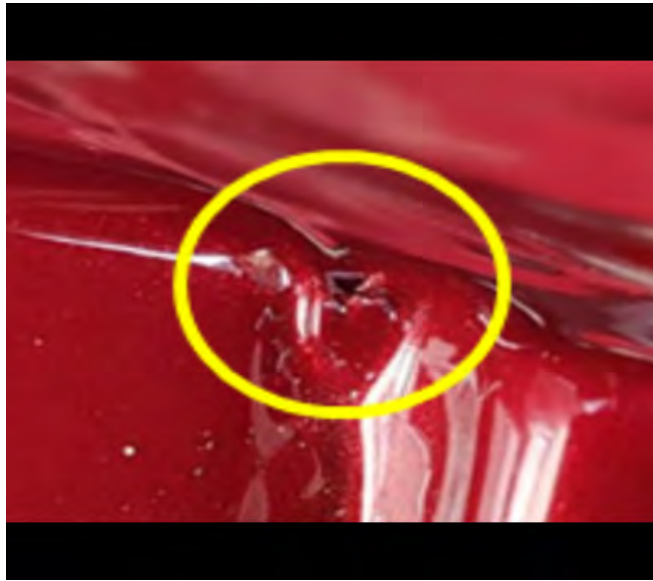
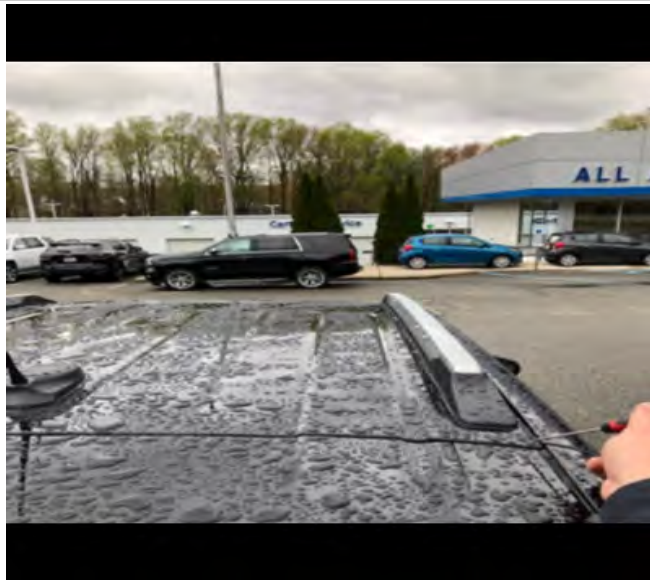
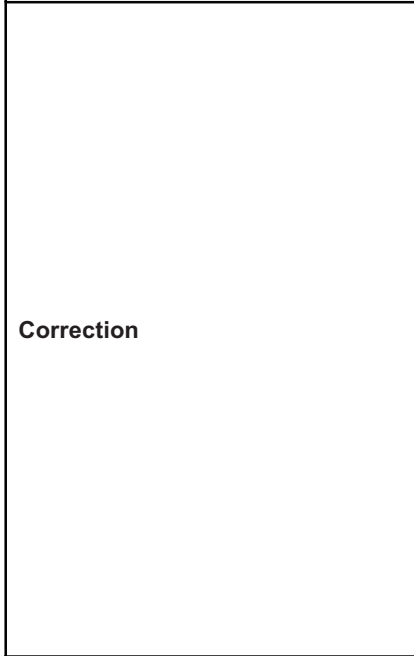
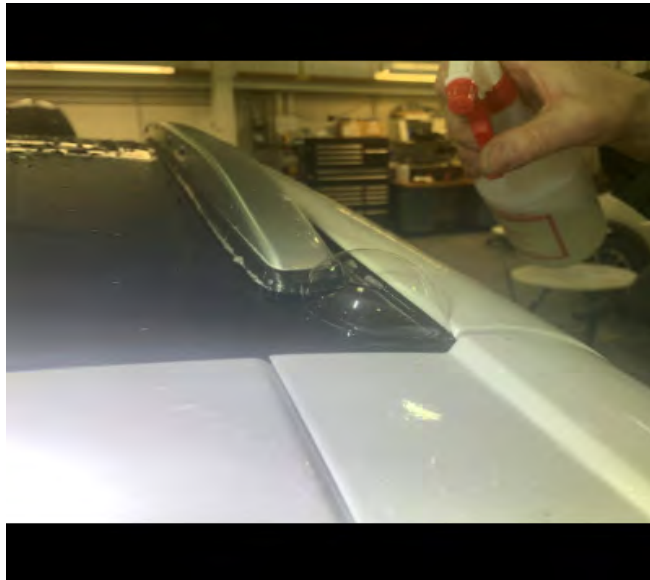
| Condition | Some customers may comment on a water leak in the front and/or rear of the vehicle (water found under A-pillar and B-pillar trim or in the spare tire area). |

The cause of the condition may be a pin hole in the roof body seam welding/sealing.

Inspect for a leak and repair as necessary.

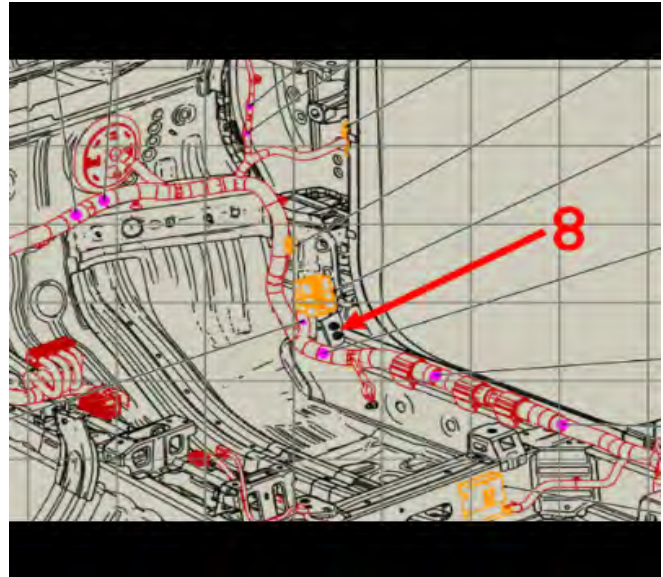
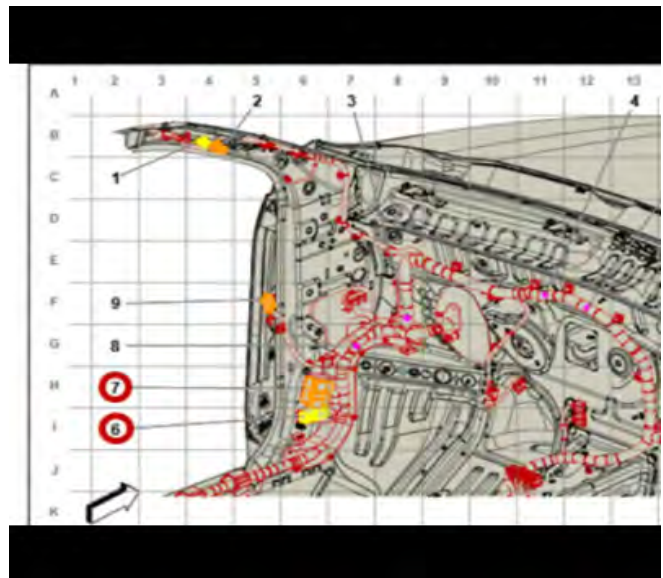
(#8) — X204 Instrument Panel Harness to Body Harness, 76-way connector right side

(#6) — X202 Instrument Panel Harness to Body Harness, 2-way connector left side

(#7) — X200 Instrument Panel Harness to Body Harness, 76-way connector left side

Clean the water inside of the connector and apply NYOGEL on terminals for waterproofing.

3. Inspect the connectors for any moisture. If needed, clean using a clean nylon bristle brush and dry connector using compressed air.
4. Preparing NYOGEL 760G (electrical grease) and flatting tool, apply on IP harness inline connector surface. Make sure all terminal pins are covered enough by grease.
5. Reattach the connectors. Make sure the 2nd locking tab is closed.
6. Reinstall the garnish trim.

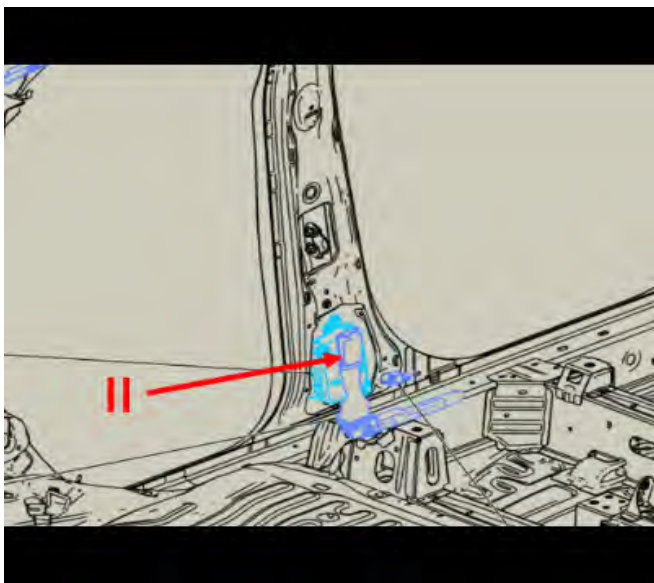
5752327

(#11) — F112D Seat Belt Retractor Pretensioner - Driver

(#4) — F112P Seat Belt Retractor Pretensioner – Passenger (not shown)
