Service Bulletin

Bulletin No.: 20-NA-132

Subject: Warranty Administration – Battery Testing and Warranty Replacement Requirements (North America ONLY)

Brand:	Model:	Model Year:		Breakpoint:		Engine:	Transmission:
		from	to	from	to		
Buick	GM Passenger Cars and Trucks (including Medium Duty)	2010	2021	—	—	—	—
Cadillac							
Chevrolet							
GMC

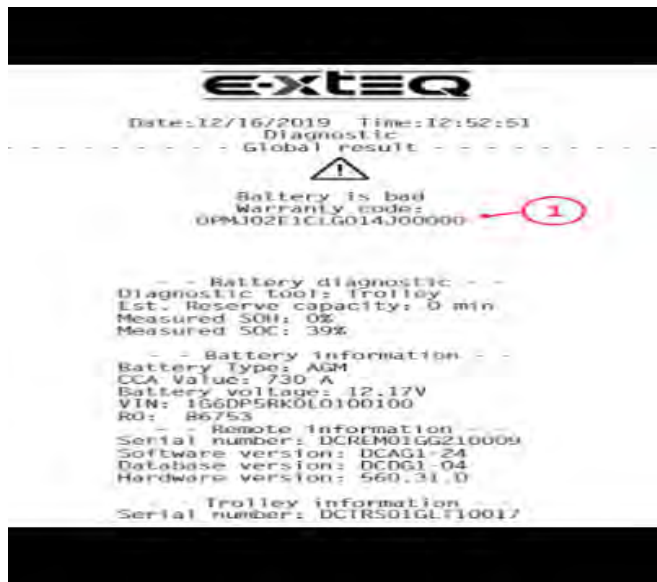
DCBS Example:

The “Warranty Code” is the correct code to enter on the transaction (1). This code is unique to each test performed and is decodable by GM.
