Service Bulletin

Bulletin No.: 20-NA-169

Subject: Creak, Pop and/or Snap Type Noise Heard Coming from Passenger Side B-Pillar Area

Brand:	Model:	Model Year:		Breakpoint:		Engine:	Transmission:
		from	to	from	to		
Chevrolet	Traverse	2020	2021	-	-	-	-

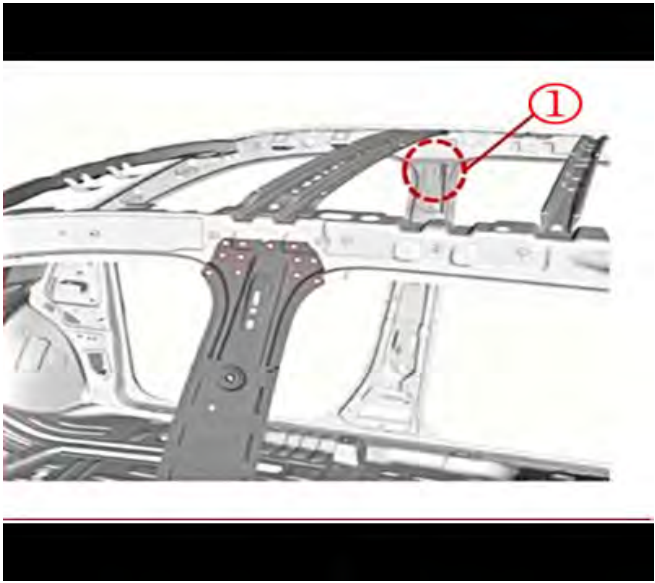
Involved Region or Country	United States, Canada, Mexico, Uzbekistan, Israel, Palestine, Colombia (West), GM Korea Company, Russia, Middle East, Chile and Peru.
Condition	Some customers may comment on a creak, pop and/or snap type noise heard coming from passenger side B-Pillar area.
Cause	<div style="text-align: center;">

</div> <p style="text-align: right; font-size: small;">5642213</p> <p>This condition may be caused by metal to metal contact between the front roof inner front side rail and the center pillar inner panel (1), as shown in the picture above.</p>
Correction	Apply structural adhesive into the gap between the Roof Rail Inner and the Center Pillar Inner Panel follow the procedure below.
