Service Bulletin

Bulletin No.: 20-NA-197

Subject: Malfunction Indicator Lamp (MIL) Illuminated - DTC P0087, P0089, P0191, P026D, P1089, P163A, P163B, P2293, P228A, P228B, P228C, and/or P228D Set

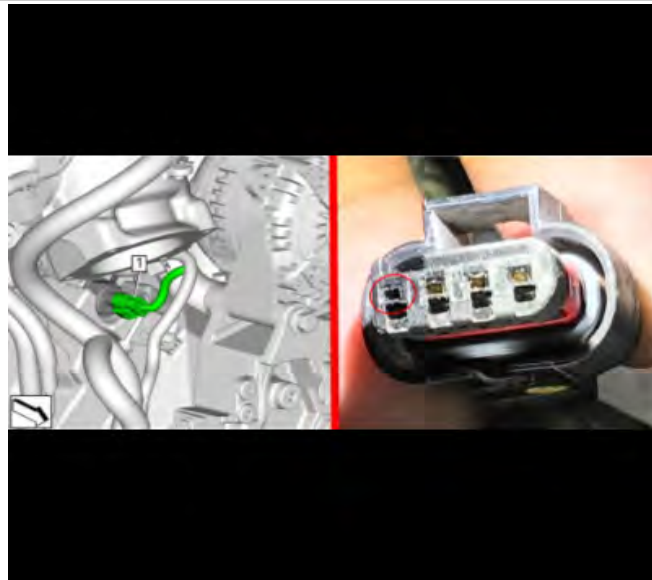
5652222

Cause	This condition may be caused by corrosion or damaged at the fuel pressure sensor electrical connector.

Inspect the fuel pressure sensor electrical connector for corrosion or damage.

⇒ It may be necessary to use a generous enough amount of dielectric grease in the connector to reach the entire terminal and use J-35616-16 (LT GN) terminal test tool and drag the tool up to 10 times to find/identify corrosion or fretting.
