Service Bulletin

Bulletin No.: 21-NA-032

Subject: DTC P0101 Mass Air Flow (MAF) Sensor Performance, P1682 Set after MAF Replacement

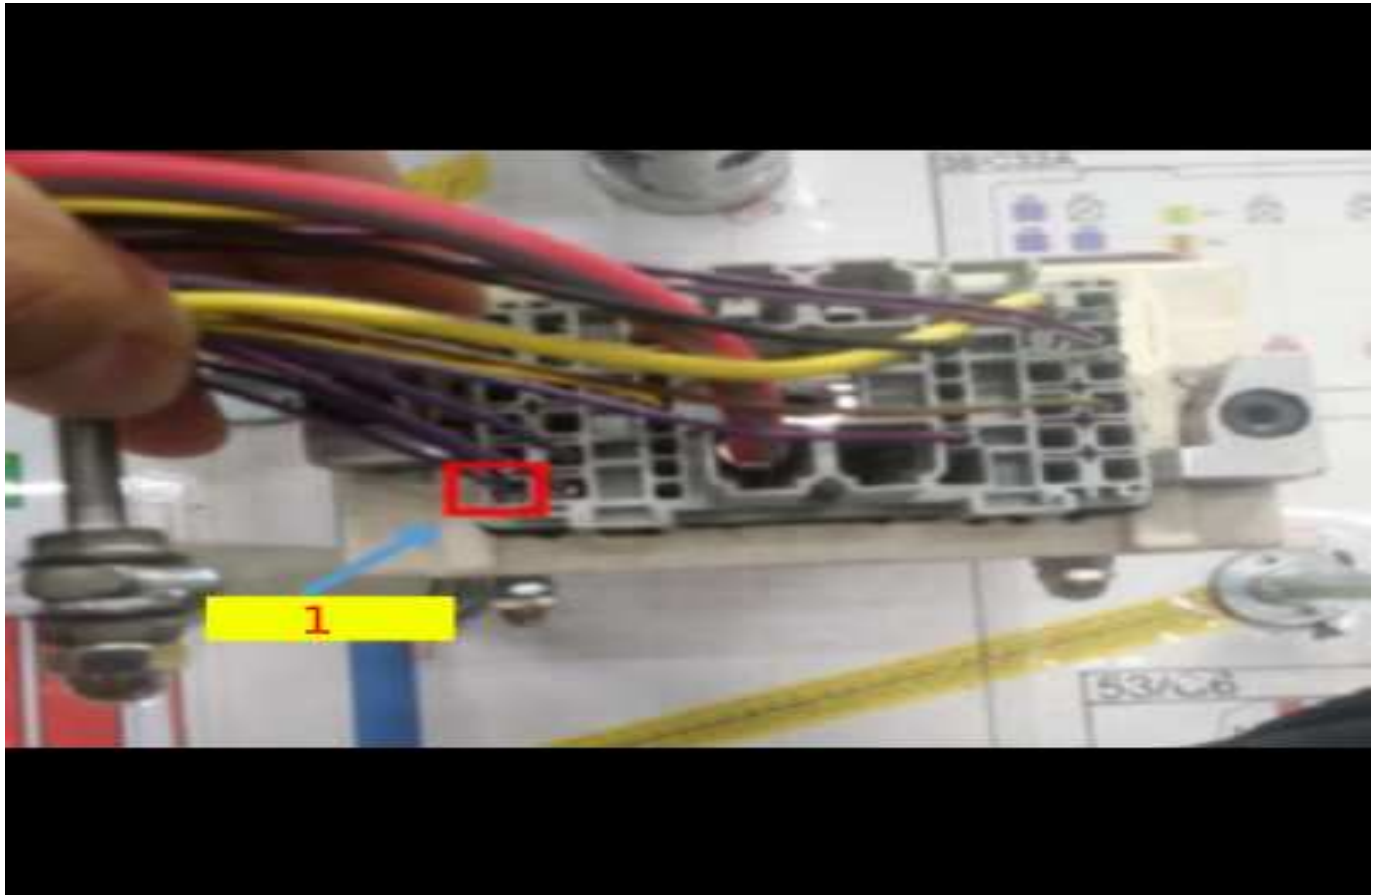
5735855

1. Locate the X50A Fuse Block- Underhood X3 Connector

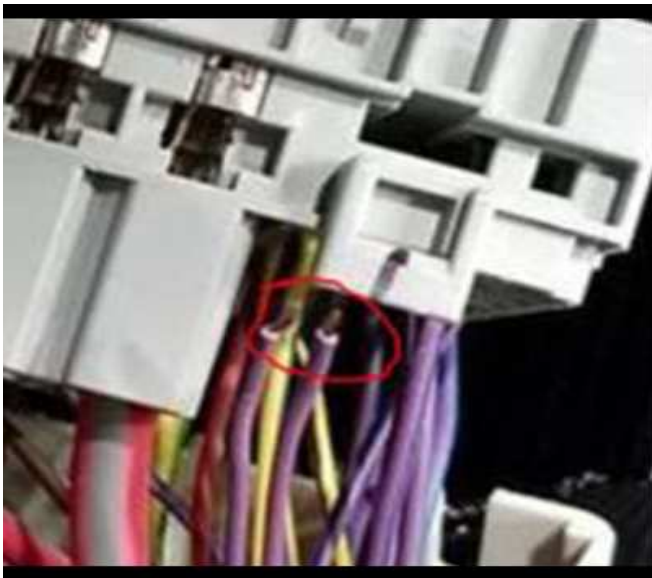
5735789

2. Locate the dual-crimp wire in the H6 pin (1).
3. Verify the dual crimp wire at the H6 pin

- If the dual crimp is like the example above, repair the wire. Refer to *Repairing Connector Terminals (Terminal Repair)* in SI.
