Service Bulletin

Bulletin No.: 21-NA-046

Subject: Loss of Window Motor Memory – Window Drops Down

Brand:	Model:	Model Year:		VIN:		Engine:	Transmission:
		from	to	from	to		
GMC	Terrain	2018	2021			All	All
Chevrolet	Equinox		2020				
Holden	Equinox

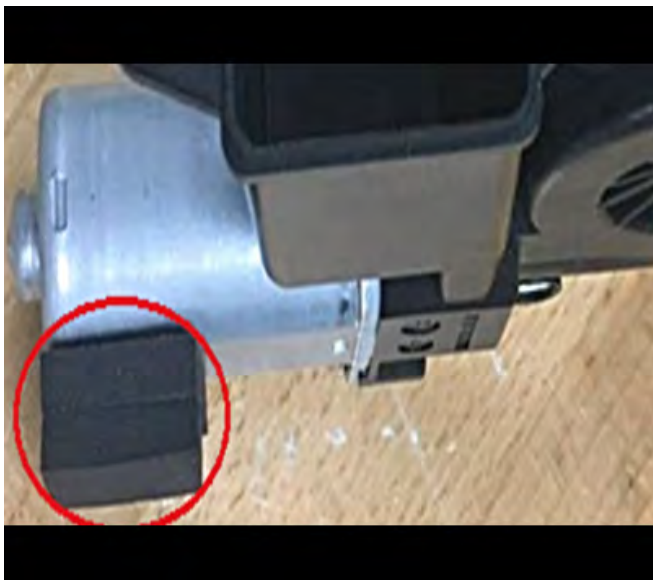
5752753

Note: In the graphic above, the foam is shown in the correct location on the motor housing, but will be applied to the inner door panel, not the motor housing.

3. Cut dense, adhesive backed, closed cell foam (Kent Automotive P/N 83327 or equivalent) to reach a 12 mm (1/2") thickness and 25 mm (1") square. In this example, there are 2-6 mm x 25 mm x 25 mm (1/4" x 1" x 1") squares adhered together.
