Service Bulletin

Bulletin No.: 21-NA-047

Subject: Shake and/or Shudder During Light Throttle Acceleration Between 25 and 80 MPH (40 and 128 KM/H) at Steady Speed

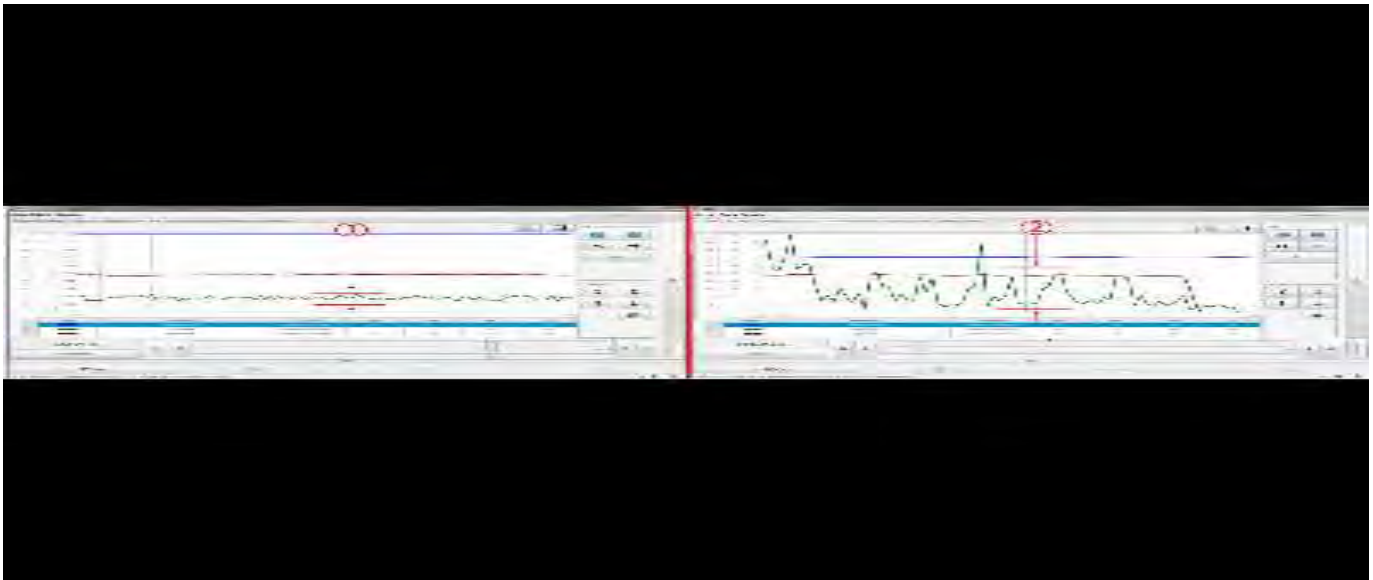
5752700

TCC SLIP CONTROL TEST RESULT	TCC RPM Slip Peak to Peak (At Steady Throttle)	ACTION	Note
Normal	Below 20 rpm	Do nothing	-
Degraded	Near 60 rpm repeating	Flush transmission fluid	Shudder, surge, fish bite likely

7. Evaluate collected data with line graph and compare data from a normal (1) and degraded. (2).

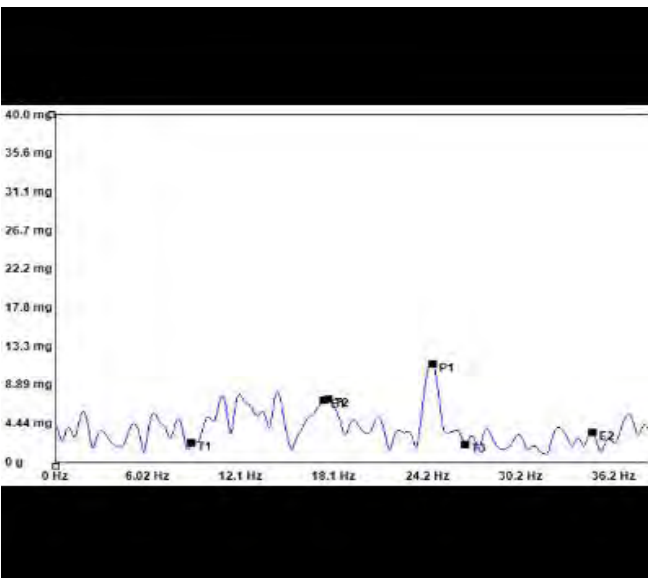
5751608

The graph above depicts a normal frequency.

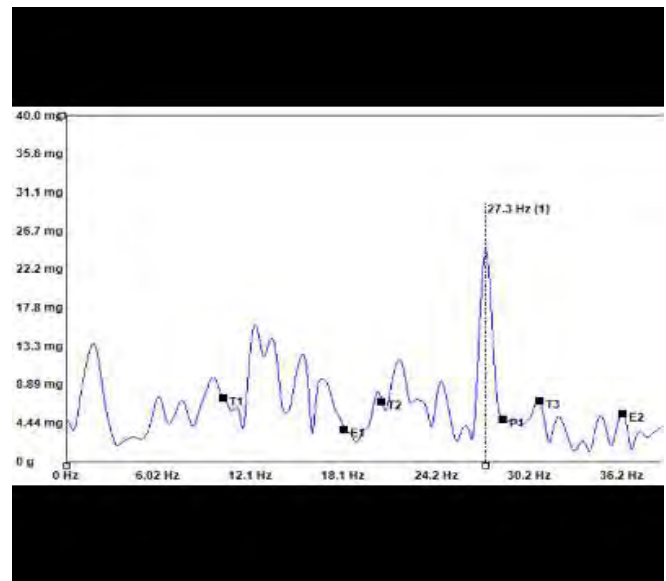
5751612

The graph above depicts a degraded frequency or shudder.

any other known vehicle vibration issues (tires, brakes, etc.) before conducting test. If TCC Shudder is present, a vibration peak will appear. TCC Shudder vibration frequency is stationary in 8th gear. If the vibration frequency follows vehicle speed or engine speed, then it is NOT TCC Shudder.

Vehicles that are presented with TCC shudder should have the appropriate fluid exchange procedure completed. Diagnosis beyond the customer complaint is not required if vehicle was built prior to production dates indicated above.
