Service Bulletin

Bulletin No.: 21-NA-050

Subject: Paint Chipping or Peeling on Front Fascia, at Interface of Front Fender and Fascia Near Headlamp

Brand:	Model:	Model Year:		VIN:		Engine:	Transmission:
		from	to	from	to		
Cadillac	Escalade Models	2021	2021			All	All
Chevrolet	Suburban Tahoe						
GMC	Yukon Models

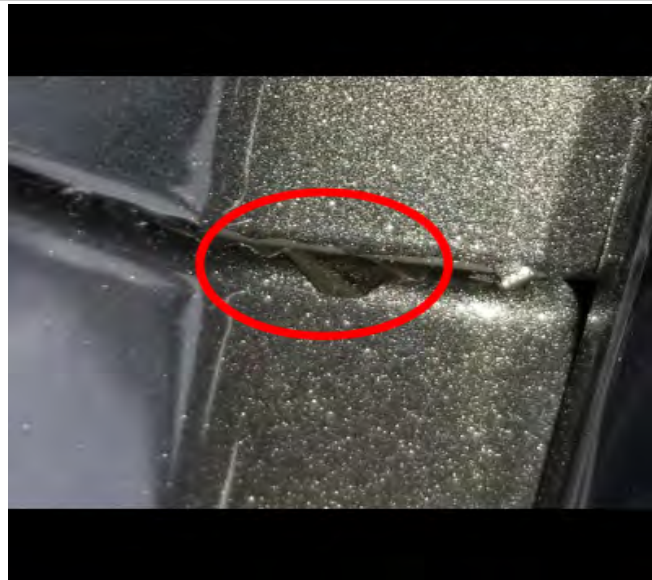
5758467

Note: Several examples of the paint damage is shown in the graphic above. The call-outs are (1) fender, (2) fascia and (3) headlamp.

Some customers may comment on seeing paint chipping or peeling on the front fascia at interface of front fender and fascia near headlamp.

The cause of the condition may be a fascia guide bracket stiffness issue.

Remove and reinstall the front fascia, and repair fascia paint as necessary, following the steps in the Service Procedure below.

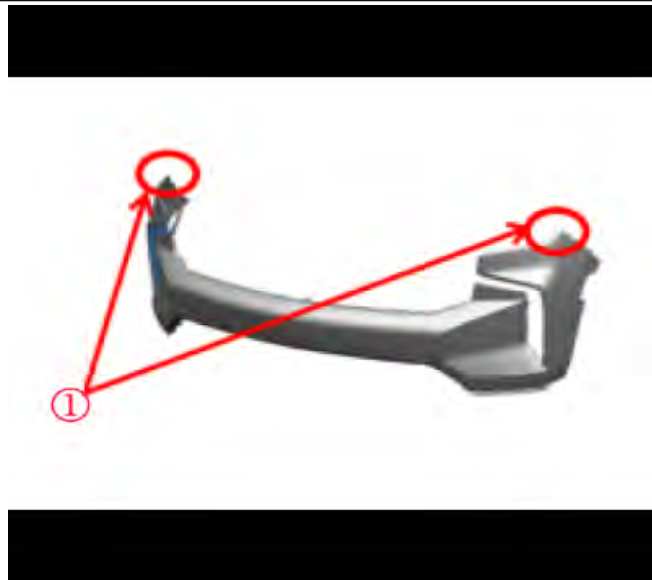
5758469

Note: The area(s) (1) of concern are commonly the rear, upper corners of either, or both sides, of the front fascia.
