Service Bulletin

Bulletin No.: 21-NA-052

Subject: False Traction Control or Stability Event During Slow Speed Sharp Turns

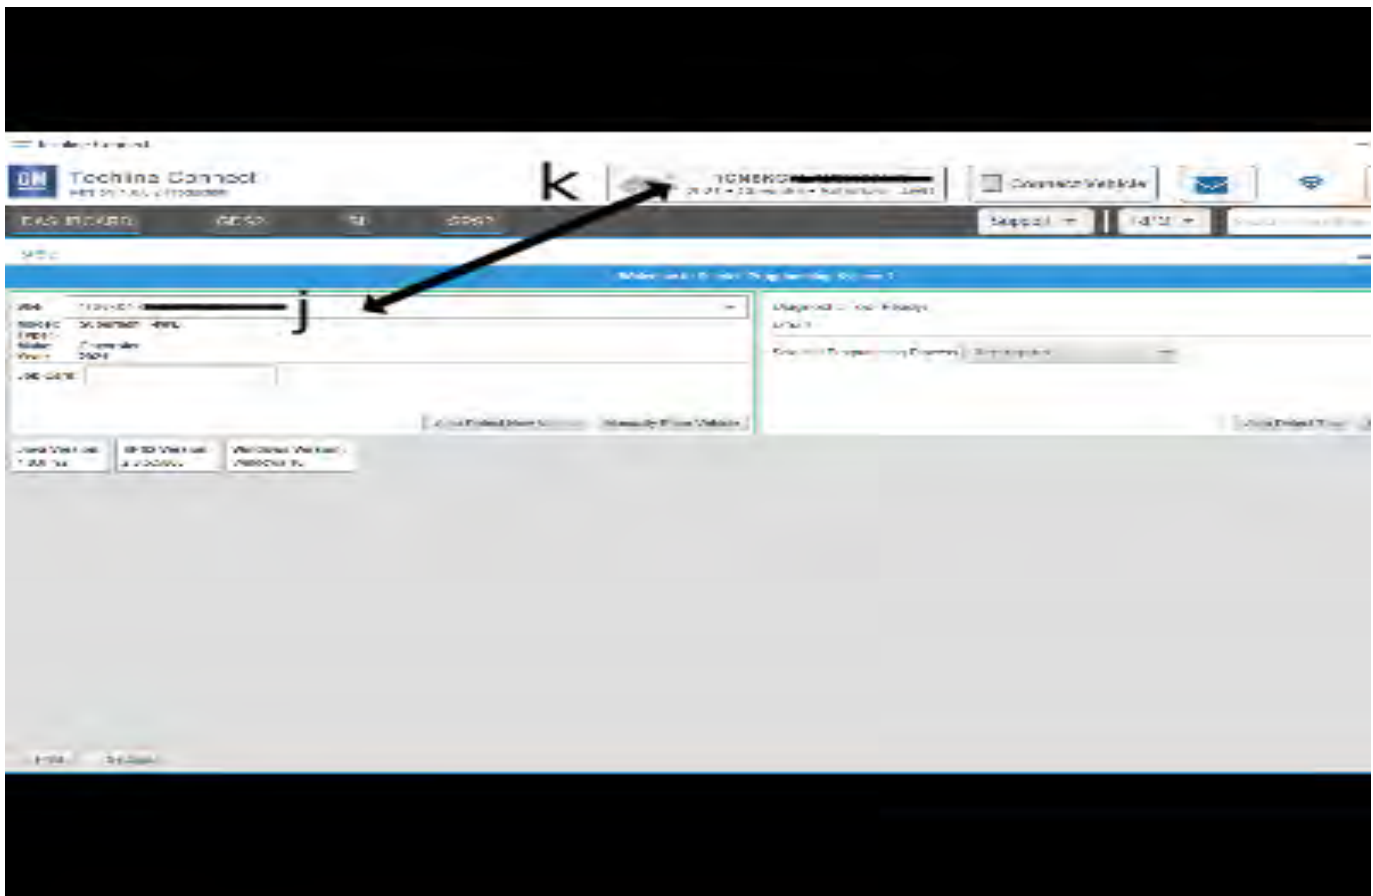
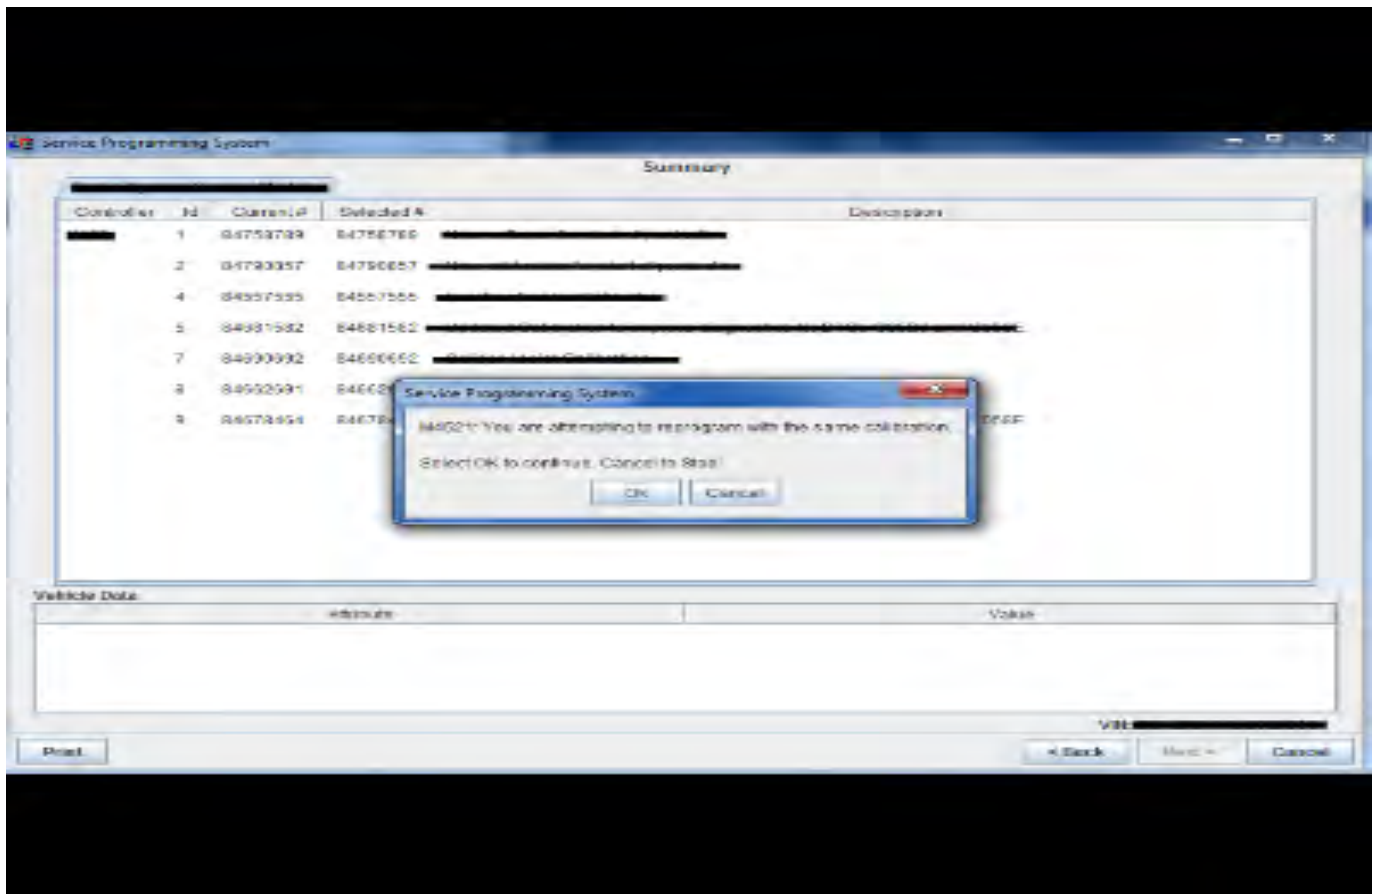
Caution: Be sure the VIN selected in the drop down menu (1) is the same as the vehicle connected (2) before beginning programming.

Important: Techline Connect and TIS2WEB screens shown above.

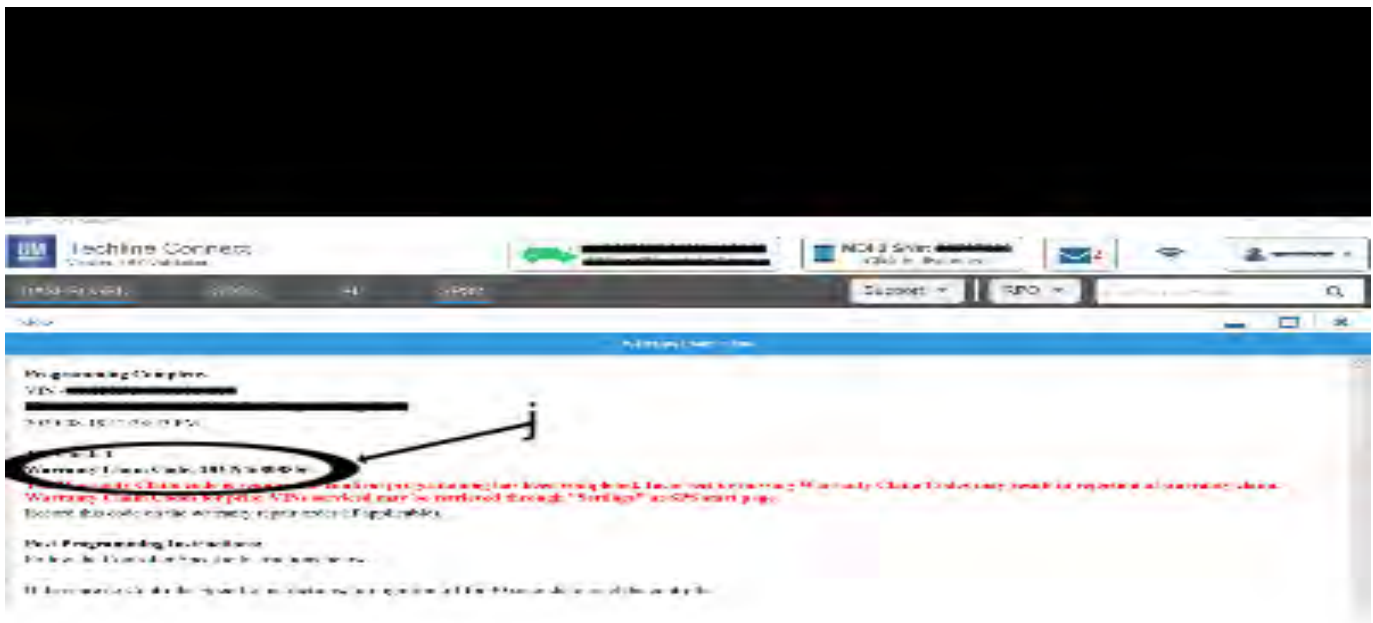
Note: The screenshots above are an example of module programming and may not be indicative of the specific module that is being programmed. Module selection and VIN information have been blacked out.

Important: To avoid warranty transaction rejections, you **MUST** record the warranty claim code provided on the SPS Warranty Claim Code (WCC) screen shown above on the job card. Refer to callout 1 above for the location of the WCC on the SPS screen

1. Reprogram the Electronic Brake Control Module. Refer to *K17 Electronic Brake Control Module: Programming and Setup* in SI.
