# Service Bulletin

Bulletin No.: 21-NA-053

**Subject: Radio Software Version V155 Update**

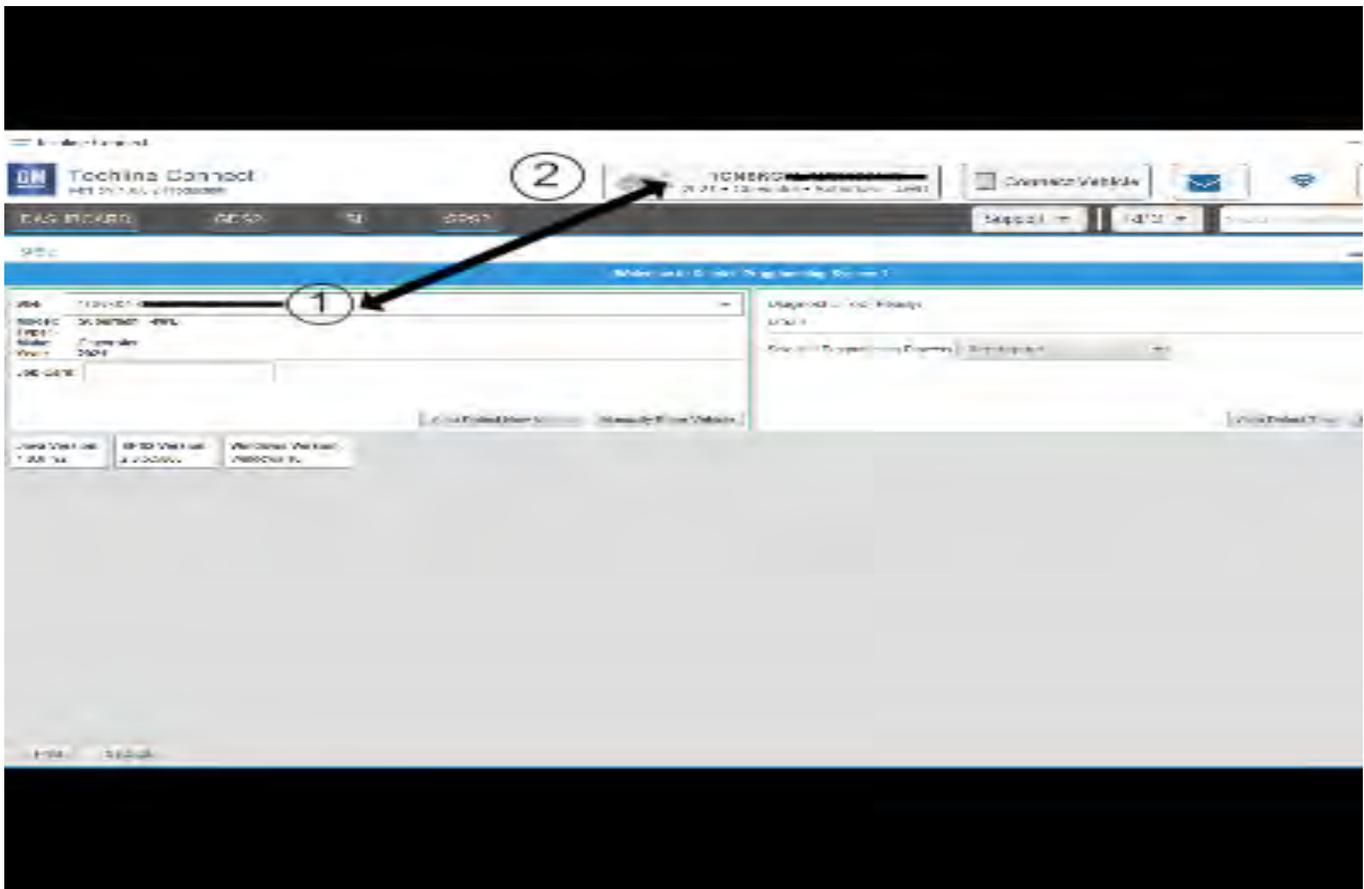
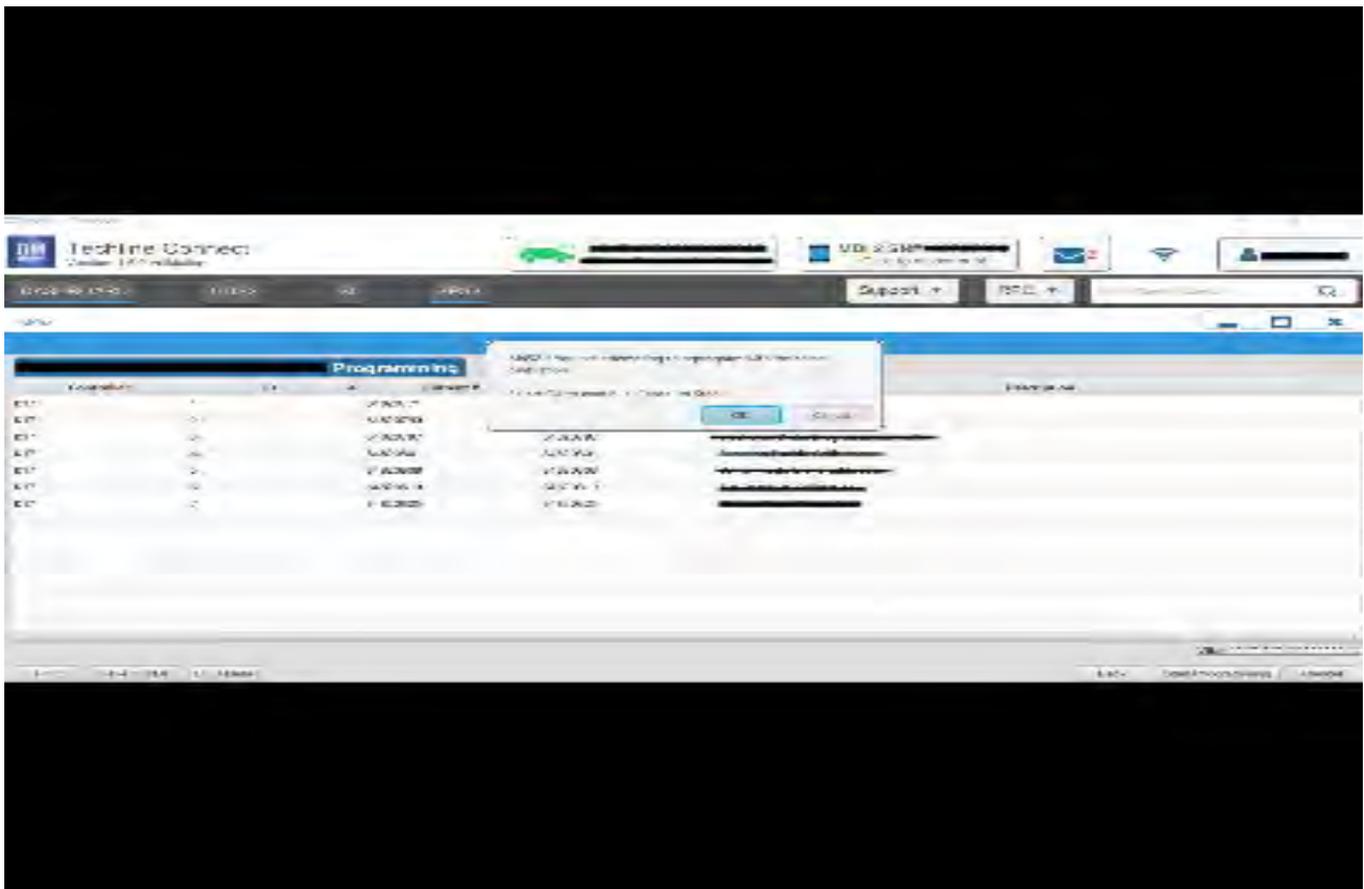
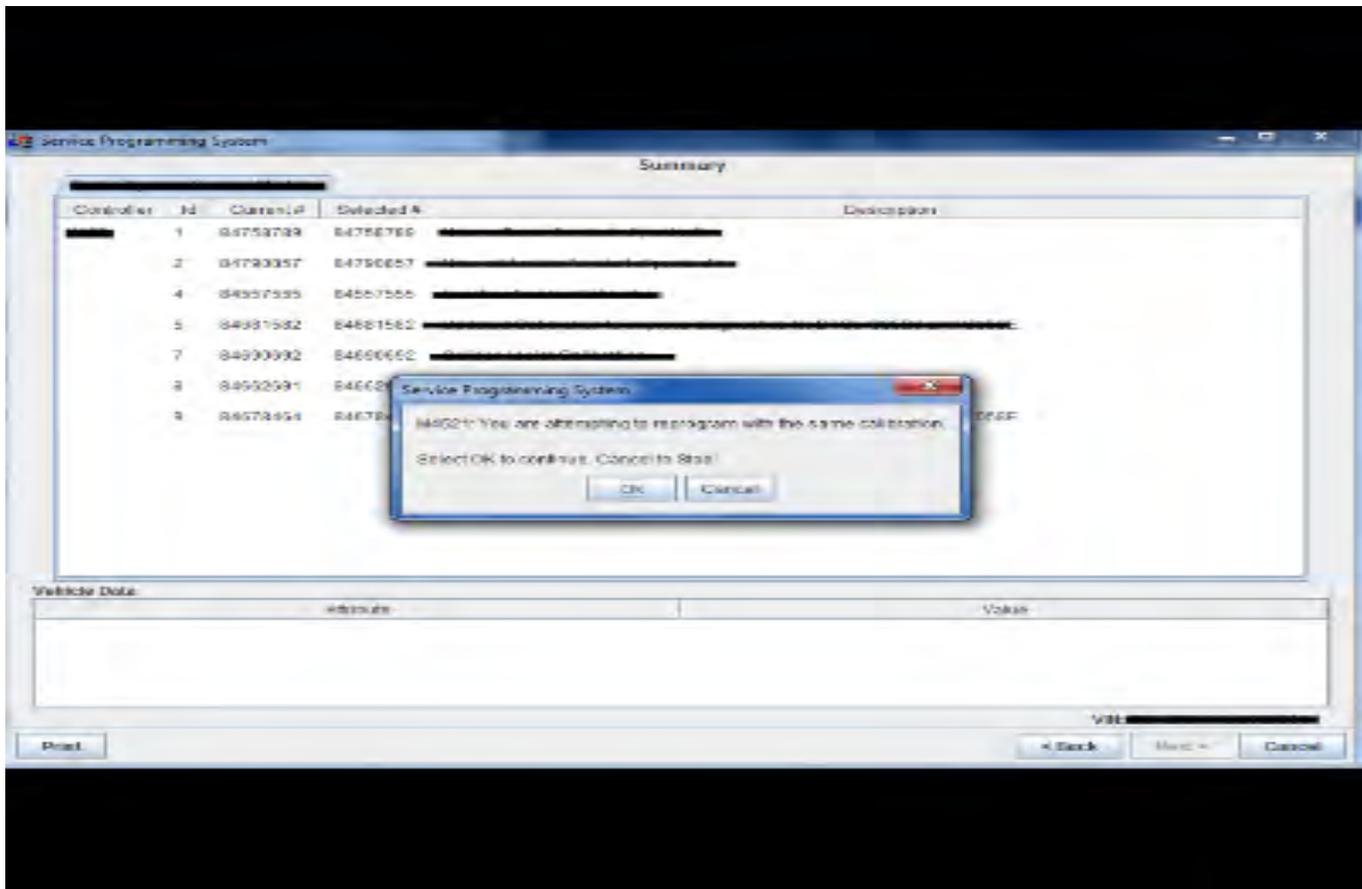
**Caution:** Be sure the VIN selected in the drop down menu (1) is the same as the vehicle connected (2) before beginning programming.

**Important:** Techline Connect and TIS2WEB screens shown above.

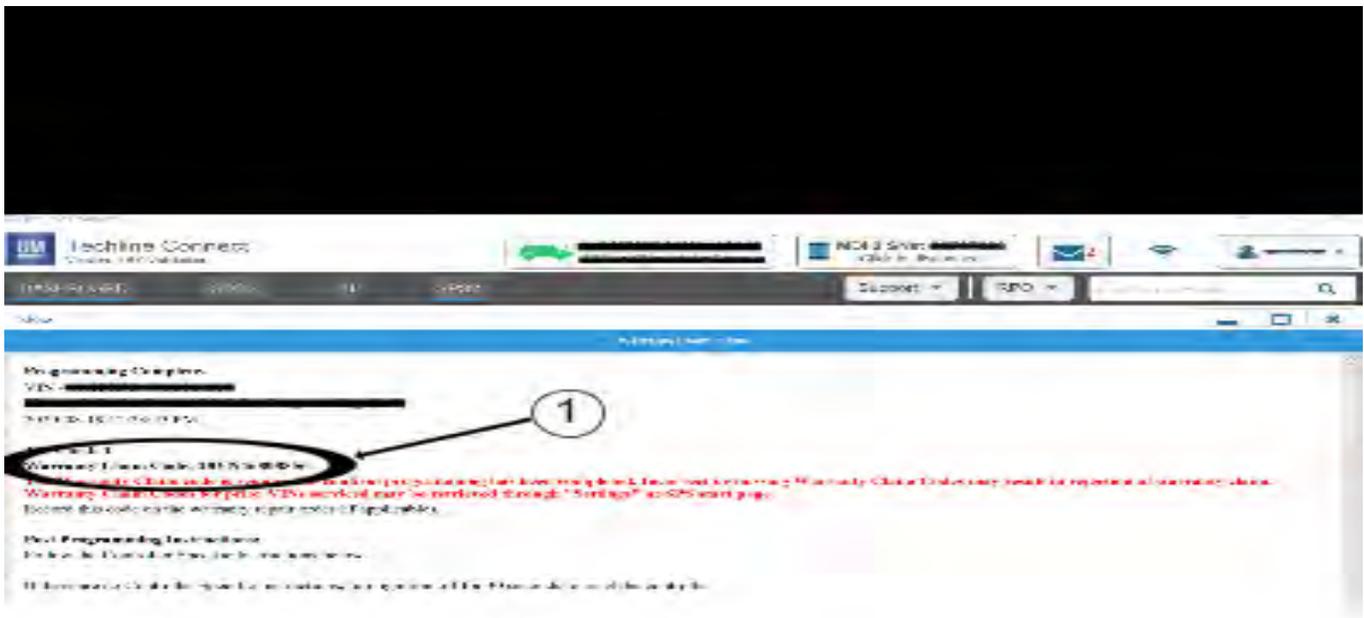
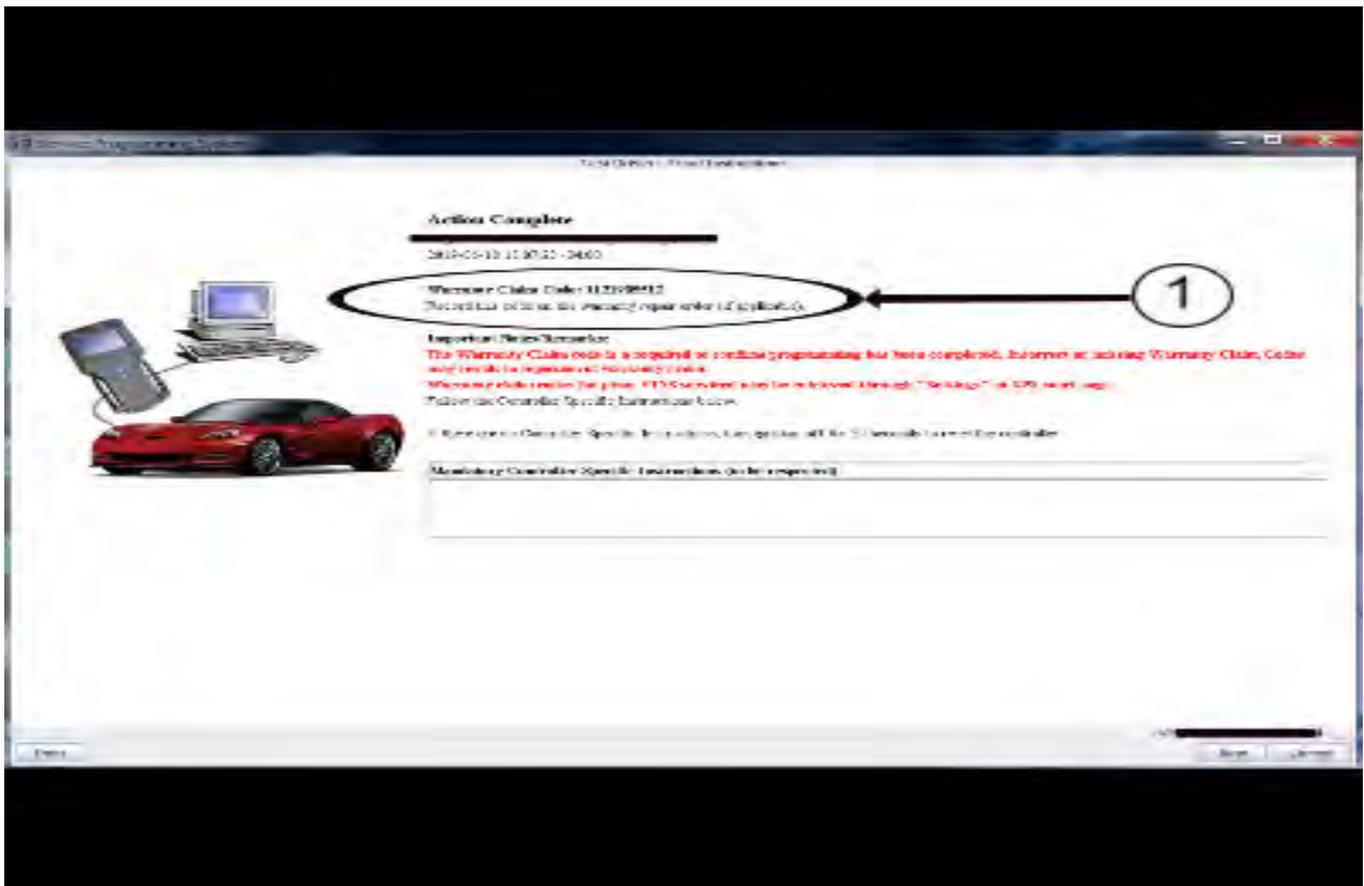
**Note:** The screenshots above are an example of module programming and may not be indicative of the specific module that is being programmed. Module selection and VIN information have been blacked out.

**Important:** To avoid warranty transaction rejections, you **MUST** record the warranty claim code provided on the SPS Warranty Claim Code (WCC) screen shown above on the job card. Refer to callout 1 above for the location of the WCC on the SPS screen.

- Record the SPS Warranty Claim Code on the job card for warranty transaction submission.
