# Service Bulletin

Bulletin No.: 21-NA-054

**Subject:** Instrument Cluster Resets, Center Display Goes Blank or Gauges Inoperative

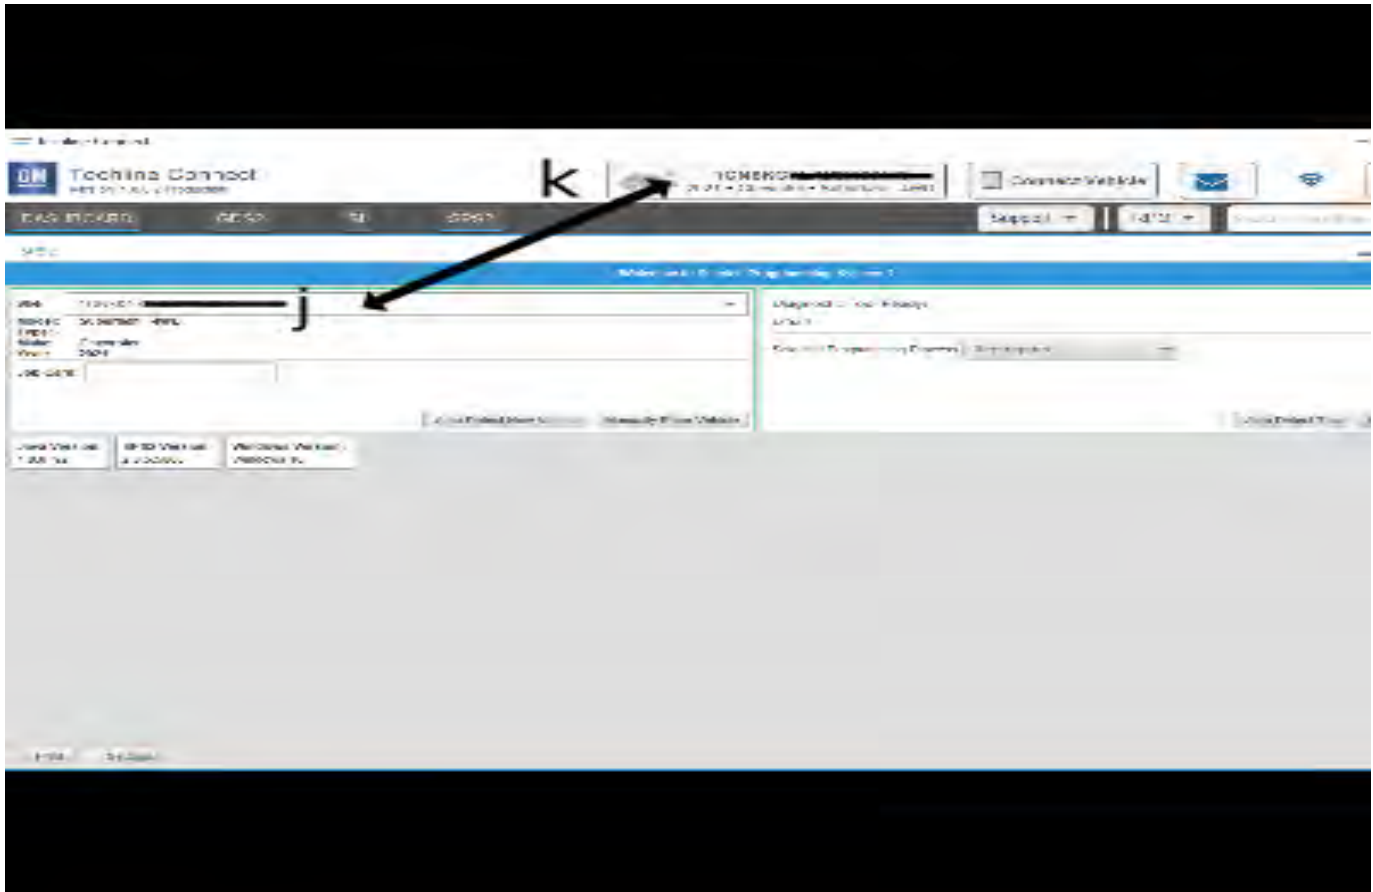
5743643

**Caution:** Be sure the VIN selected in the drop down menu (1) is the same as the vehicle connected (2) before beginning programming.

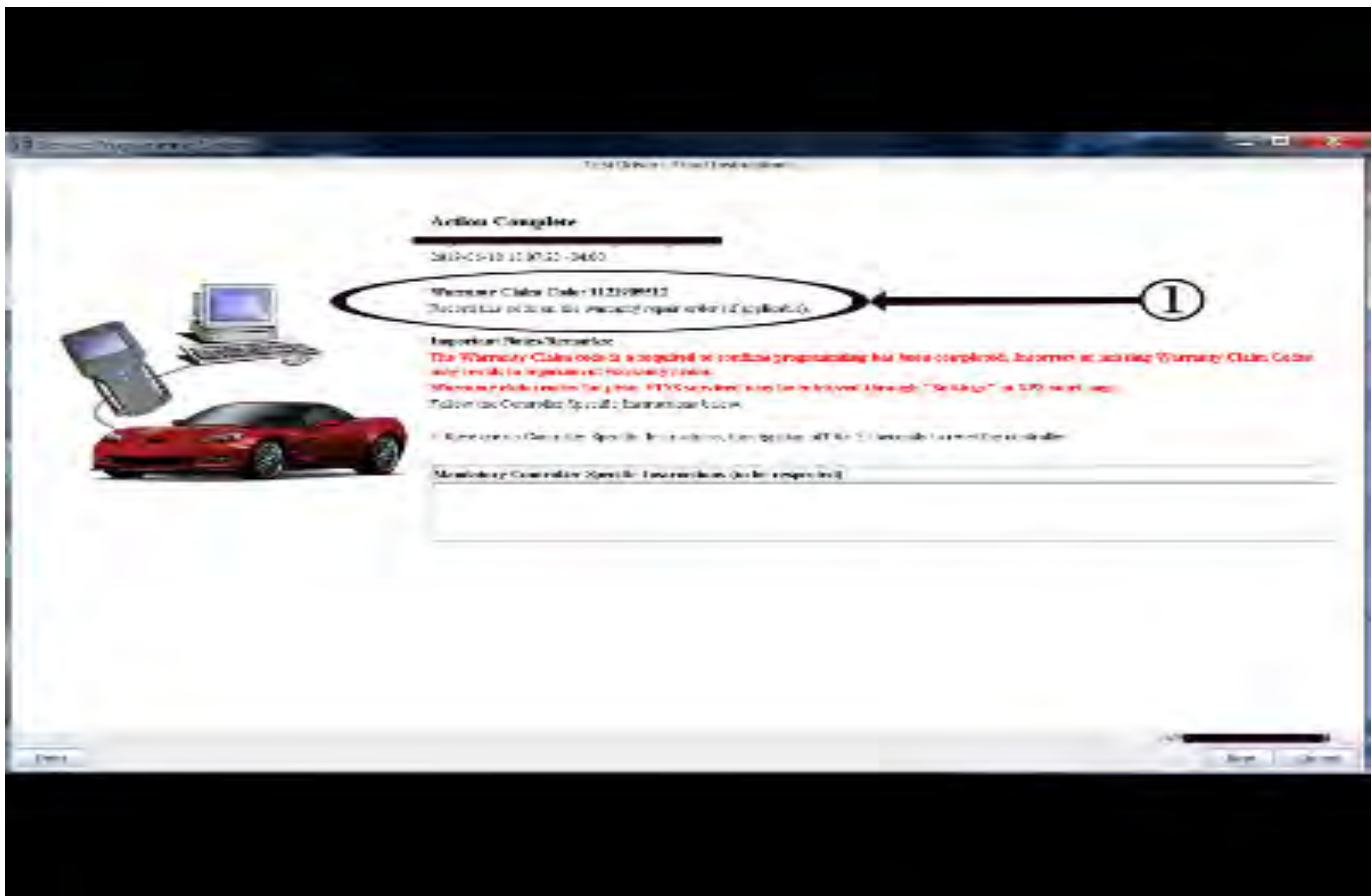
5431209

**Important:** To avoid warranty transaction rejections, you **MUST** record the warranty claim code provided on the SPS Warranty Claim Code (WCC) screen shown above on the job card. Refer to callout 1 above for the location of the WCC on the SPS screen.
