# Service Bulletin

Bulletin No.: 21-NA-058

**Subject: Radio Software Version 382 Update**

Brand:	Model:	Model Year:		VIN:		Engine:	Transmission:
		from	to	from	to		
Cadillac	Escalade Escalade ESV	2021	2021

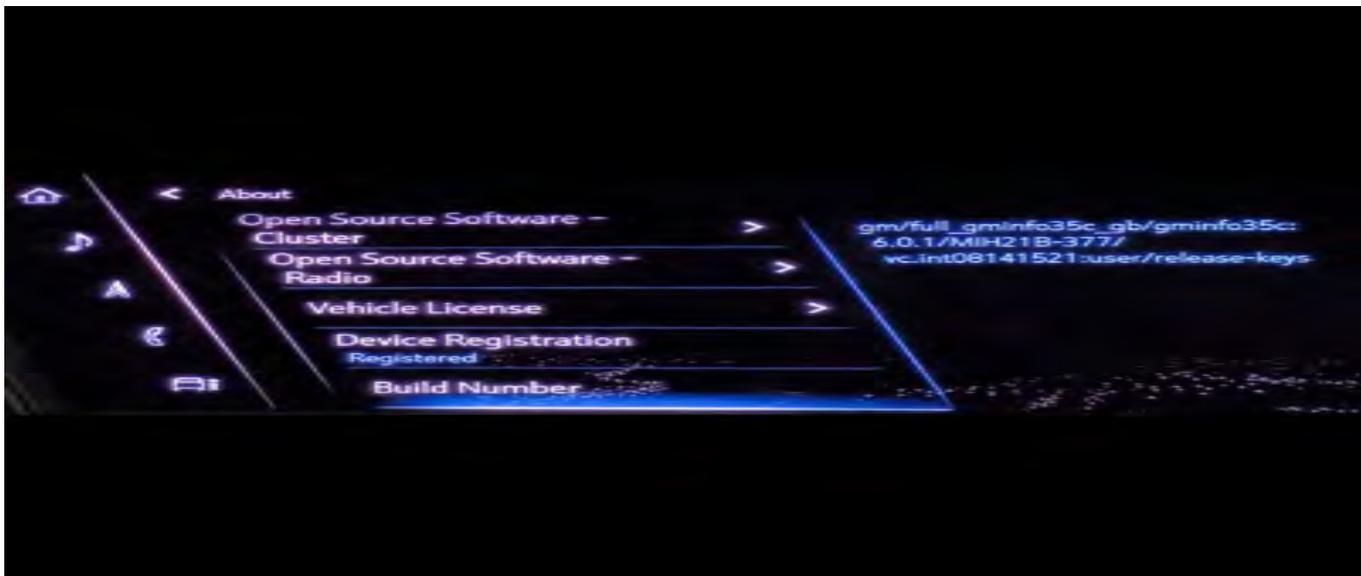
5766434

**Important:** It is important to ensure that the technician is inspecting the full information found within *Build Number*. To identify the current software installed in the radio requires the user to locate the *Build Number* to view the full software version file name. In the middle of this long file name look for 382. (The illustration below shows software version 377, thus that would be outdated.) The number would be numerically lower if the radio is not up to date, or numerically higher if newer versions were released and installed.

1. Inspect the current radio software version. Navigate to Settings -> About -> Build Number to view and verify the software version.
  - If equal or greater than 382, this bulletin does not apply. Refer to SI for diagnostics.
  - If less than 382, update the radio software via USB. Refer to *A11 Radio: Programming and Setup* in SI.

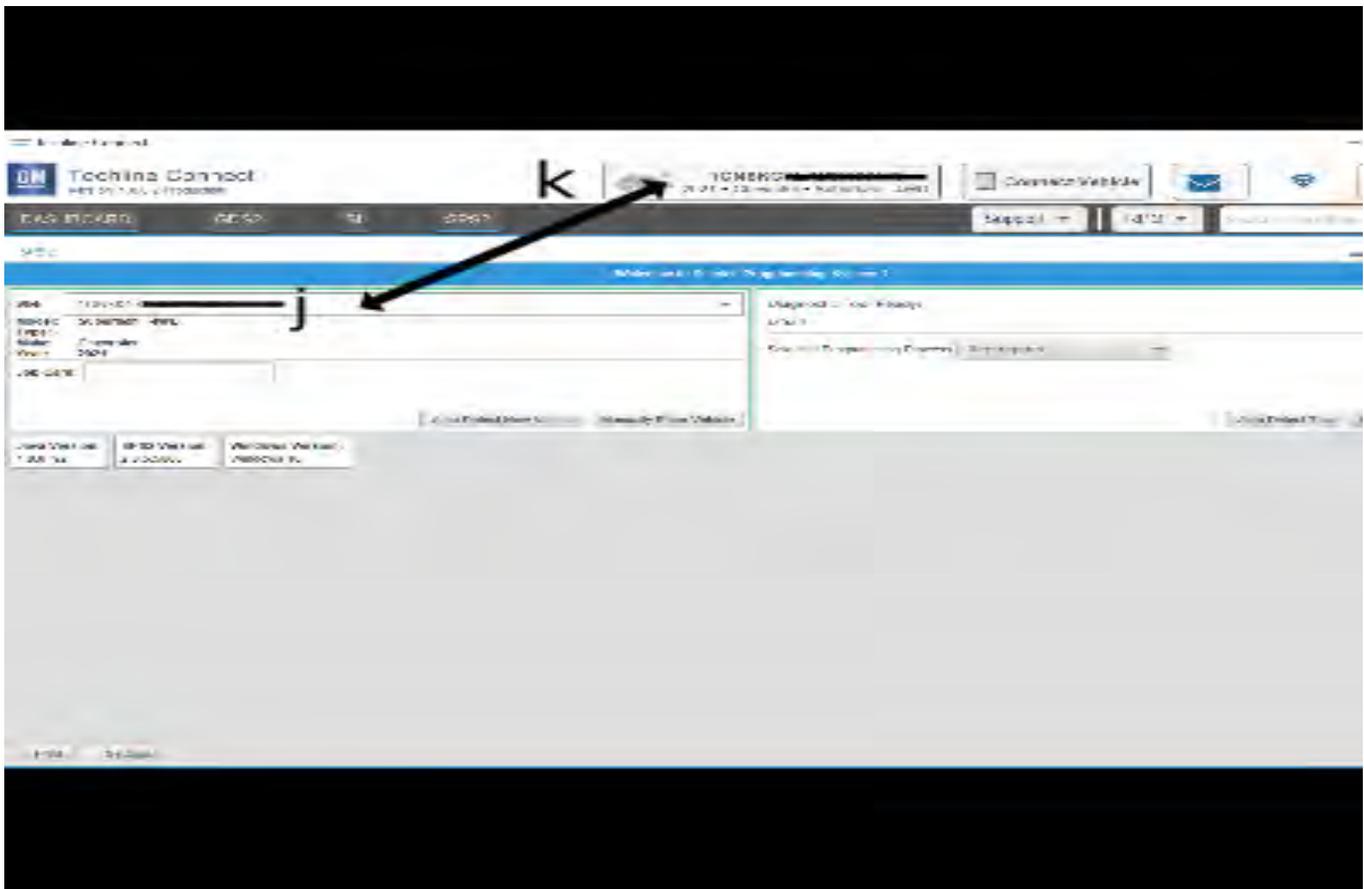
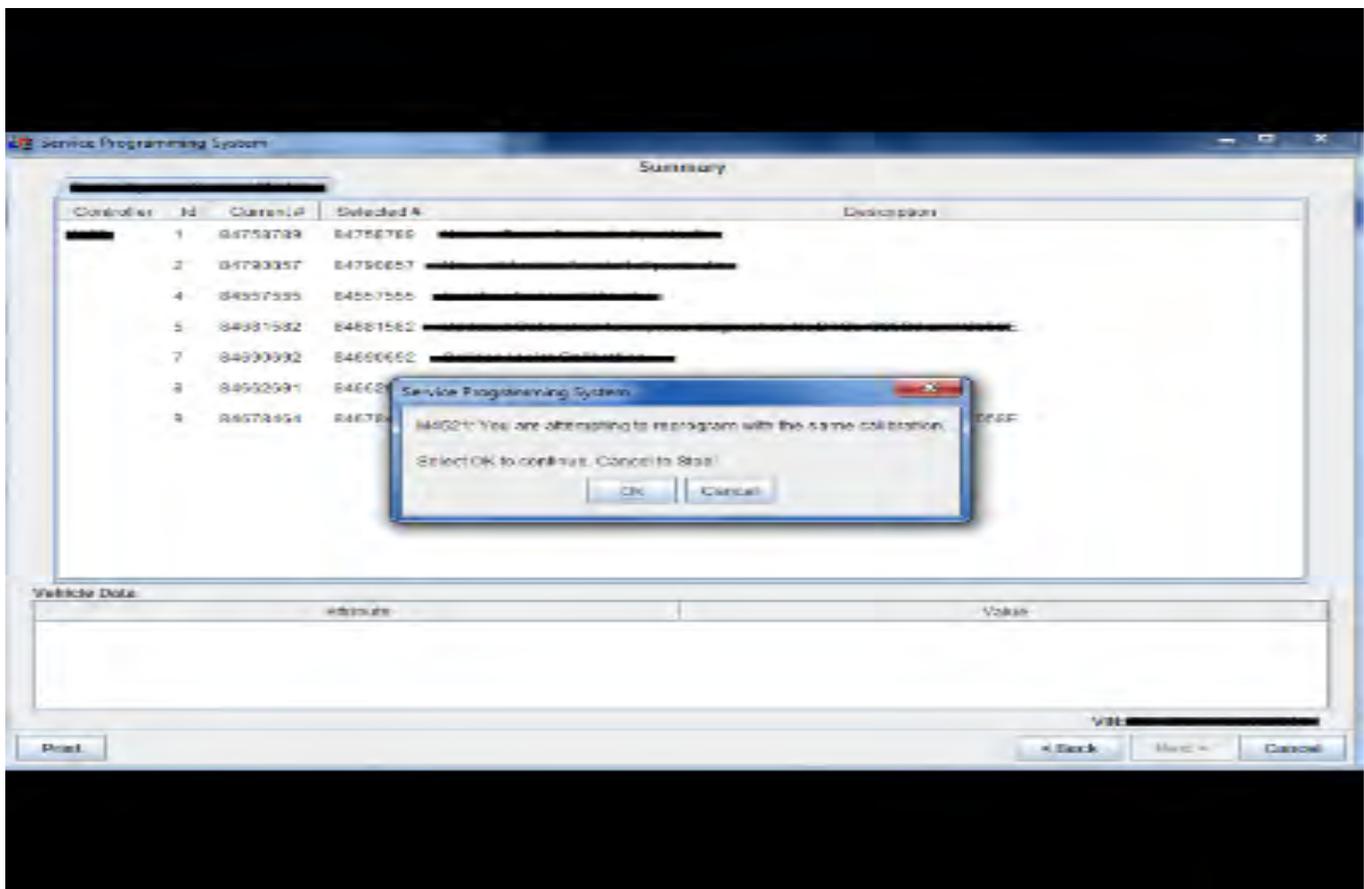
**Caution:** Be sure the VIN selected in the drop down menu (1) is the same as the vehicle connected (2) before beginning programming.
