Model Series 223 – Steering Column Switch Module/Cover - Caution When Removing

| Topic number | LI46.10-P-072751 |
| Function group | 46.10 - Steering wheel, jacket tube, steering shaft, steering lock |

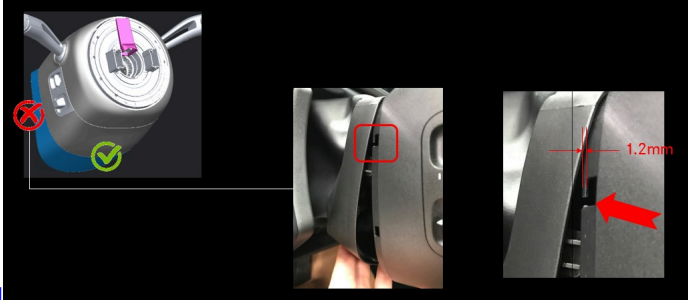
When removing the steering column switch module, a fracture may occur in the bridge of the locking hole on the steering column switch module cover, at the join with the bellows extension.

| Attachments | |
|--|--|
| 1_MRSM-SCCM.jpg | Illustration: A fracture may occur in the bridge of the locking hole on the steering column switch module cover, at the join with the bellows extension. |

Undersizing of catch tabs on steering column switch module cover.

Remove cockpit frame/bellows extension and steering column switch module without undoing clip-on connection.
