GROUP ELE	MODEL 2019MY~ Niro EV (DE EV)
	NUMBER 234	DATE April 2021
<p align="center"><b>TECHNICAL SERVICE BULLETIN</b></p>		
<p><b>SUBJECT: DRIVE UNIT INSPECTION &amp; REPLACEMENT FOR EV MOTOR RUMBLE NOISE</b></p>

This bulletin provides the procedure to inspect and repair the EV motor drive unit and reduction gear on some 2019MY~ Niro EV (DE EV) vehicles produced from December 5, 2018, which may exhibit an abnormal rumble noise while driving (refer to noise sample videos below). The rumble noise may be heard repeatedly when the traction motor is operating, while driving slowly in “D” range, or when slowly accelerating/decelerating between 0~25 mph. To correct this concern, follow the procedure outlined in this bulletin to inspect and repair the traction motor and/or reduction gear.

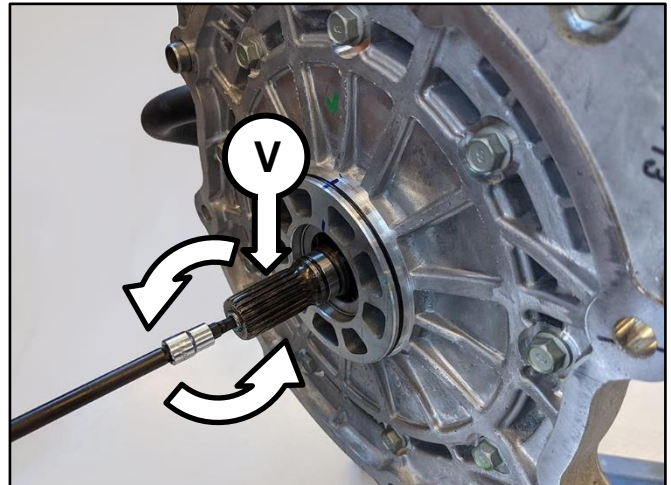
1. Rotate the drive motor shaft (V) to check for a rumble noise.
  1. Connect a 5mm hexagon tip to the taper plug at the end of the shaft.
  2. Start a counterclockwise rotation by gently turning with your hands.
  3. Use a power tool to increase the speed of rotation.

Listen for an abnormal noise.

- If there is an abnormal noise, replace the drive motor.
- If no abnormal noise is heard, proceed to the '**Reduction Gear Noise Inspection**' on page 12.

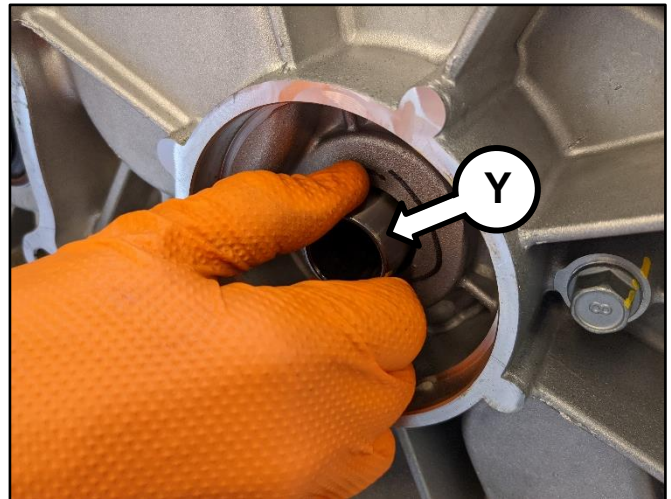
3. Rotate the reduction gear input shaft (Y) by hand to check for noise and/or jamming.

- Normal: Shaft can be turned freely by hand, and no abnormal noise or significant vibration is felt when rotating in any/one direction.
- Abnormal: Noise or jamming when rotating in any/one direction.

- If an abnormal noise and/or jamming occurs, replace the reduction gear.
- If no abnormal noise is heard, proceed to '**Reduction Gear Vertical Reassembly**'.
