# Service Alert

MRCC CANCELED AND/OR FRONT RADAR OBSCURED WARNING MESSAGE AND NO DTC'S STORED

Service Alert No.: SA-003/21

## **APPLICABLE MODEL(S)/VINS**

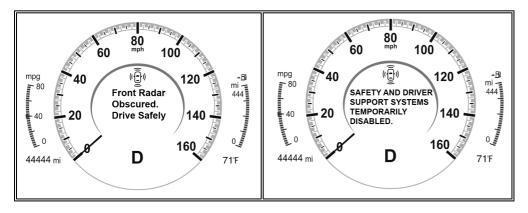
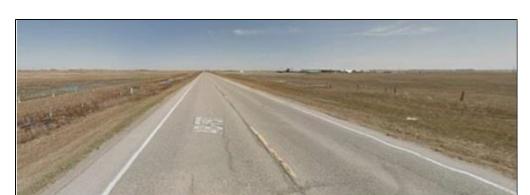
- While using Mazda Radar Cruise Control (MRCC), the MRCC cancels by itself.
- When MRCC is not in use, "Safety and Driver Support Systems Temporarily Disabled. Front Radar Obscured."
  message appears in the instrument cluster / "Remove dirt on the front radar sensor" message appears in the
  center display and related i-ACTIVSENSE functions stop working.

This is caused by the front radar (under specific road conditions) detecting a false error as if the radar sensor is dirty, resulting in cancellation of the MRCC. (no metallic object reflects the radar wave such as a vehicle ahead, an oncoming vehicle, a road sign or a guard rail).

- Yes: Replace the front radar sensor, then go to next step.
- No: No repair is needed at this time.
  - Document your inspection results on the repair order.
  - Mazda will take note of the concern and all information gathered will be forwarded for research.
