Subject: CONNECTED VEHICLE SYMPTOM TROUBLESHOOTING	Service Alert No.: SA-013/21
	Last Issued : 04/27/2021

2019-2021 Mazda3
2020-2021 CX-30
2021 CX-5
2021 CX-9

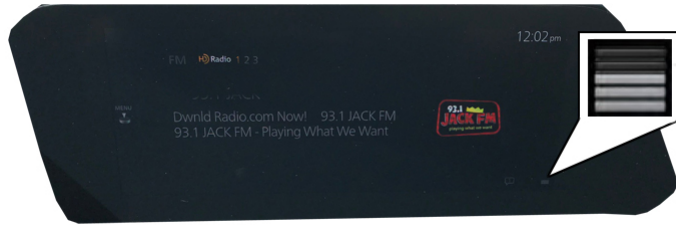
Confirm the customer's phone and vehicle have good to strong reception during the concern as shown in the table below.

Indication	Explanation
	Radio waves are not being received. Move to a location with good reception.
	Weak reception.
	Good Reception
	Strong reception.
	Currently conducting an operation check of the communication unit. If this condition continues, consult an Authorized Mazda Dealer.
	Currently conducting an operation check of the onboard communication unit. NOTE: Communication is not possible during this display.
<p>CX-5, CX-9</p>	<p>The communication function is temporarily disabled due to infotainment system setting.</p>
<p>Mazda3, CX-30</p>	<ul style="list-style-type: none"> • Connected Service contract has ended (Subscription expired) • Customer deactivated Connected Services (Opt-Out)

- If the reception is weak, move the vehicle to a location where the reception is good to strong as shown in the table, then try to get the Authorization Code and/or operate the remote functions before proceeding to the Repair Procedure if there is still an issue.
- If the reception is good to strong, proceed to the Repair Procedure.

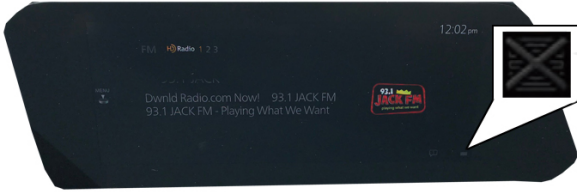
Mazda3, CX-30

- Connected Services via the MyMazda app
- MAZDA CONNECT connected vehicle reception strength icon shows "X" or "\".

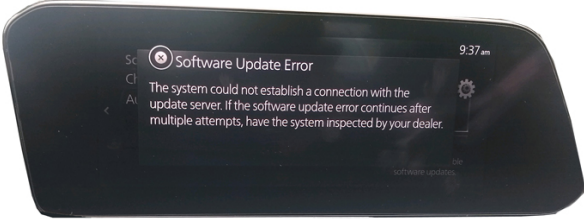
<p>Go to CSP07 Repair instructions.</p>
<p>2020 Mazda3 only:</p> <ul style="list-style-type: none"> • Infotainment center display does not provide Authorization Code during the MyMazda App Connected Vehicle enrollment and infotainment Software Update Error message.

<p>Go to SSPC1.</p>
<p>2021 Mazda3 and CX-3 functions inoperative:</p> <ul style="list-style-type: none"> • Vehicle Status Alert • Remote Engine Start / Stop • Remote Door Lock / Unlock • Remote Hazard Lights ON / OFF • Vehicle Finder (vehicle location mapping function is available) 	<p>Vehicle's electrical control area network (CAN) is in "Sleep Mode".</p>
