Technical Service Bulletin

90 Instrument cluster: car silhouette depicts the wrong model

90 21 01 2063086/1 April 30, 2021.

Model(s)	Year	VIN Range	Vehicle-Specific Equipment
RS 5	2021	All	Audi virtual cockpit

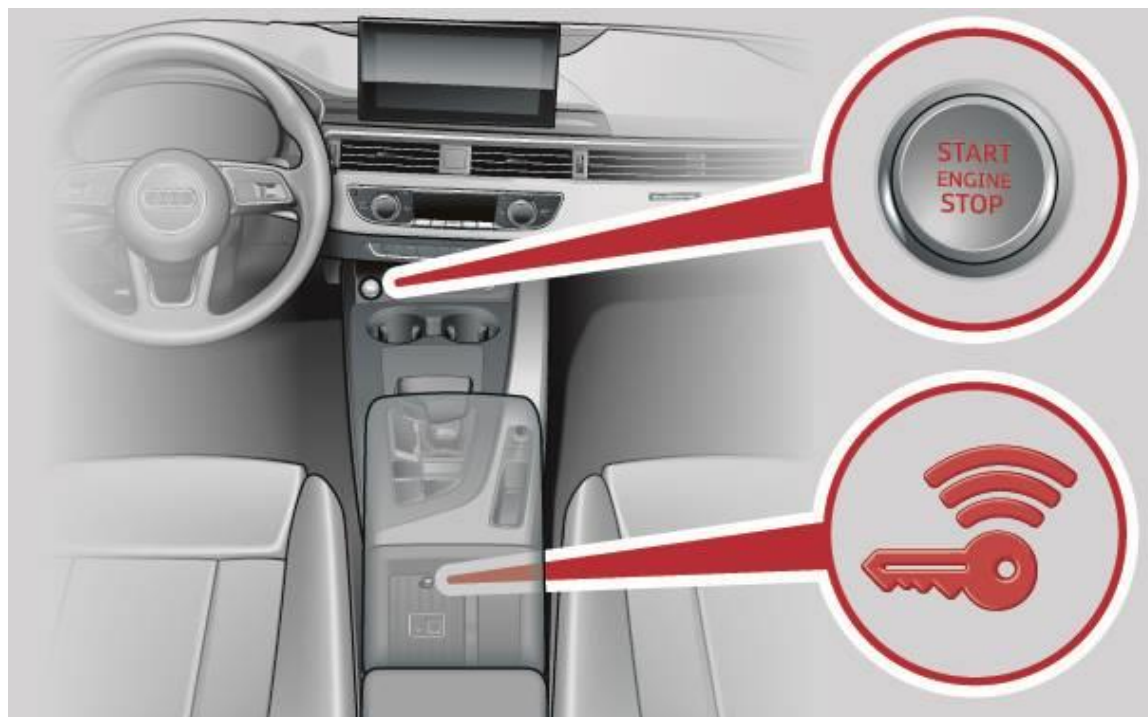
Figure 1. Center console in the Audi RS4/RS5 with a mark for the vehicle key (example).

1. Locate and affix the vehicle's key over the key transponder coil (Figure 1).

2. If the message "...hold the vehicle key on the transponder..." is displayed, make sure that the vehicle's key is correctly placed. Keep the key on the transponder coil until the update is finished.
3. Update the Instrument Cluster using either Method 1 or Method 2 according to TSB 2060523: *91 MIB3 Software Update Instructions* and use SVM code FPKWW0161.
